Town Creek: Path to Recovery

For: Eel River Recovery Project

December 31, 2018

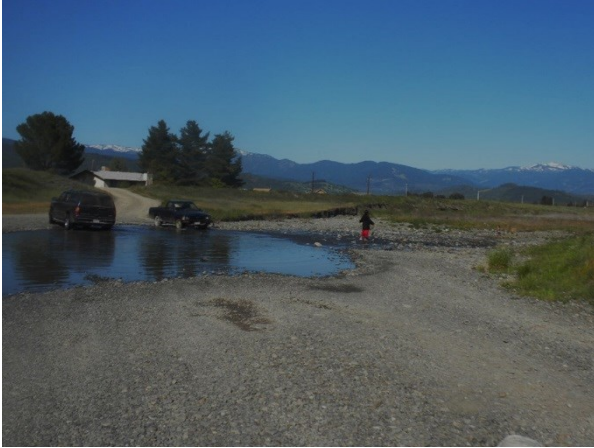
Town Creek only flows seasonally on the valley floor near Covelo, although this may not have been its historic condition. Today surface flows resume with rains in fall, but by late May to mid-June the creek loses surface flow (Figure 2). This is highly undesirable since the stream was likely historically perennial and loss of summer surface flow greatly diminishes aquatic productivity including production of juvenile salmonids. Town Creek likely maintains perennial surface flow in headwater areas (Figure 3) but slips beneath the surface as it hits the valley floor.

Figure 2. Town Creek with no riparian on valley floor.

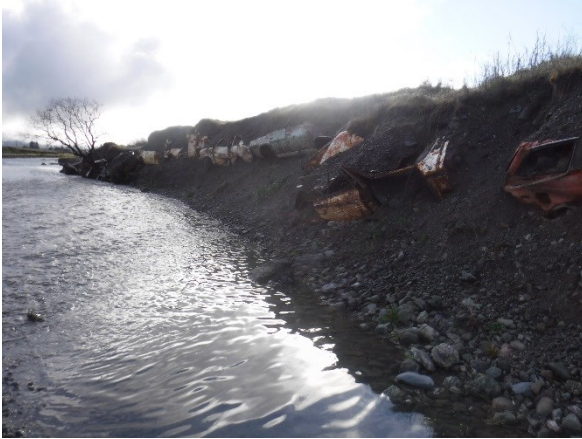
Town Creek has a long history of bank stabilization using car bodies (Figure 5) and truck tires (Figure 6). According to local residents, this was a technique used through the middle 1980's and was actually subsidized as a method of erosion control. The tires and cars leak low levels of toxics into the environment. Car bodies can produce jagged edges and present a hazard to people and migrating fish.

Figure 5. Car bodies used for stabilization embedded in bank.

This report recommends that planning begin immediately to restore the reach of Town Creek immediately downstream of Airport Road. Figure 11 shows where bioengineered structures should be used to replace cabled truck tires and car bodies in this reach. However, channel excavation should be undertaken to direct the flow off the north bank where a 10 foot high cut-bank has developed. If such action is not taken, bank erosion at this location will increase and ultimately could threaten residential parcels nearby. After recontouring the channel, willow baffles would be installed to stabilize the gravel bar and to trap new sediment that would help continue to build a point bar. One isolated reach of the south bank is also eroding, and it would need treatment with rock and willow structures.

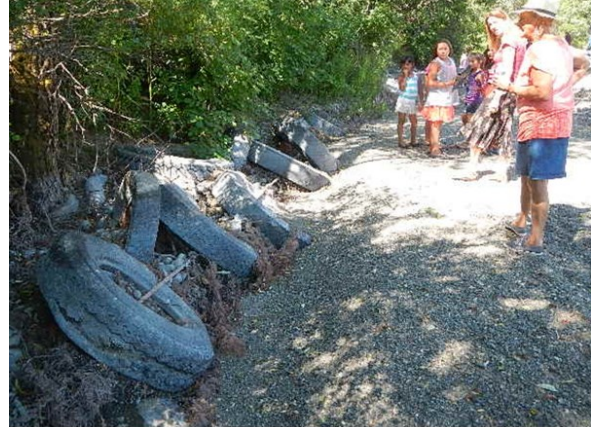
Figure 6. Cabled truck tires used to prevent Town Creek bank erosion.

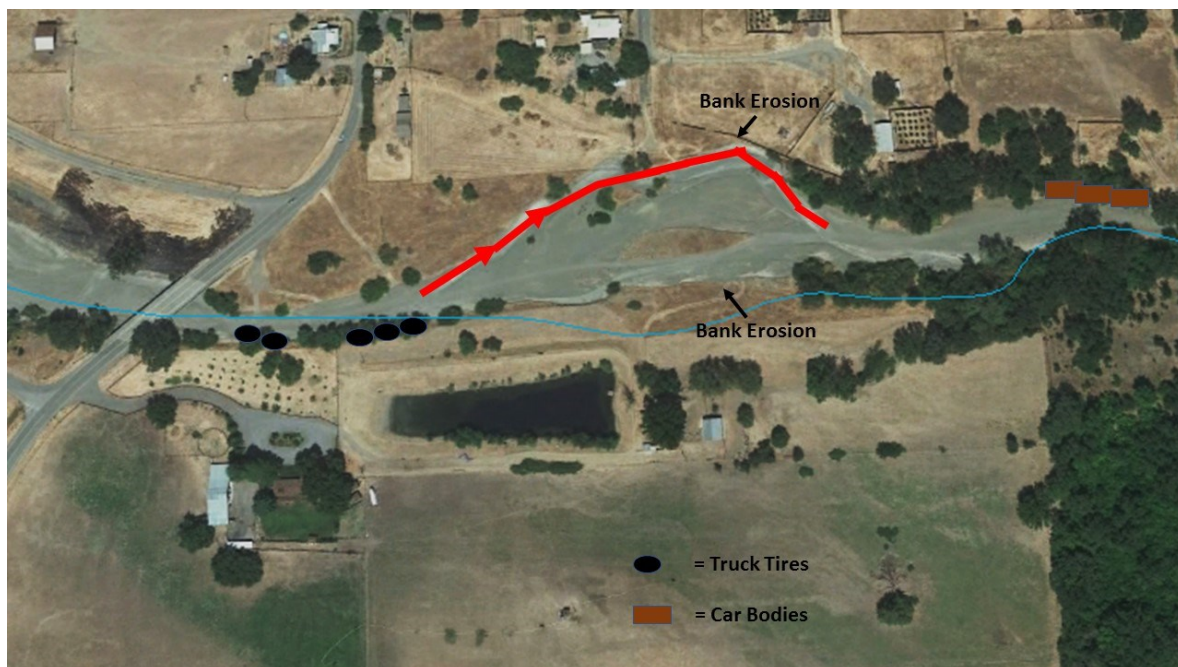
The reach of Town Creek of greatest interest with regard to restoration is just downstream of Airport Road, which is the study reach used by RVES teachers and ERRP. While the riparian conditions improve at this location, the stream flow skews to the north just downstream of the Airport Road bridge and is creating a substantial bank erosion problem (Figure 7).

Figure 7. Town Creek reach below Airport Road with current channel (red line), areas of eroding banks, and locations of car bodies and truck tire bank stabilization.

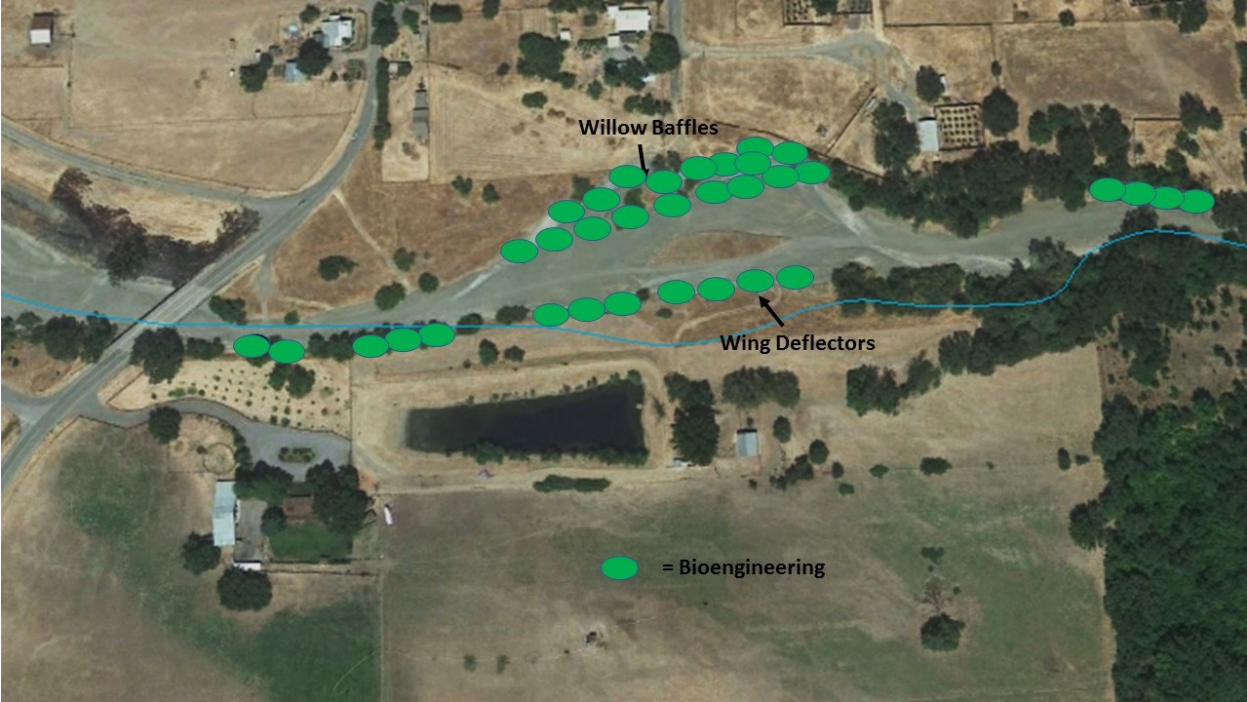
Figure 11. Recommended treatment for Town Creek channel downstream of Airport Road bridge.
