***Eel River 2017 Channel Change Duality:
Rejuvenation of Salmonid Juvenile Habitat and Potential Egg Mortality***

**By: Patrick Higgins, Consulting Fisheries Biologist
For: Friends of Van Duzen River & Trees Foundation
Funded by: The U.S. Forest Service/Six Rivers National Forest - More Kids in the Woods**

January 8, 2018

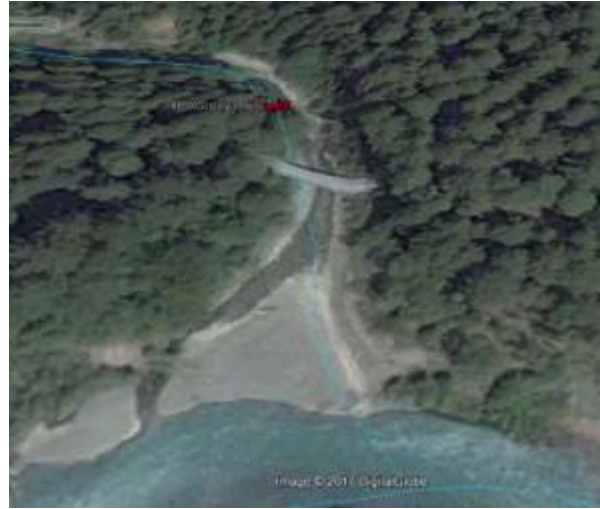
Figure 2. Grizzly at Van Duzen - May 2006

Aerial photographs of the mouth of Grizzly Creek are available on Google Earth back to 1998, but the quality of photos is highly variable. The 1998 photo shows this location as highly aggraded in August 1998 (Figure 1) as a result of major sediment over-supply with no possibility of establishment of willows. By 2006 (Figure 2), the channel has cut down and is bifurcated, with most flow in the northern channel, but has no sign of willow or alder establishment. By 2014 (Figure 3), there is well established willow across the bar, which was likely aided by the 2013-2014 drought. Flow of Grizzly Creek just above the Van Duzen in this reach had stabilized on the north side of the channel and had developed good riparian canopy. The 2016 photo (Figure 4) shows the Grizzly Creek channel had shifted to the center of the floodplain. The large cobble and small boulders visible in the aerial photo are indicative of bed coarsening, which co-related with sorting of smaller (hard ball to soft ball sized) suitable for Chinook salmon spawning.

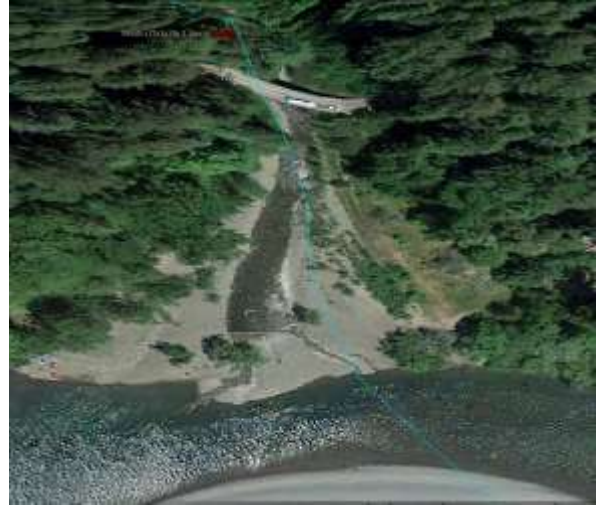
Figure 4. Grizzly at Van Duzen - May 2016

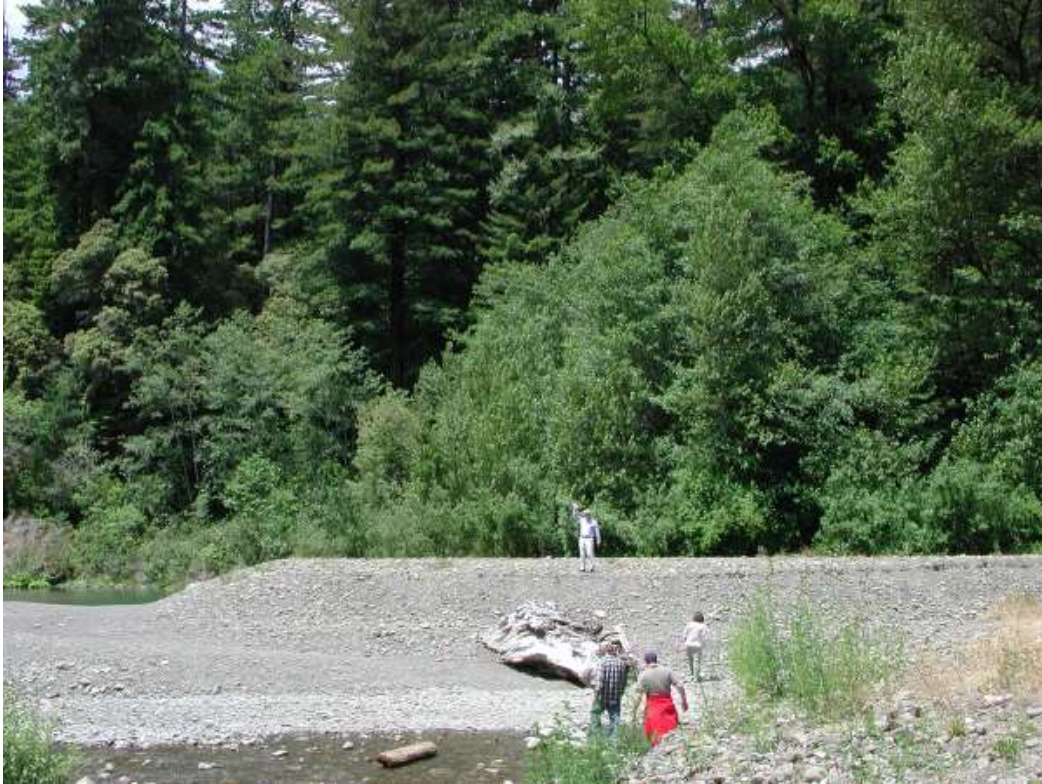
Figure 5. Delta at the mouth of Grizzly Creek 6-10 feet high. July 2003.

Ground photos taken on FOVDR field trip to the mouth of Grizzly Creek show bedload transport on the order of 6-10 feet as indicated by the height of the delta (Figure 5). A photo from the same period looking upstream towards Highway 36 also shows major terrace features indicating the previous winter's bedload transport (Figure 6). The stream bed remains dominated by gravel less than 40 mm, which is indicative of recent disturbance and sediment over-supply (Knopp 1993).

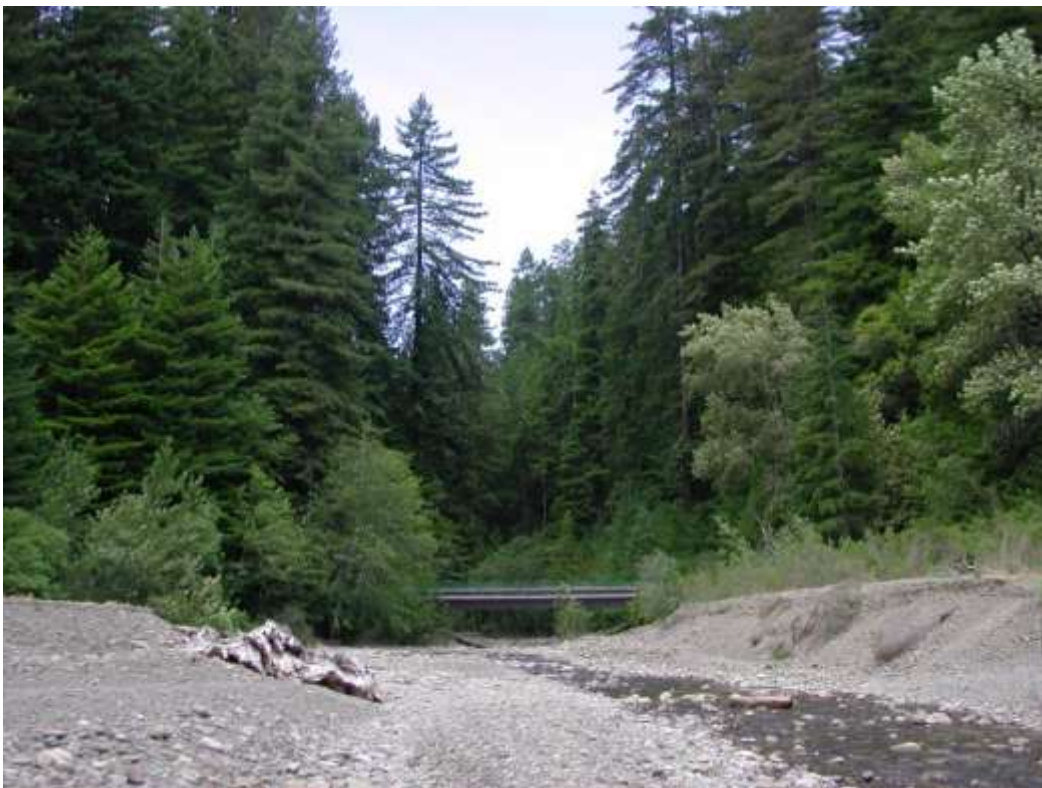
Figure 6. Grizzly Creek looking upstream from the mouth with Highway 36 Bridge for reference. Terraces and small D50 of material in transport indicate high annual bedload mobility and scour and fill that would kill salmon eggs. July 2003.

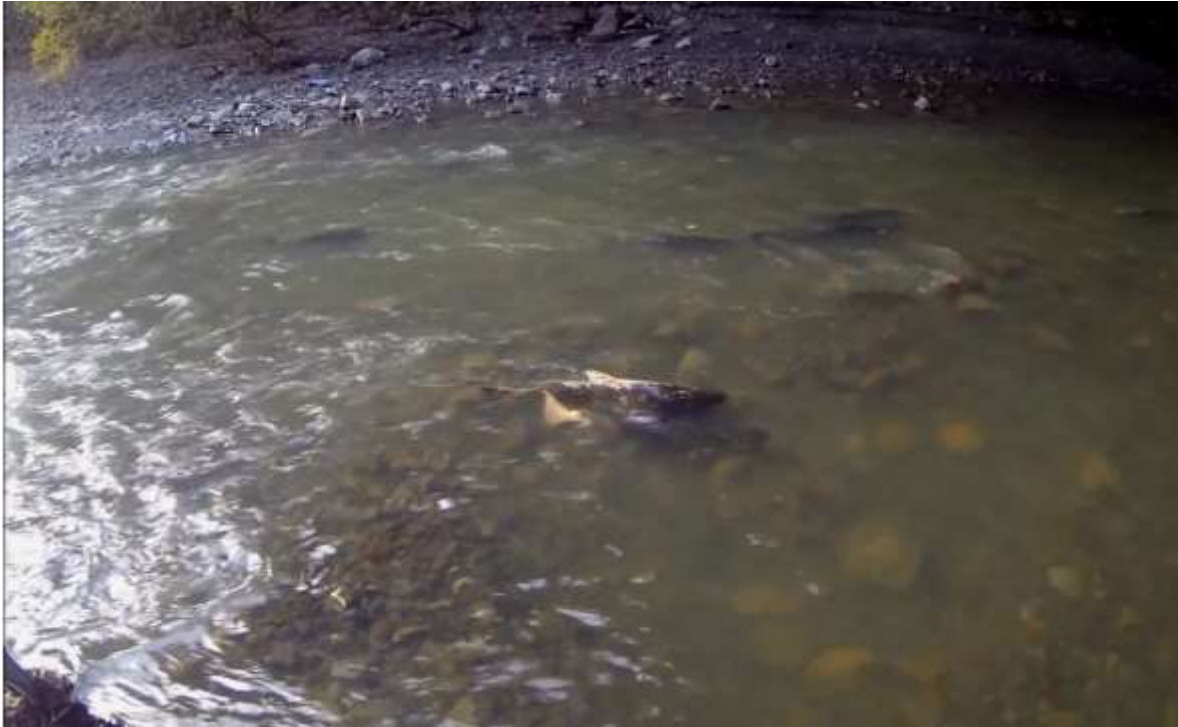
Figure 7. Spawning Chinook salmon in Grizzly Creek. 12/2/2016. Screen grab from Sal Steinberg video: <https://vimeo.com/196968491>

The More Kids in the Woods field trip of December 2, 2017 found ideal Chinook salmon substrate and Chinook salmon spawning actively (Figure 7). Where there were copious spawning gravels in 2016 and little fine sediment, by a year later conditions had reversed and there was far less spawning substrate and more sand and silt present (Figure 8). There were just two redds in the reach that had more than a dozen the year before. Did the bed change during the incubation of eggs that the students saw deposited and before the emergence of alevin as fry that could escape high flows? (See Peak Flow and Bedload Movement).

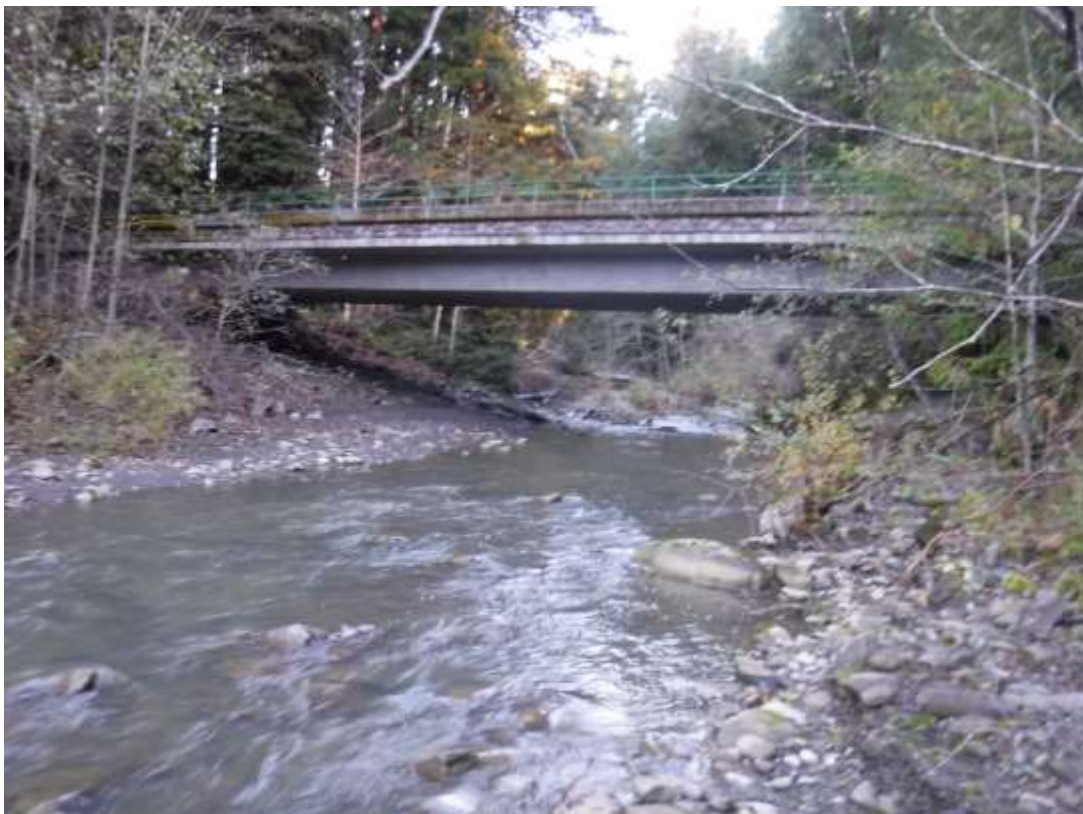
Figure 8. Grizzly Creek channel at same location as 2016 spawning, but bed had changed dramatically, including an increase in fine sediment and a decrease in optimal Chinook spawning substrate. 12/2/2017.

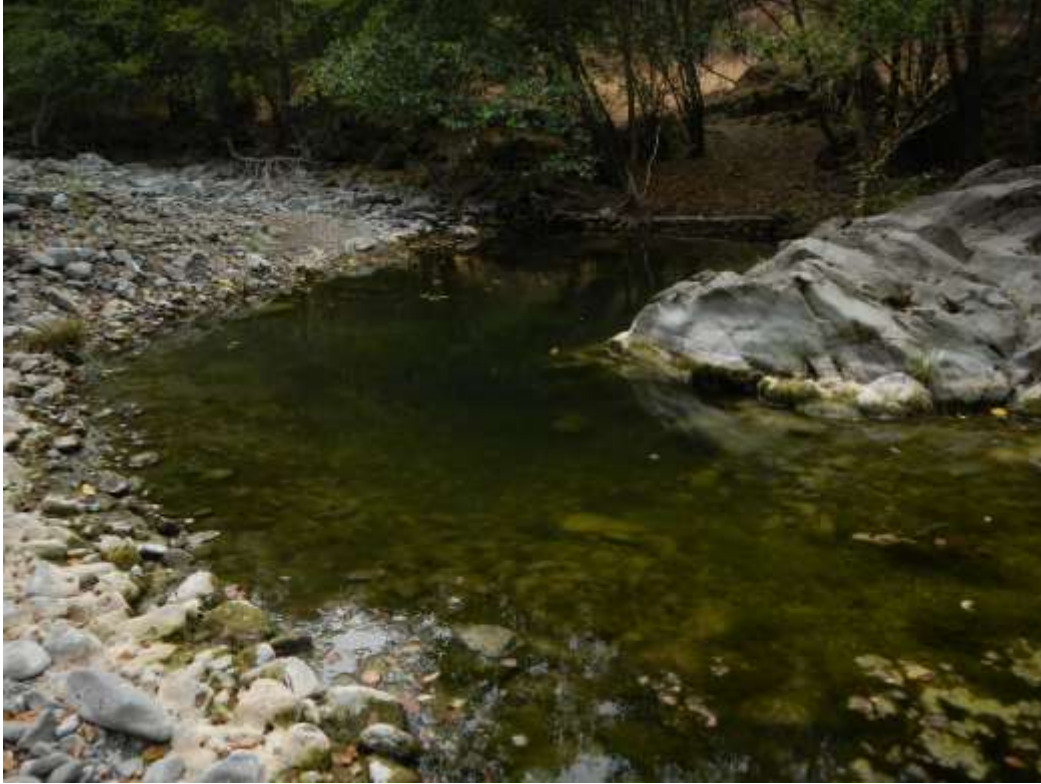
Figure 9. Pool on Chamise Creek in August 2014. Note how small inlet is at top.

While high flows in the 2015 WY had caused some bed movement, major channel changes were evident towards the end of the 2016 WY in July 2017. Figure 9 shows channel conditions in 2013 and Figure 10 is from 2017. Where Chamise Creek formerly had gravel bars with rocks less than the size of a golf ball, the winter flows flushed them downstream leaving a coarser stream bed and deeper pools and pockets for fish habitat. Figure 11 shows suspended alder tree roots indicating stream incision and Figure 12 is a cross section view of the cobble terrace that eroded during high flows in the 2016 WY. Where steelhead juveniles present before down-cutting were typically young of the year, yearling and older steelhead were present in 2017. A time-lapse camera placed on Chamise Creek shows flow flux and flow peaks that caused bedload movement (Figure 13 & 14).

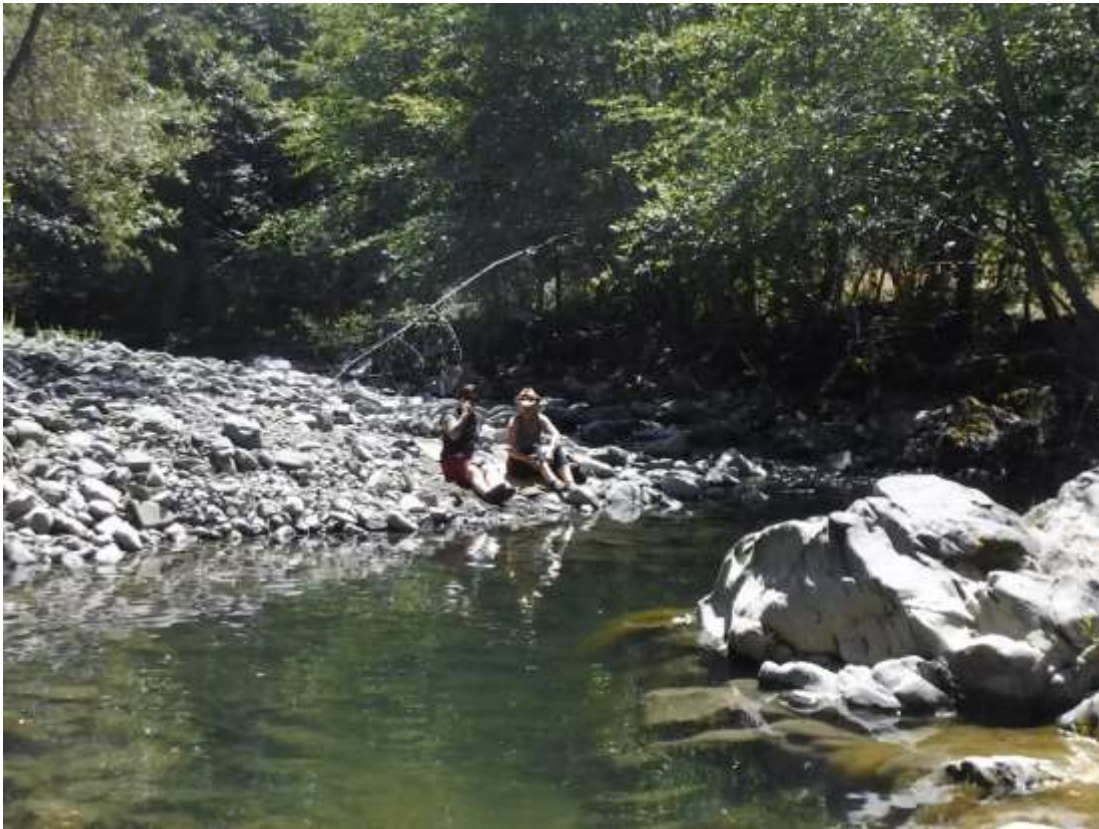
Figure 10. Chamise Creek pool scoured deeper and inlet broadened and down cut. July 2017.

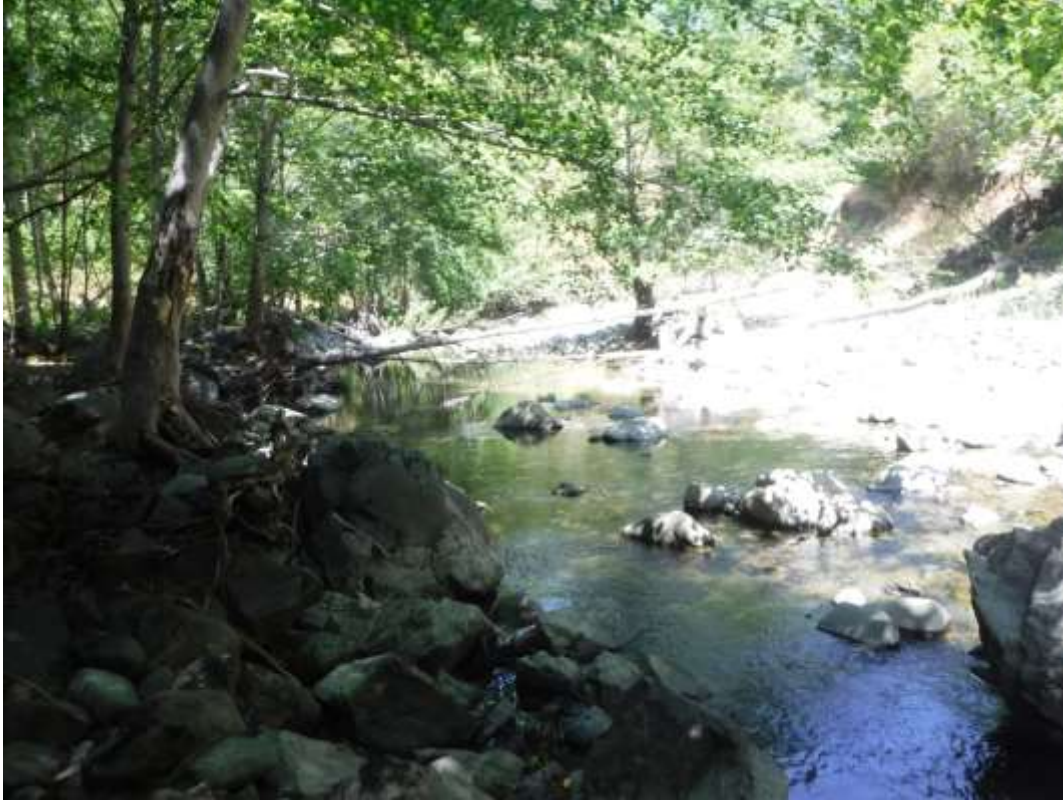
Figure 11. Chamise Creek scour evident from hanging alder roots with channel deep enough to hold older age steelhead. July 2017.

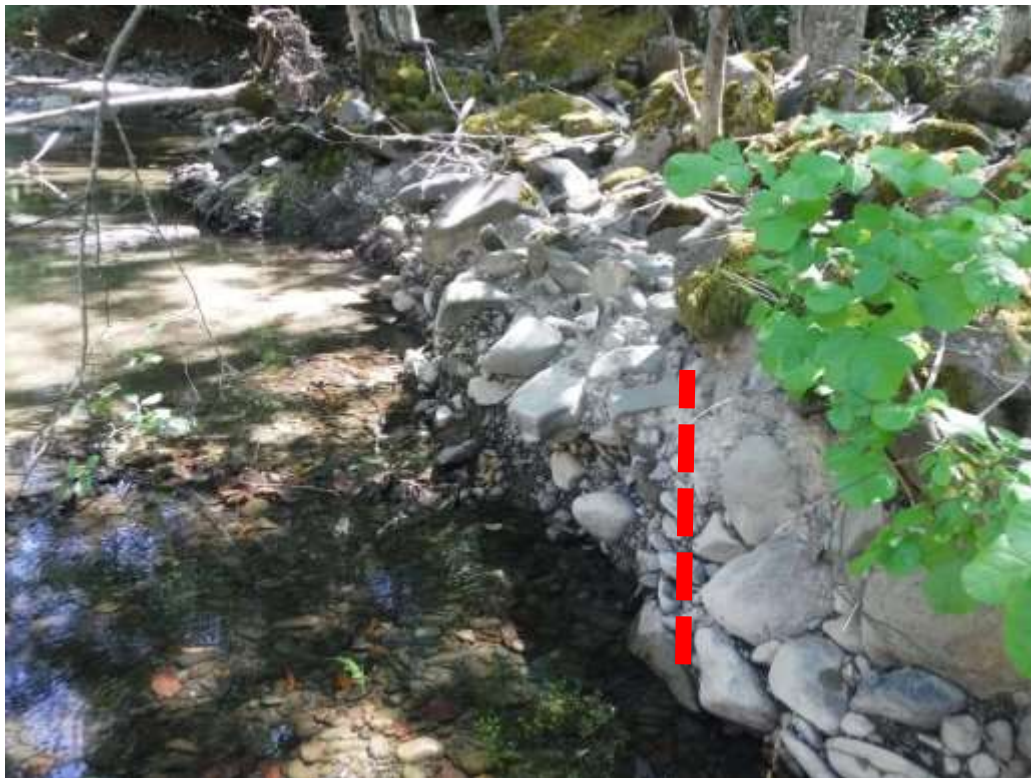
Figure 12. Cross section of cobble terrace in place since 1964 and more than 2 feet of incision in 2016 WY.

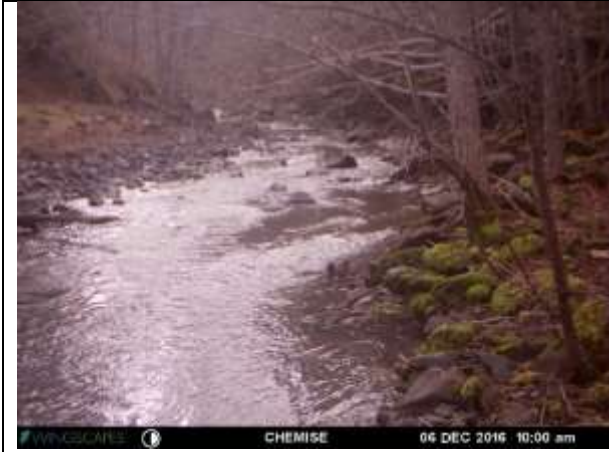
Figure 13. Low flows in early December 2016.

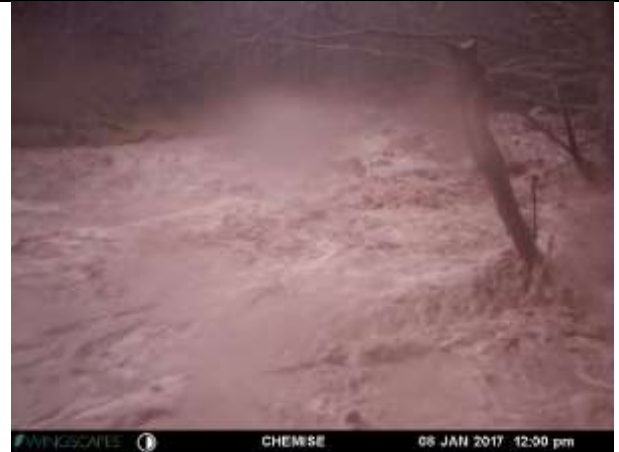
Figure 14. Chamise – January 8, 2017.

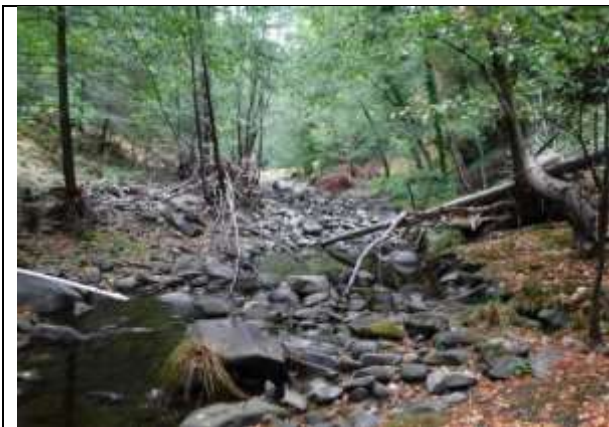
Figure 15. Sproul at Bruckenstein's – October 2015.

Lower Sproul Creek: ERRP Volunteer Larry Bruckenstein maintains a timelapse camera and deploys water temperature gauges on Sproul Creek on his property, not far upstream of the convergence with the South Fork Eel River. Timelapse camera images show low (Figure 15) and high flows (Figure 16). Figures 17 and 18 show Sproul Creek before scouring flows in the 2016 WY. The increased depth and complexity improved steelhead rearing habitat (Figure 19)

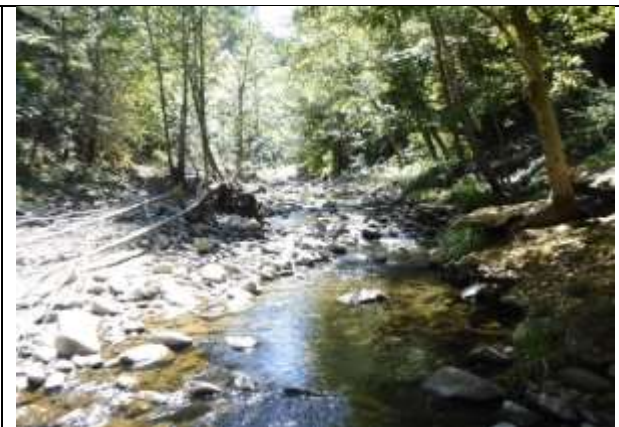
Figure 16. Sproul Cr. at Bruckenstein's, July 2017.

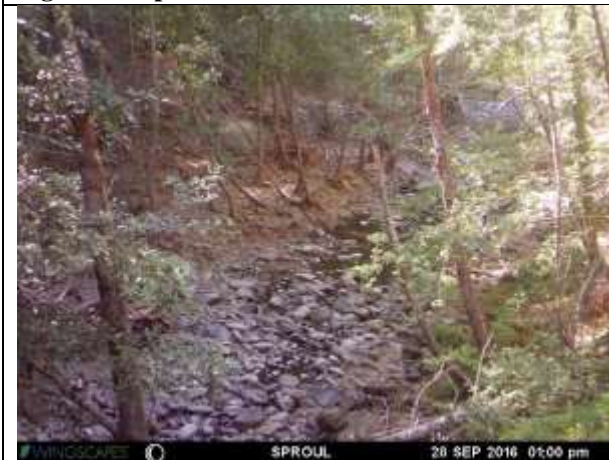
Figure 17. Sproul at Bruckenstein's – 9/28/16

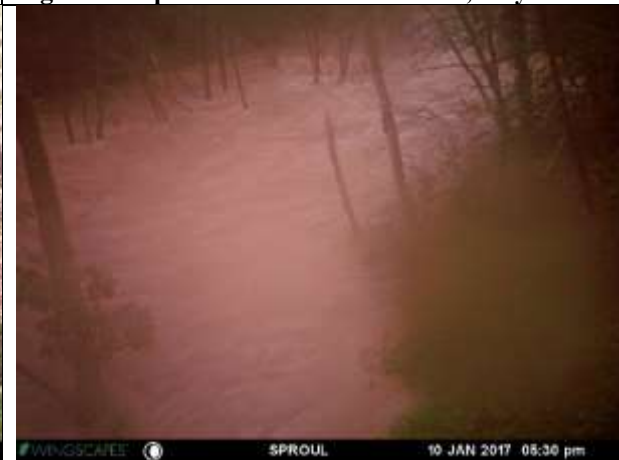
Figure 18. Sproul at Bruckenstein's – 1/10/17

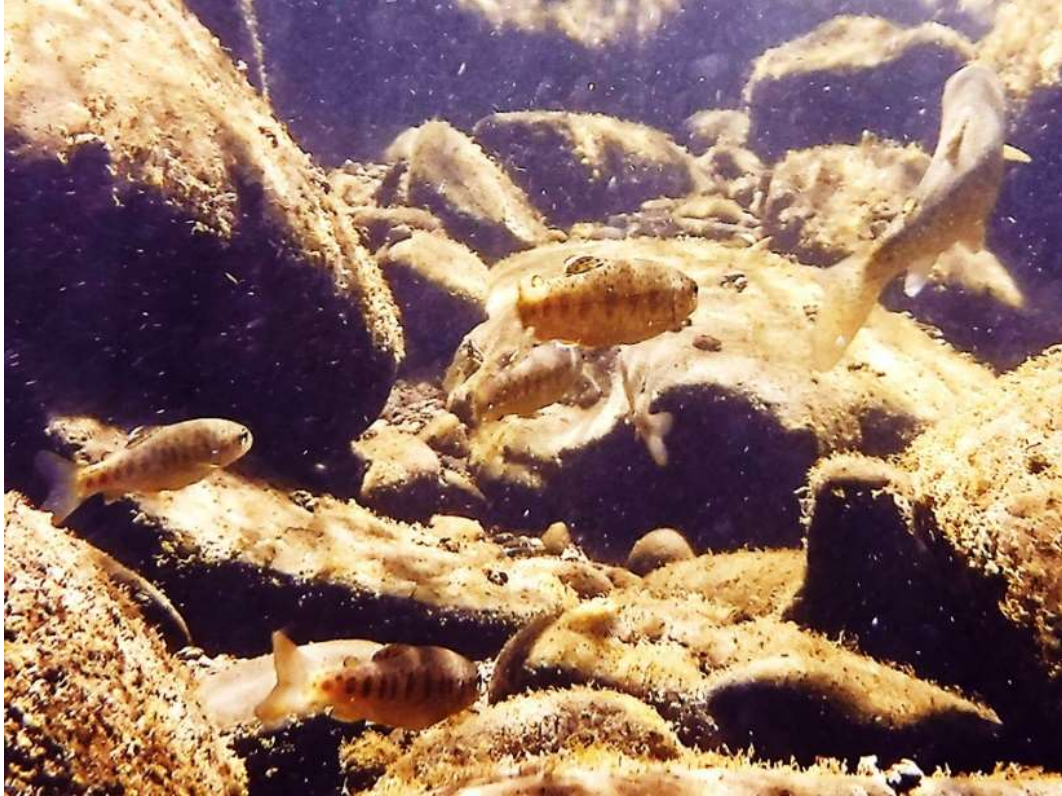
Figure 19. Several age classes of steelhead feeding in rejuvenated Sproul Creek habitat. 7/23/17.

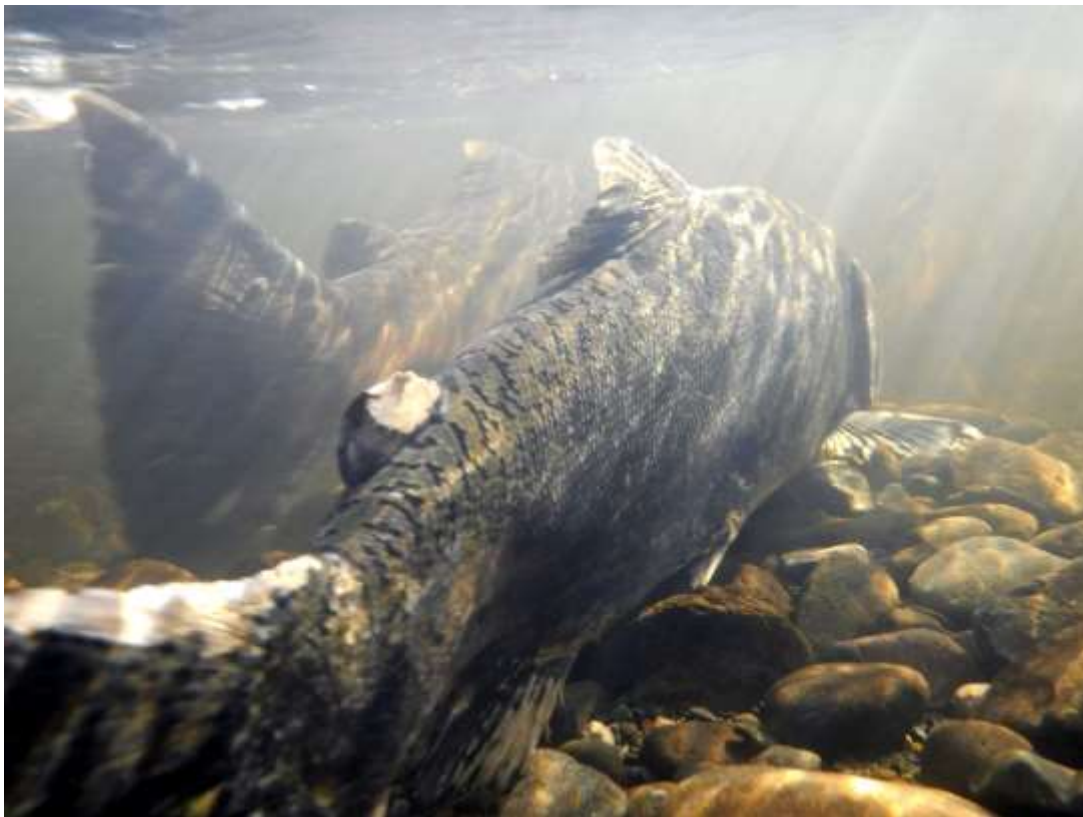
Figure 20. Spawning fall Chinook in Tenmile Creek at Black Oak Ranch. 11/16/16.

Tenmile Creek at Black Oak Ranch: ERRP found substantial numbers of spawning fall Chinook in Tenmile Creek in November 2016 and video documented spawning on the Black Oak Ranch not far downstream of Streeter Creek (Figure 20). The ideal spawning conditions were in a pool tail crest just above where the channel of Tenmile Creek flowed into a channel on the eastern bank (Figure 21) that had been in part created by a previous bioengineering project.

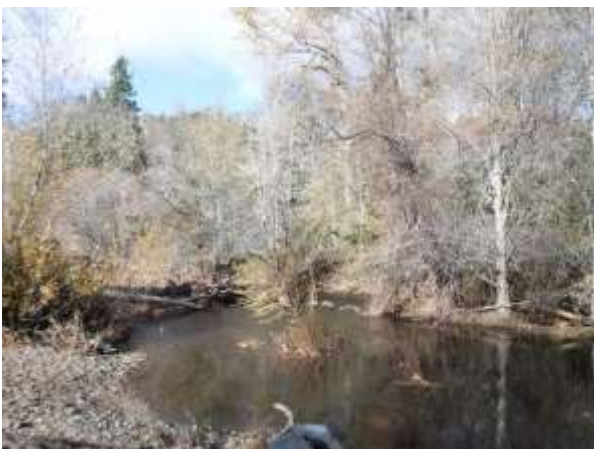
**Figure 21. Tenmile Creek at Black Oak Ranch
Chinook salmon spawning area. 11/16/16.**

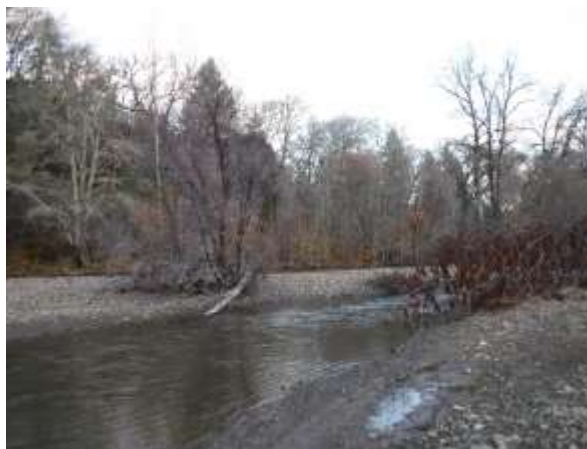
**Figure 22. Tenmile Creek at Black Oak Ranch with
new side channel below spawning beds. 11/27/17.**

Sometime during high flows in the 2016 WY, a whole tree with its root ball facing upstream lodged below the spawning area, created scour, and caused the channel to braid (Figure 22). This likely also caused bedload shift of sufficient magnitude to cause egg and alevin mortality.

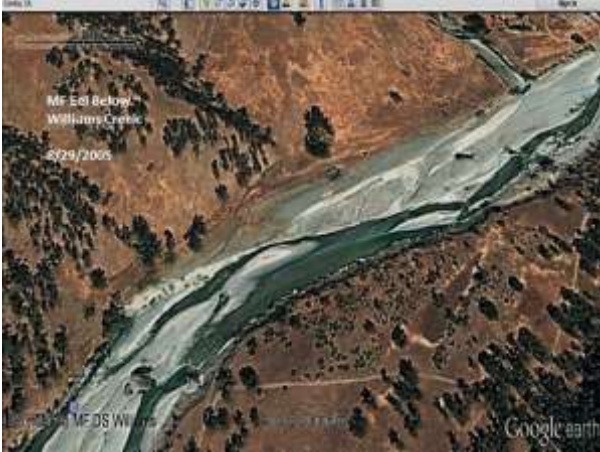
Figure 23 . MF Eel below Williams Cr. August 2005

Middle Fork Eel Below Williams Creek: ERRP monitors the Middle Fork Eel just downstream of Williams Creek with the Round Valley Indian Tribes Environmental Protection Agency for both temperature and cyanotoxins. The MF Eel has recovered substantially from past flood effects and there are indications that salmon spawning substrate conditions are ideal throughout most of the watershed, including tributaries Williams and Murphy Creek and the Black Butte River (Higgins 2013, 2014, 2016, 2017). These channels are widely used by Chinook salmon depending on the available flow, but aerial photos of the MF Eel below Williams Creek show considerable shift in channel location from 2005 to 2017 (Figures 23-26). Channel migration in some years likely entails scour and fill processes that dislodge eggs and alevin and cause decreased survival in years of high flow.

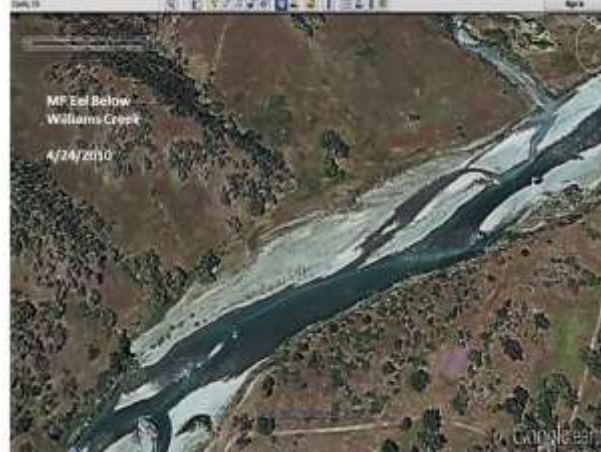
Figure 24 . MF Eel below Williams Cr. April 2010.

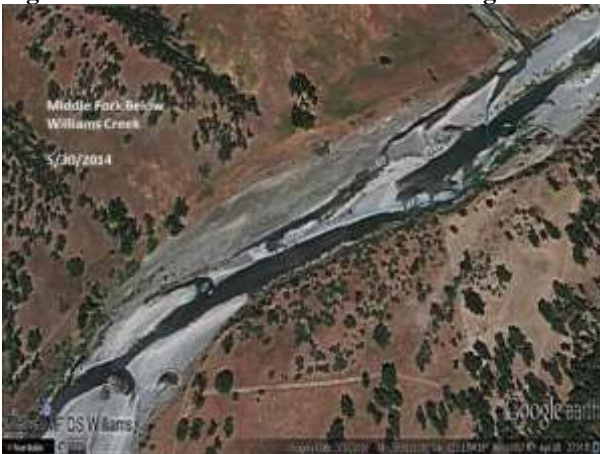
Figure 25 . MF Eel below Williams Cr. May 2014.

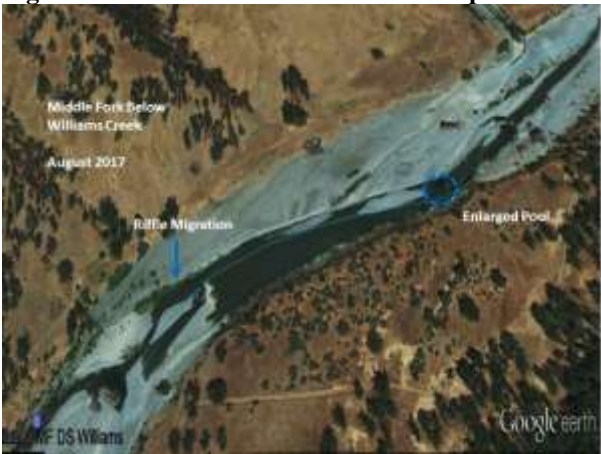
Figure 26 . MF Eel below Williams Cr. May 2014.

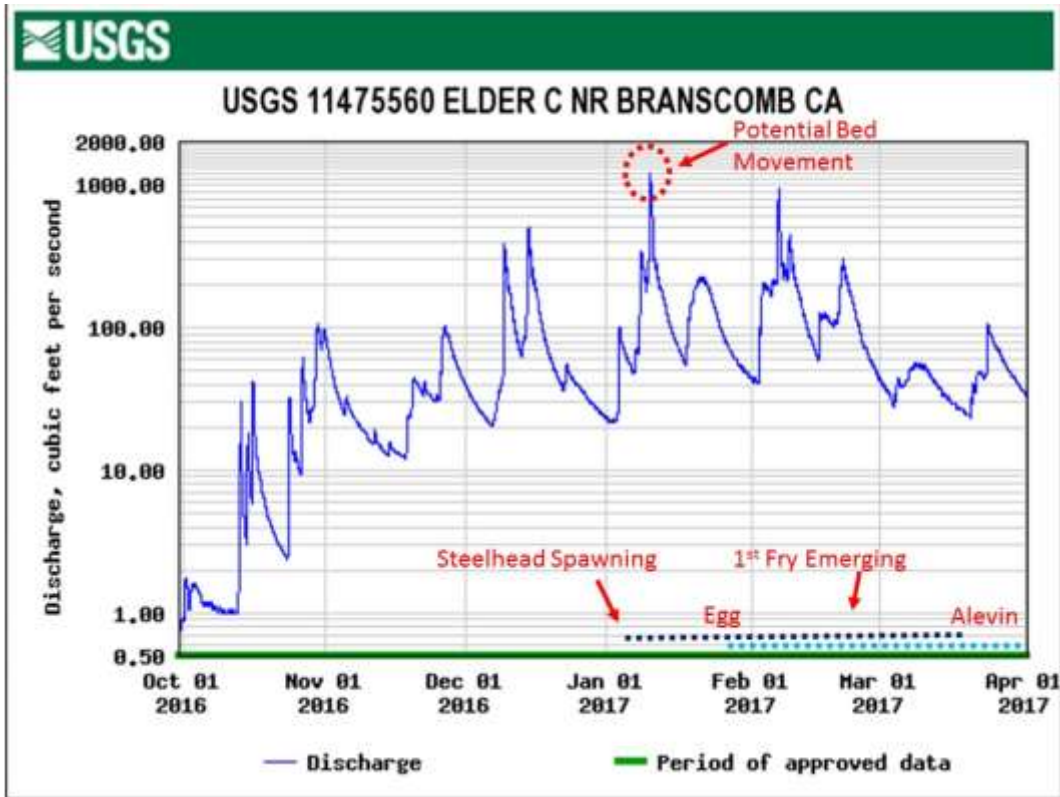
Figure 31. Elder Creek USSGS flow data with steelhead spawning information annotated.

Elder Creek is just to the west of the Tenmile Creek basin and, its flow regime from October 2016 to April 2017 (Figure 31) is interesting from two perspectives. Flow peaks are much more dampened than in Cahto Creek, which is likely due to cumulative effects in the Cahto Creek watershed causing increased peak flows. Also, the flow peak on January 10 would be earlier than steelhead spawning and Elder Creek is too steep for steelhead spawning. Therefore, there is no indication of problems for steelhead egg and alevin survival in the 20016 WY.
