*Eel River Recovery Project*

**2012 Citizen Assisted Monitoring  
Water Temperature, Flow and Toxic Algae - Final Report**

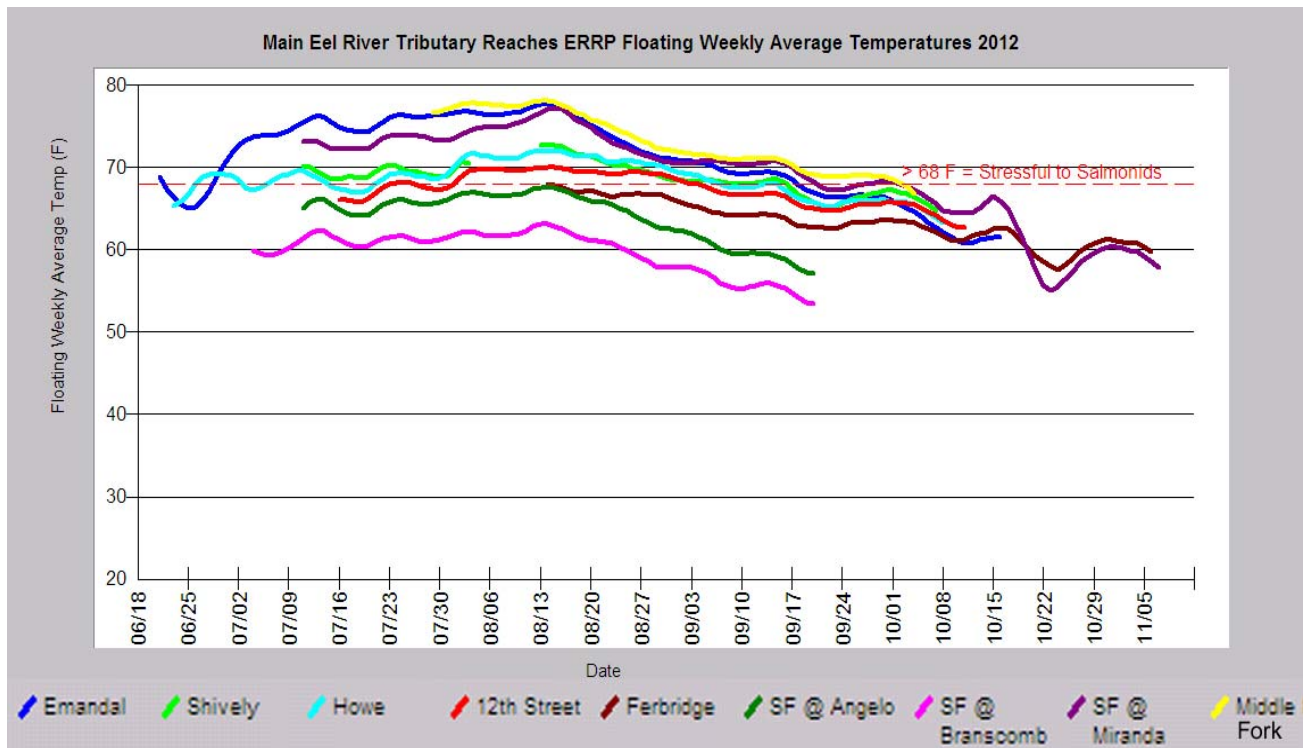
**Figure 3. Floating weekly average water temperatures at a range of mainstem Eel River sites with a reference for salmonid stress (68 F) taken from McCullough (1999).**

*Basinwide Main Eel River Reach Comparison:* Figure 3 shows water temperatures in mainstem reaches of several forks of the Eel River with a wide range of values relative to salmonid suitability. The upper mainstem South Fork above Branscomb is cool enough for coho salmon. Mainstem reaches further from their headwaters at the Middle Fork below Williams Creek, upper main Eel at Emandal and the South Fork at Miranda all fell in ranges that were highly stressful or

lethal. Water temperatures in the lower Eel River (12th, Fernbridge) are cooled by proximity to the ocean, but become elevated within a short distance upstream near Howe Creek and warmer still at Shively.

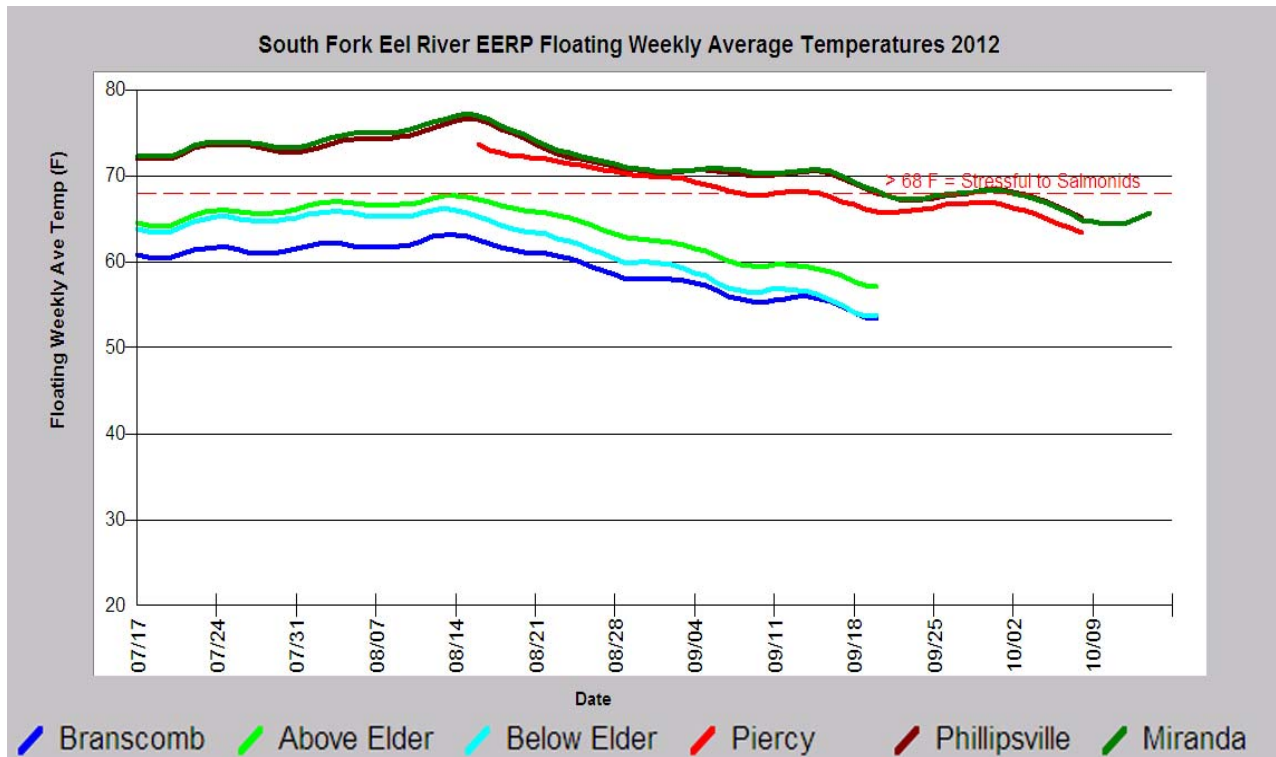
Figure 4. Mainstem South Fork Eel River water temperatures warm progressively down stream from its headwaters near Branscomb. Temperature reference for salmonid stress is from McCullough (1999).

*Mainstem South Fork Eel River:* The upper South Fork Eel above Branscomb Road and downstream within the UC Angelo Preserve (Figure 4) are some of the coolest mainstem locations in the entire Eel River basin. As the river increases in size further from its headwaters it warms considerably. The temperature near Piercy near Cook's Valley is intermediate but above optimal for salmonids, while the South Fork at Phillipsville and Miranda are both in the highly stressful range for salmon and steelhead juveniles. Temperature monitoring in the lower reach, downstream from Piercy, was also part of the toxic algae analysis project.

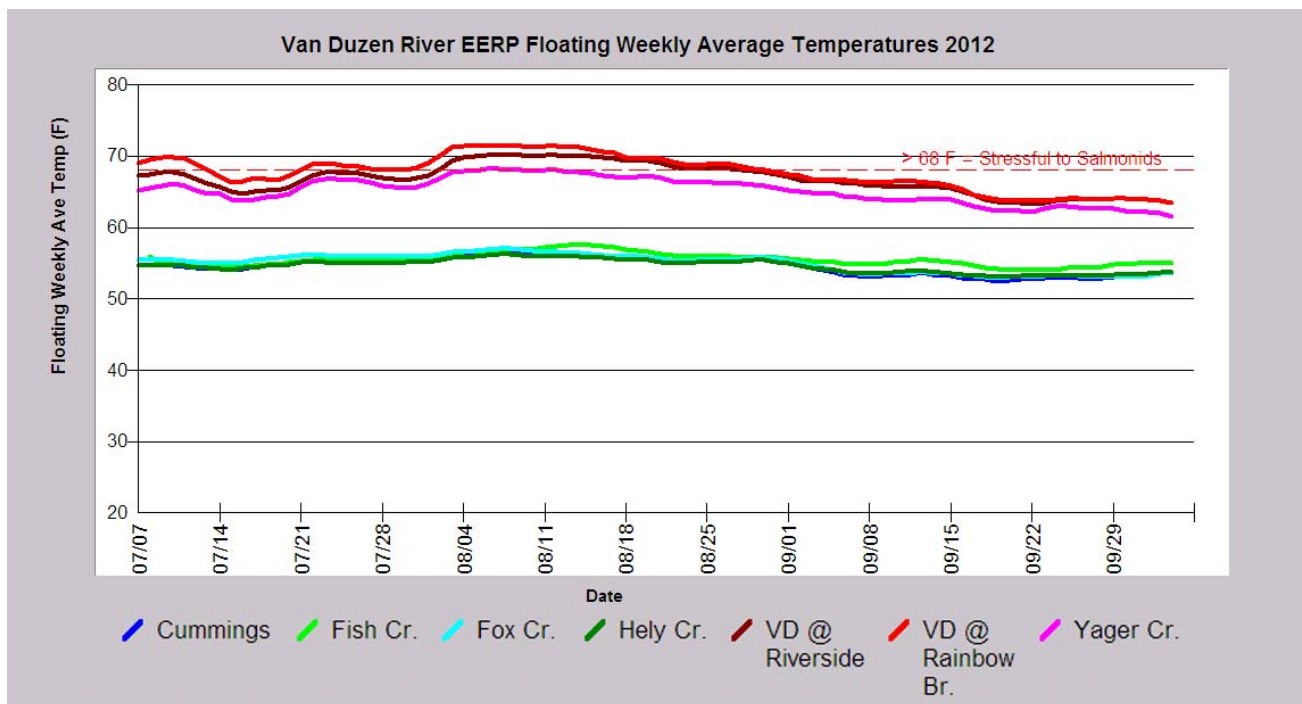
Figure 5. Some Van Duzen River tributaries had very cool water temperatures in the range suitable for coho salmon (Welsh et al. 2001) but mainstem reaches warm considerably and were in the stressful range for salmonids in 2012. Temperature reference for salmonid stress is from McCullough (1999).

*Van Duzen Tributaries and Mainstem Reaches:* The floating average weekly temperature of the mainstem Van Duzen River was in the stressful range for salmonids (McCullough 1999), while tributaries Cummings, Fish, Fox and Hely creeks were cool enough for coho salmon (Figure 5). Yager Creek is the largest Van Duzen tributary and its temperature is cooler than the mainstem but warmer than smaller streams. Temperature monitoring in the lower reach of the Van Duzen is also part of the toxic algae analysis project.

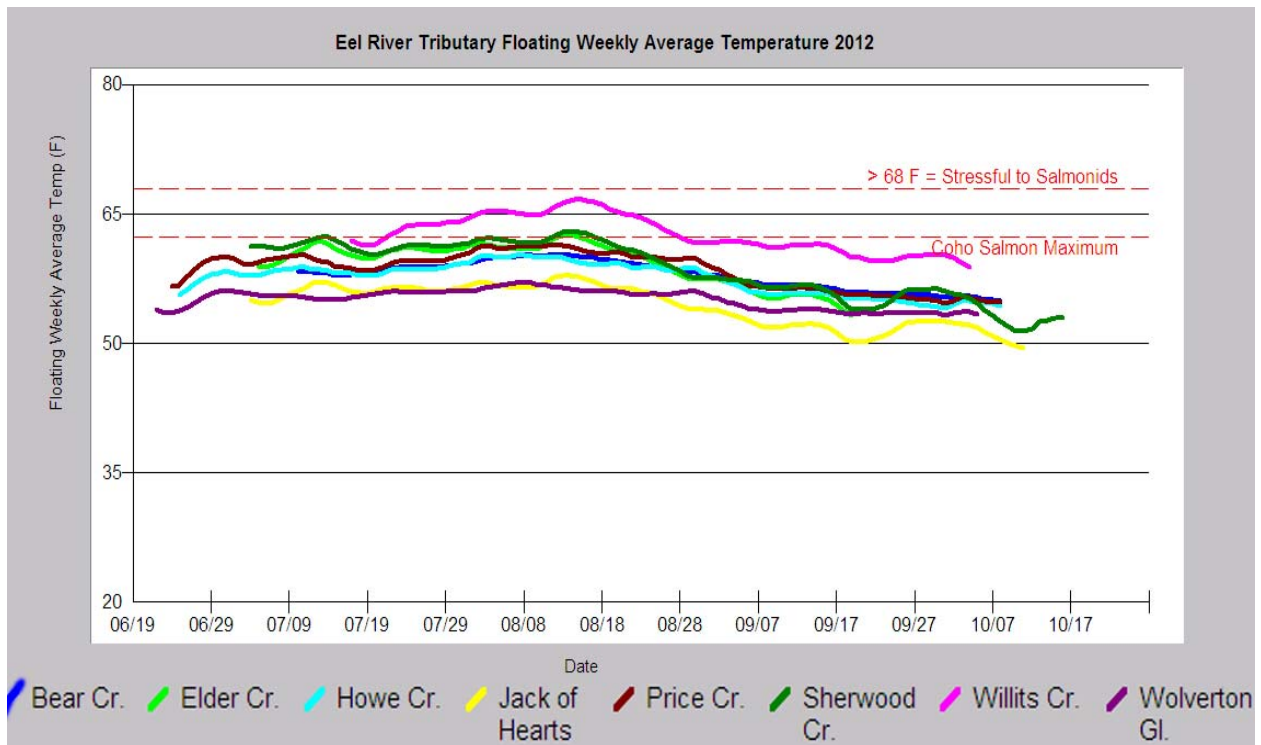
**Figure 6. Seven tributaries surveyed for temperature by ERRP in 2012 were cool enough to support coho salmon (Welsh et al. 2001), including Bear (lower Eel), Howe, Price, Sherwood, and Elder creeks and Wolverton Gulch. Reference for salmonid stress is from McCullough (1999).**

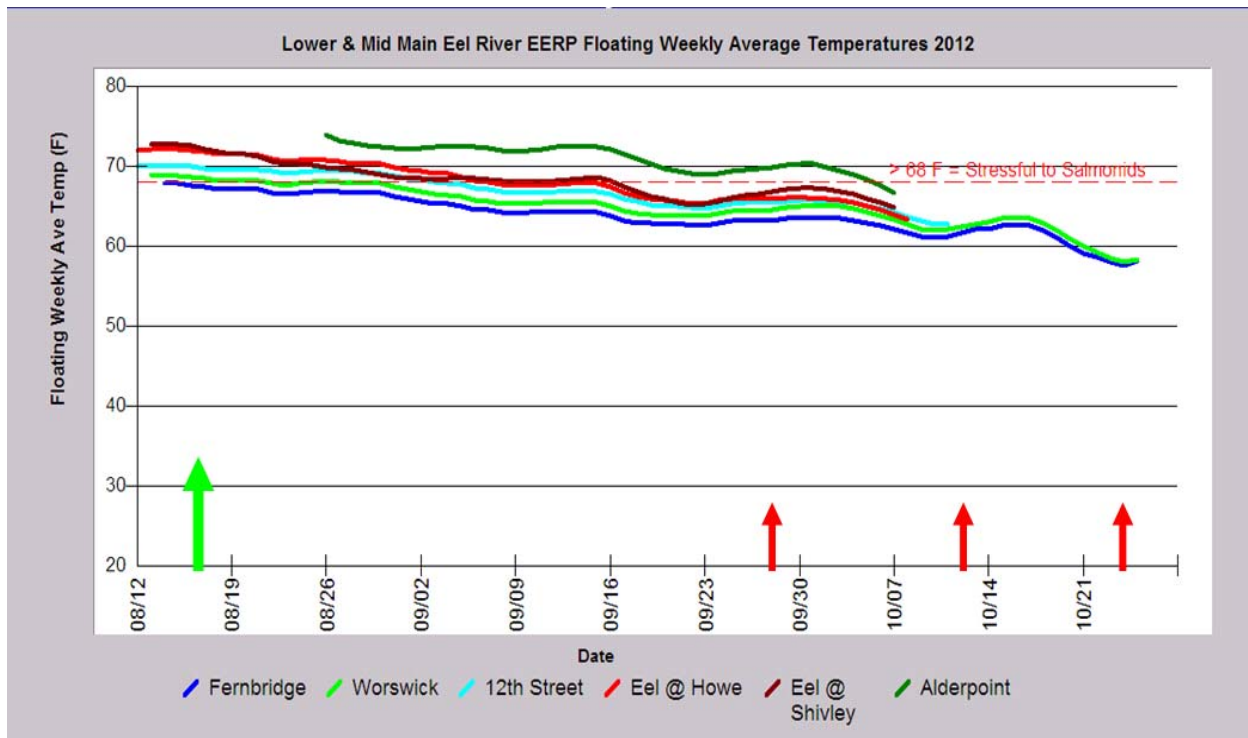
**Figure 7. Lower Eel River temperatures at several locations show that water temperatures were over stressful for adult Chinook at the time of first entry (green arrow). ERRP fall Chinook dive survey dates are denoted with red arrows. Reference for salmonid stress is from McCullough (1999).**

*Lower Eel River:* The ERRP 2012 monitoring project also focused on the lower Eel River to check for suitability for holding adult Chinook salmon (Figure 7). Water temperatures in the lower Eel River are coolest at Fernbridge and warm progressively upstream, with a substantial jump between 12th Street and Howe Creek. The main Eel near Shively, below Dyerville, is sometimes cooler than the river downstream at Howe Creek. The floating weekly water temperatures of the lower Eel River reaches accessible to Chinook salmon remained above stressful until early September. The vanguard of the salmon run entered the lower Eel on August 16 (Vincent DiMarzo, personal communication).

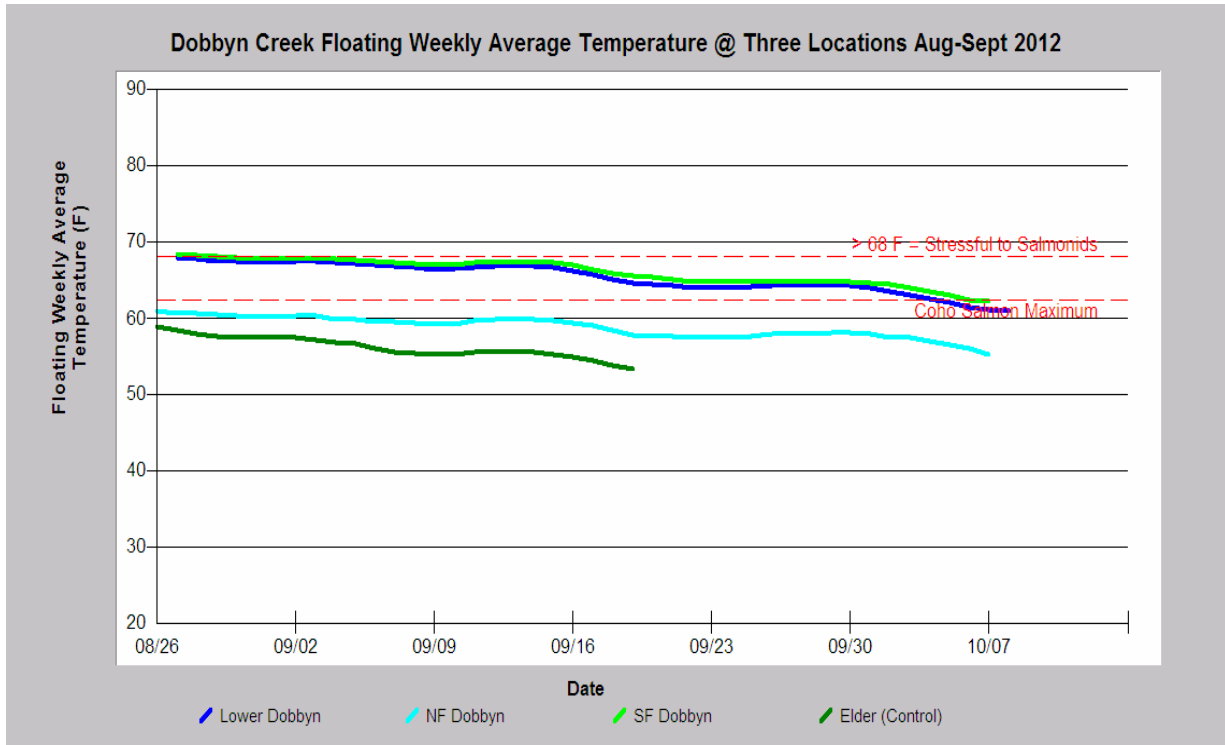
**Figure 8. Floating weekly average water temperature of lower mainstem, South Fork and North Fork Dobbyn Creek with Elder Creek included for comparison as a control stream. References from McCullough (1999) and Welsh et al. (2001).**

*Dobbyn Creek Water Temperatures:* ERRP placed automated water temperature probes in Dobbyn Creek at several locations because of a request from Casterlin Elementary School teacher Stephanie Stephano-Davis, who is concerned about possible damage to the creek as a result of an earthflow (see Discussion). Dobbyn Creek is a large tributary that joins the Eel River near Fort Seward. The water temperature near the mouth of Dobbyn Creek was cooler than the South Fork in 2012 (Figure 8). The North Fork Dobbyn had water temperatures cool enough to support coho salmon juvenile rearing and would also be optimal for juvenile steelhead rearing.

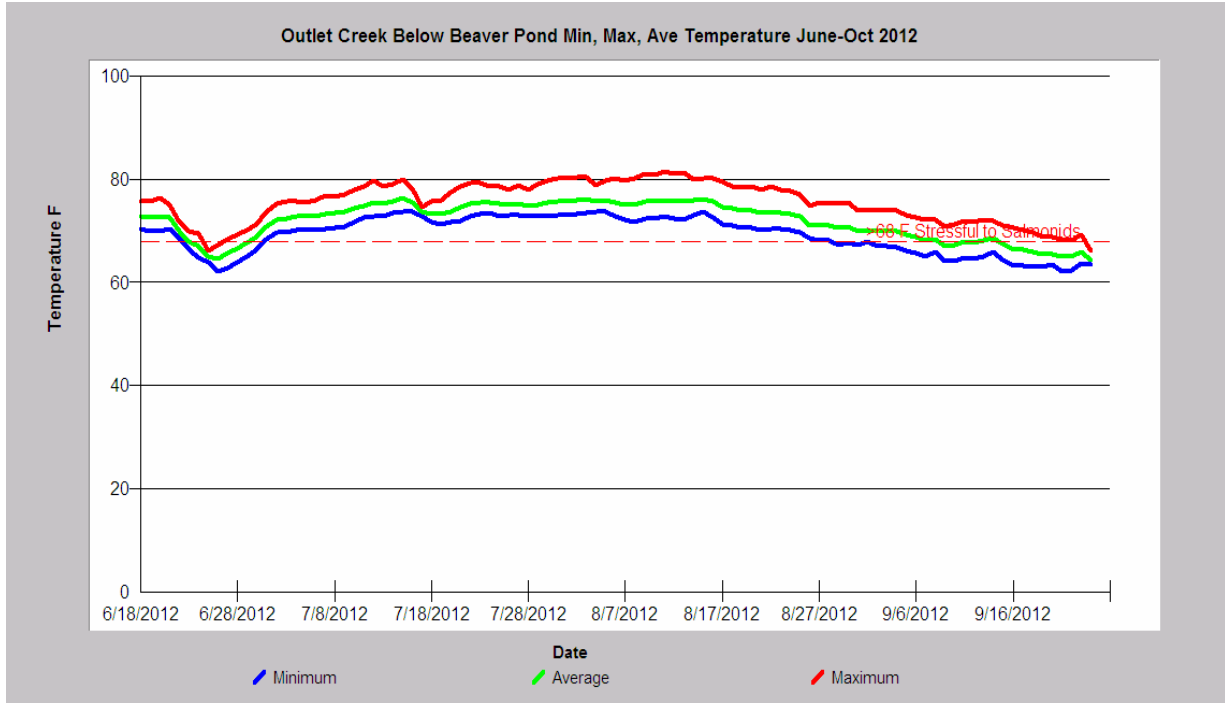
**Figure 9. Minimum, average and maximum daily water temperature of area immediately below beaver dam on Outlet Creek. During the period of record beavers constructed another dam downstream that kept the probe submerged. The pond had elevated water temperatures unsuitable for salmonids.**

*Temperature Below Outlet Creek Beaver Dam:* ERRP volunteer Cathy Warren assisted with placement of water temperature probes in the lower Outlet Creek basin. She was curious as to what effect beaver dams had on water temperature, so a probe was placed downstream of a large dam. The beavers actually built another dam downstream of where the sensor was placed, which created a lake that kept the probe submerged. However, Outlet Creek was dry upstream and downstream of the beaver dams in late September 2012 (Figure 10). Therefore, the minimum, average and maximum water temperature recorded by that probe are not necessarily reflective of Outlet Creek temperatures (Figure 9).

*Beaver Dams and Temperature, Water Supply and Water Quality:* The water temperature probe placed downstream of the beaver dam on Outlet Creek recorded very warm water temperatures, but there was a substantial amount of water impounded and aquatic habitat formed. Furthermore, there were no nuisance algae blooms or toxic algae present (Figure 19). This may be because the beaver ponds are surrounded by a cattail marsh, which is known to produce slightly acidic conditions that stifle blue-green algae development (Wetlands Research Consortium 2009).

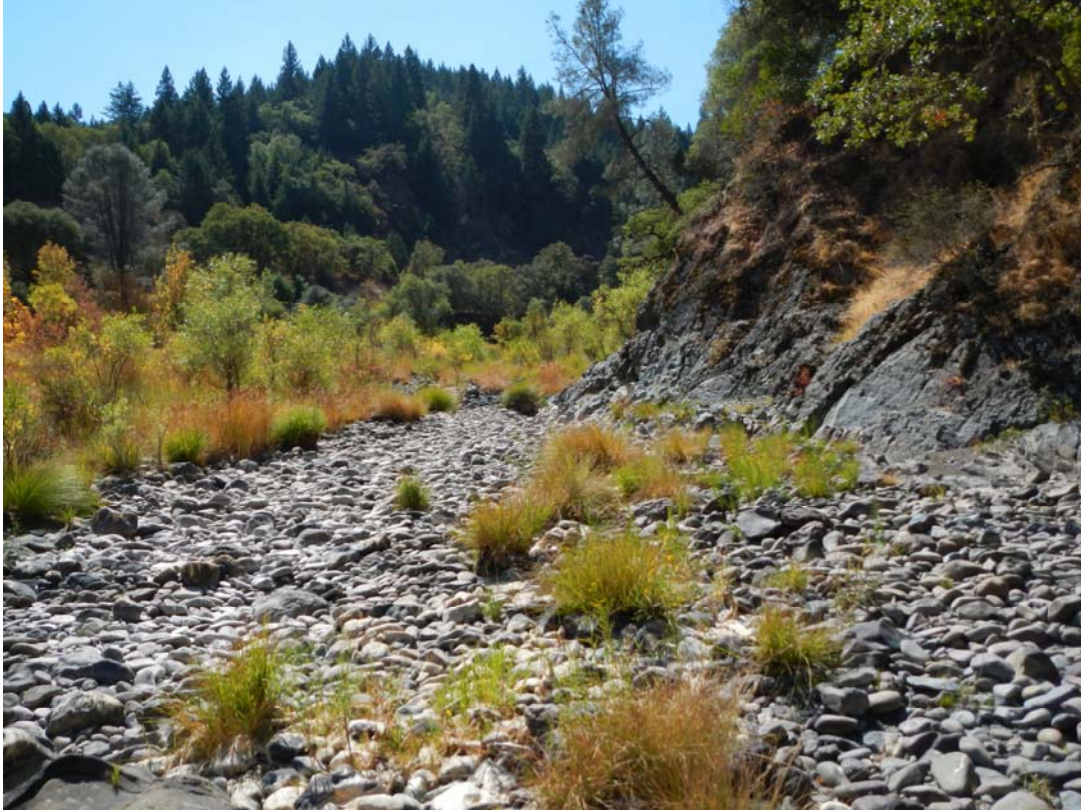
**Figure 10. The bed of Outlet Creek upstream of Bloody Run Creek on September 26, 2012 showing the stream with no surface flow.**

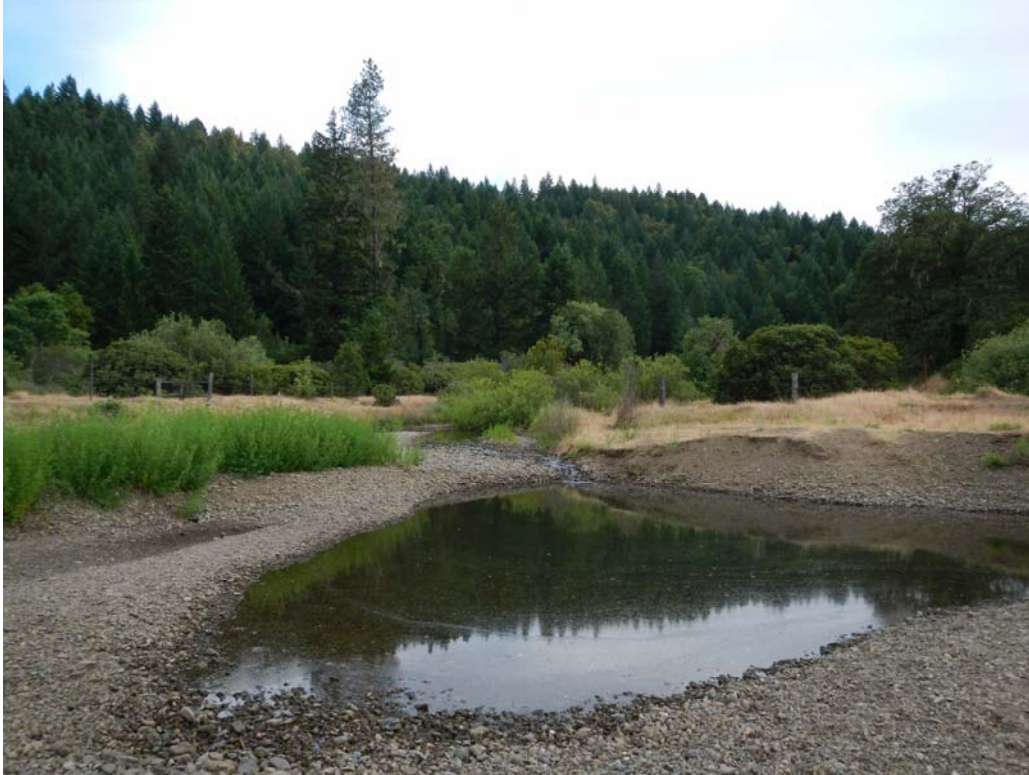
**Figure 10. Tomki Creek at Rocktree Creek (center), showing that flow was already disconnected when visited by ERRP on June 14, 2012.**

ERRP planned to place a water temperature gauges in Tomki Creek, but surface flow at the mouth of Rocktree Creek (Hearst-Willits Road Xing) was interrupted on June 14, 2012 and no probe was placed (Figure 10). Ten Mile Creek went dry in August 2012 at Black Oak Ranch (Figure 11) and also at Branscomb Road west of Laytonville, where Friedrichsen (1998) found stream flows to be perennial in 1996 and 1997.

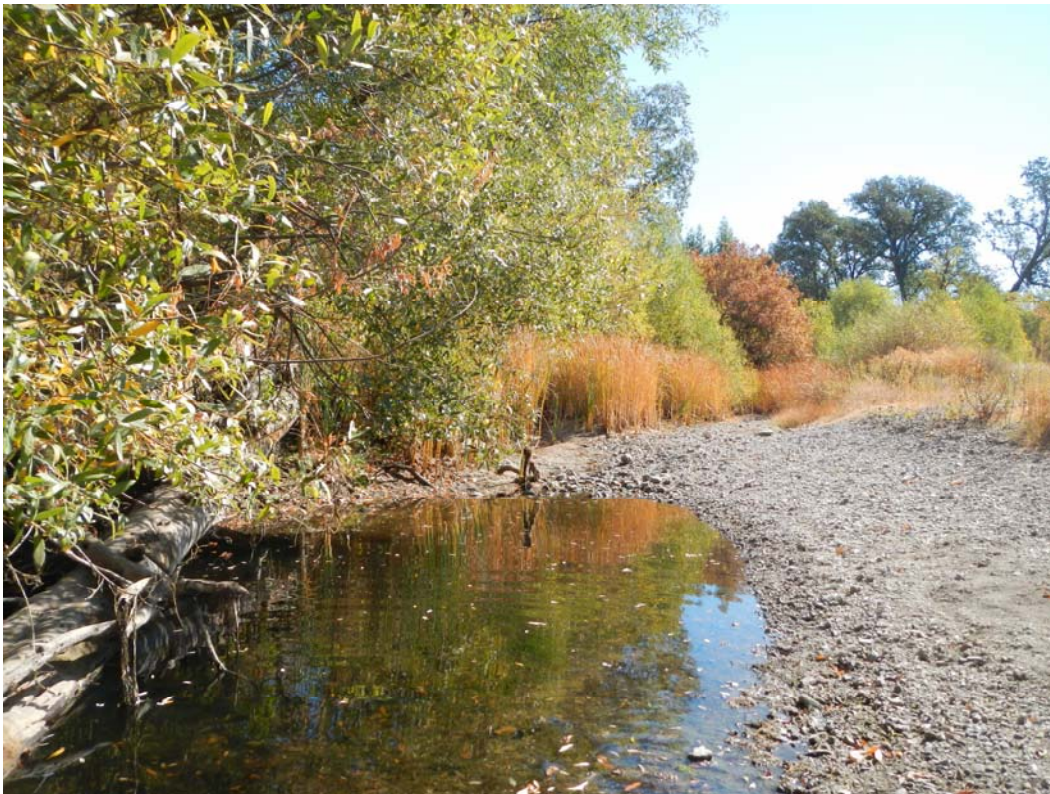
**Figure 11. Isolated pool on the Black Oak Ranch below Laytonville with the streambed of Ten Mile Creek leading into the pool, which is drying up.**

*Loss of Groundwater Cooling in Isolated Pool:* The pool at the Black Oak Ranch, shown in Figure 11, still harbored a steelhead yearling as of mid-August, despite many warm-water adapted invasive species also being present. The automated probe hourly data in Figure 13 show that water temperatures were cool enough to sustain the steelhead for the first few weeks after probe placement, but by late September water temperature warmed dramatically. Isolated pools in northern California streams often remain cool because of surface and groundwater connections (Nielsen et al. 1994); therefore, it is likely that the change in pool temperature on Black Oak Ranch resulted from loss of this groundwater cooling influence.

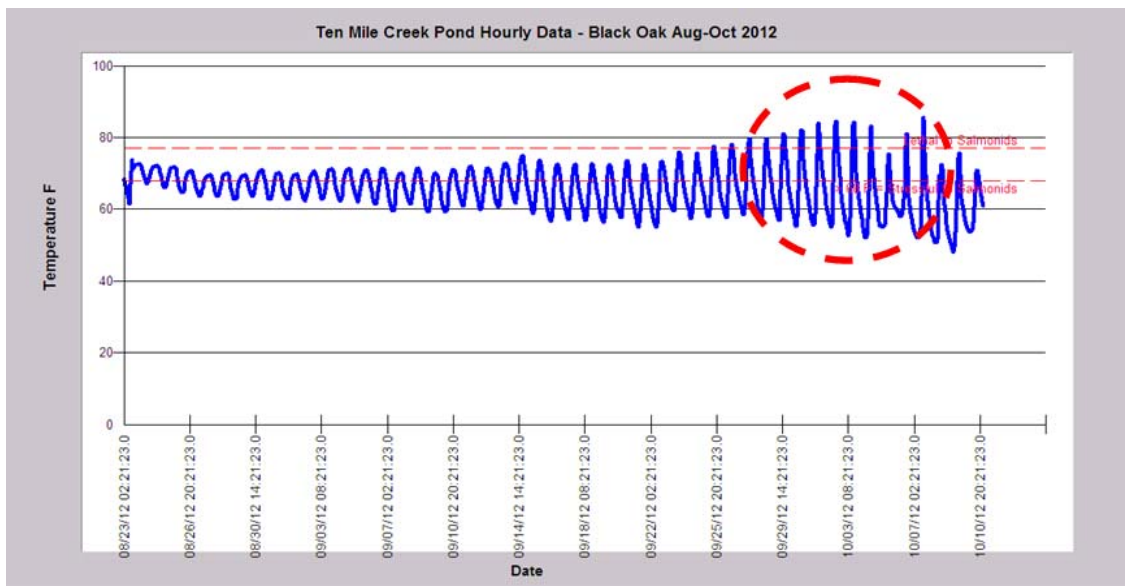
Figure 13. The isolated pool in Ten Mile Creek had temperatures that support steelhead juvenile rearing in August, but greatly elevated temperatures in late September and early October.

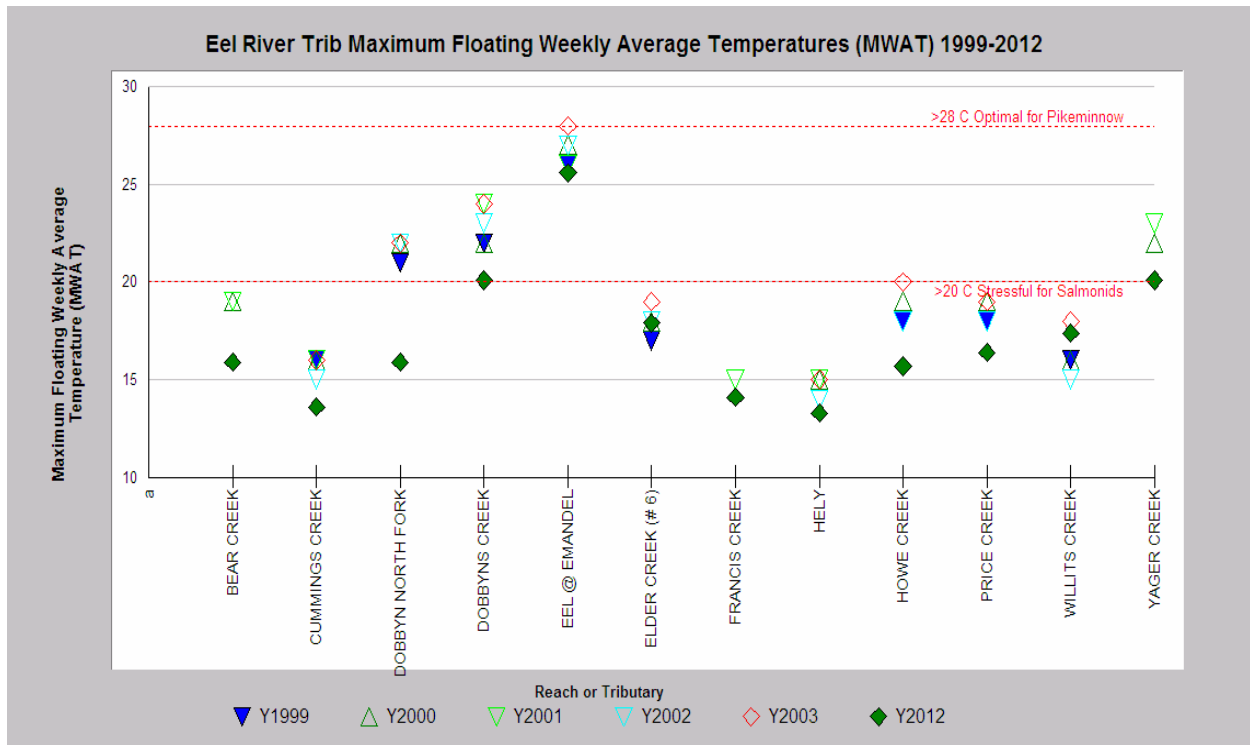
Figure 14. Maximum floating weekly average water temperature (MWAT) at 12 locations in the Eel River basin, comparing 1999-2003 Humboldt County RCD data with 2012 ERRP data.

*Inter-Annual Comparisons:* Figure 14 shows the maximum floating weekly average water temperature (MWAT) recorded by ERRP in 2012 compared with values at the same locations from 1999 through 2003 data collected by the Humboldt County RCD. The thorough comparison of air temperature, flow and rainfall data necessary for rigorous inter-annual analysis was beyond the scope of this year's project. Three sites where stream habitat conditions were known not to have changed between 1999 and 2012 are Elder Creek, Francis Creek and the mainstem at Emandal. All three show 2012 MWAT values in the same range as 1999-2003 or slightly lower. This suggests that 2012 temperatures were within the normal range, but a little on the cool side. However, Bear, Cummings, Howe and North Fork Dobbyn creeks showed improvement far greater than that likely driven by inter-annual variability.

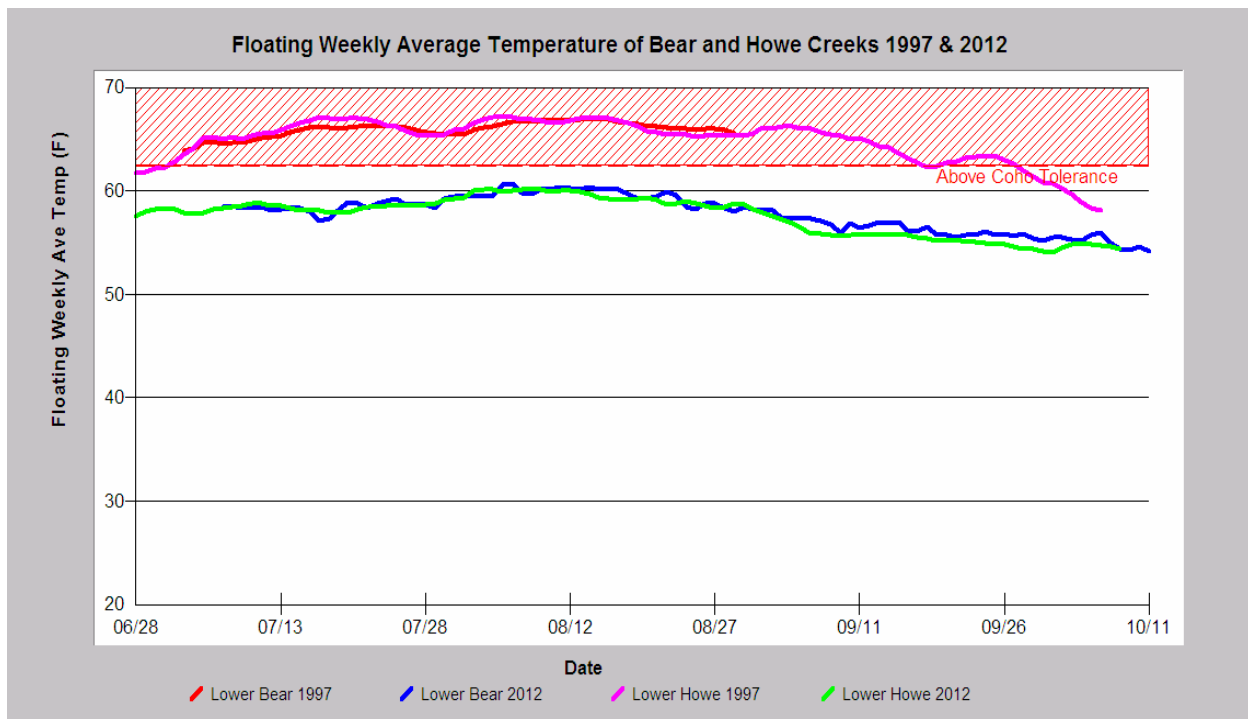
**Figure 16. Floating weekly average water temperatures of Bear Creek (lower Eel) and Howe Creek in 2012 were cool enough for coho salmon rearing (MWAT <62.4 F) (Welsh et al. 2001), while water temperature in 1997 was highly stressful.**

Bear Creek joins the lower Eel River at Shively and Howe Creek converges with the Eel River below Scotia. Both watersheds were intensively timber harvested prior to the January 1, 1997 storm and debris torrents caused major changes in their stream channels (Pacific Watershed Associates 1998) (Figure 15a). Excess sediment buried or scoured out riparian zones, thereby reducing shade, and increasing width to depth ratios, which also promoted stream warming. Cessation of block clear cutting has allowed watershed recovery, the stream bed is narrowing and increasing in depth, fine sediment has decreased and an alder canopy is re-developing (Figure 15b). Therefore, it is not surprising that water temperature and aquatic habitat has improved along with forest and watershed health. The floating weekly average water temperatures of these two streams in 1997 (Friedrichsen 1998) were far above optimal for salmonid rearing (McCullough 1999), while 2012 values fall in the range of suitability for both steelhead trout and coho salmon juvenile rearing (Welsh et al. 2001) (Figure 16).

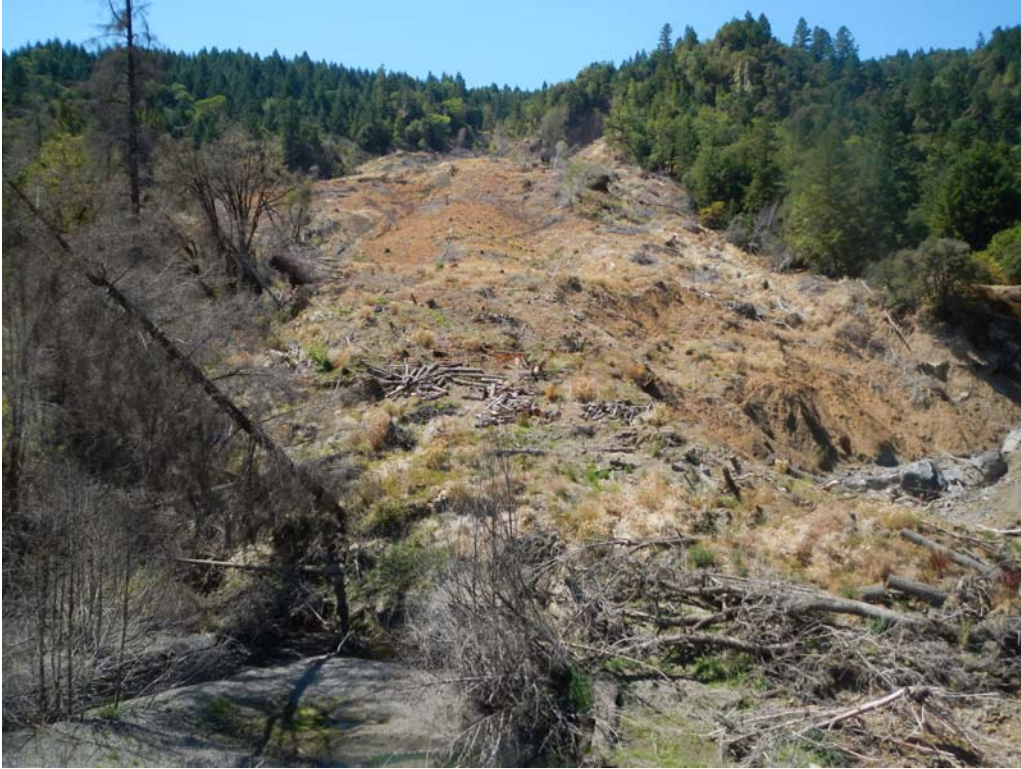
**Figure 17. Earthflow just upstream of the convergence of South Fork and North Fork Dobbyn Creek. Photo taken August 26, 2012.**

*No Damage from Dobbyn Creek Earthflow:* In winter 2010 a huge earthflow occurred on the South Fork Dobbyn Creek just upstream of its convergence with the North Fork (Figure 17). As discussed above, landslides can overload streams with sediment, cause stream warming and damage riparian zones. Temperature data indicated cooling of lower Dobbyn Creek. Similarly, there was no indication of excess fine sediment or coarse sediment transport, the riparian zone remained intact, and large woody debris was present that would otherwise have been buried or dislodged (Figure 18).

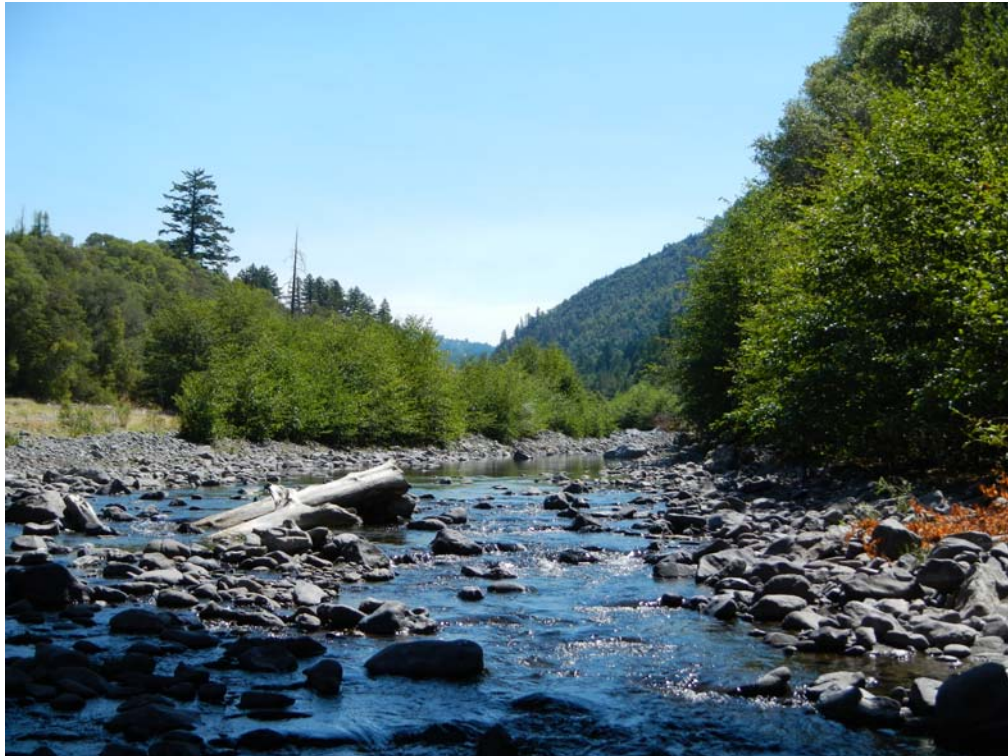
**Figure 18. Lower Dobbyn Creek looking upstream from site where automated temperature probe was placed. Lack of fine sediment, intact riparian and large wood give indicate no damage resulting from the 2010 earthflow.**

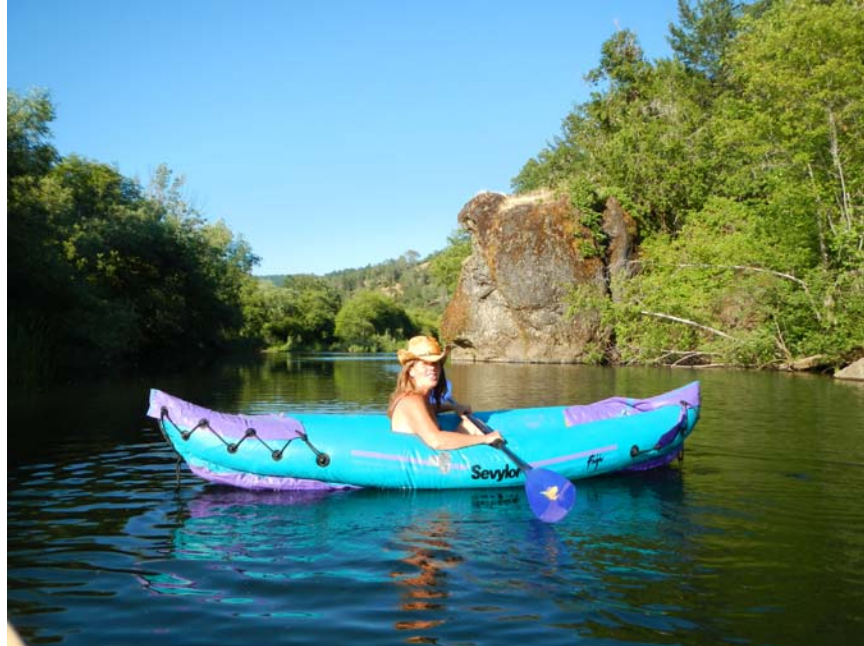
**Figure 19. Cathy Warren on Outlet Creek beaver pond in July 2012. There was no sign of nuisance algae blooms or toxic algae development.**

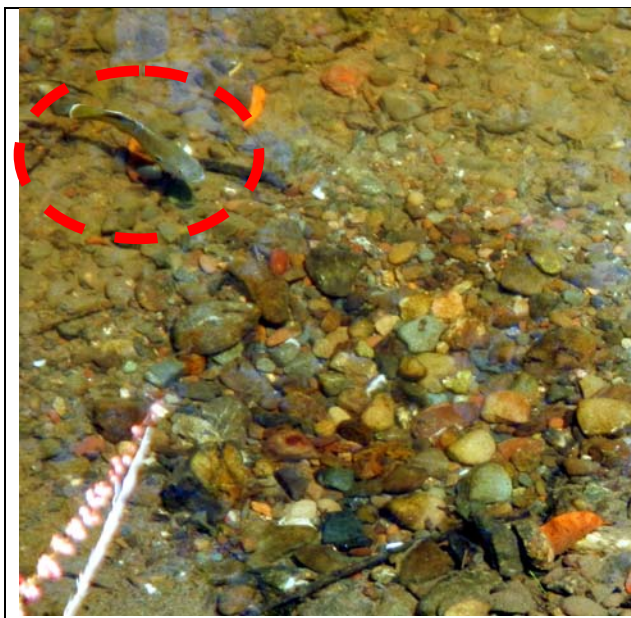
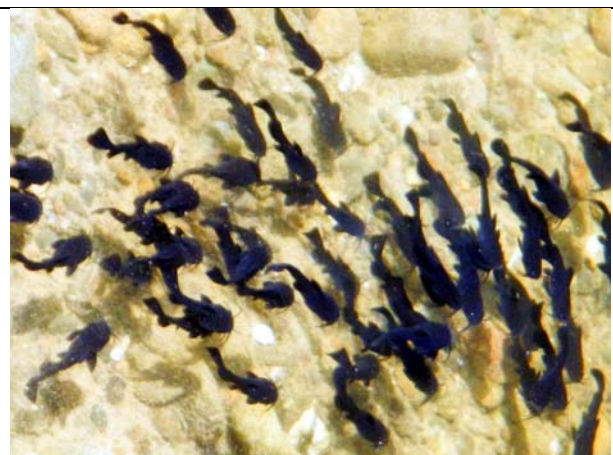
**Black catfish juveniles**

**Figure 20. (Left) Green-eared sunfish over a circular nest. (Above) a swarm of black catfish larvae in an isolated Ten Mile Creek pool at Black Oak Ranch in August 2012.**

*Ecological Problems Related to Agricultural Ponds:* ERRP Volunteer Coordinator Patrick Higgins visited Ten Mile Creek on the Black Oak Ranch throughout late summer and early fall 2012 and made the following observations. Hundreds of bull frog tadpoles inhabited the isolated pool near the outdoor concert area. The frogs had sprouted legs by late August and had emerged as young adults by late October. Green-eared sunfish were noted in pools in early August 2012, before stream flow dried up, and continued to thrive in isolated pools, even building nests (Figure 20a). Dozens of black catfish juveniles were photographed on August 13 (Figure 20b).

Green-eared sunfish and black catfish are exotic fish species originally native to lakes or Mississippi River tributaries in the Mid-West and South. They cannot survive flashy, high winter flows in Eel River tributaries such as Ten Mile Creek. The annual supply of warm water exotic species that dominate stagnating tributaries is coming from agricultural impoundments that provide ideal conditions. All three species are often introduced by land owners for recreation and their amusement, despite legal prohibitions of transplanting these organisms without a permit. Ecological effects of non-native warm-water fish are modest, but impacts from bull frogs on native frogs and amphibians are high due to their competitive size advantage.

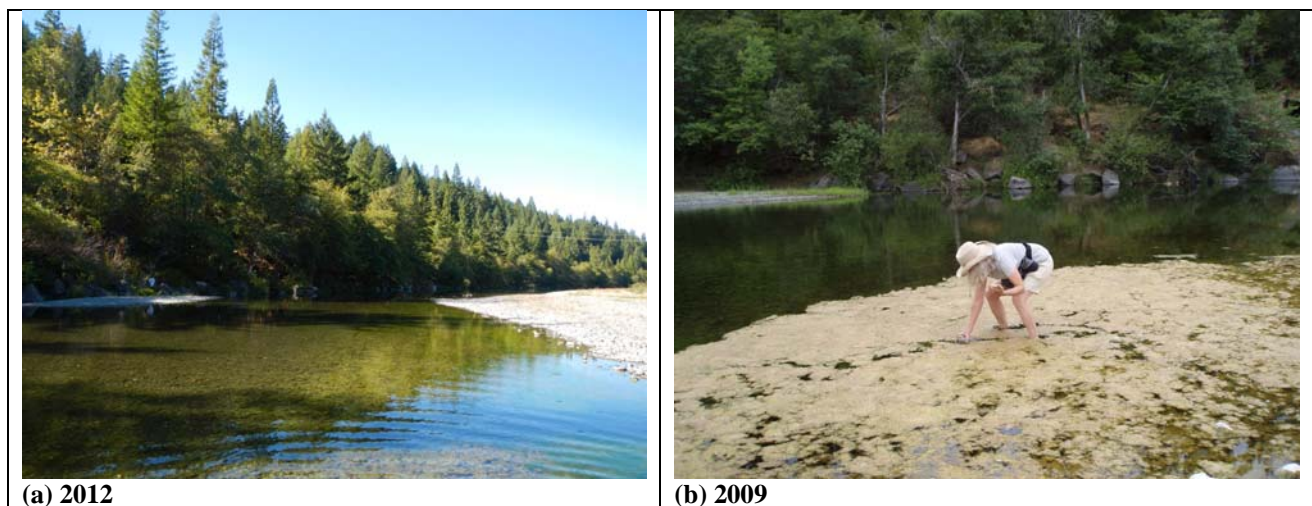
**Figure 21.** These photos show the South Fork Eel River at Phillipsville in 2012 (left), when no toxic algae formed, and in 2009 (right) when dog mortality was caused by the bloom depicted. Humboldt County Public Health Department provided the 2009 photo and staffer Harriet Hill is shown taking a sample.

*Summary of Toxic Algae Findings:* The 2012 water year lacked early winter rainfall but precipitation continued through late spring, which promoted cool early-summer water temperatures. The summer air temperatures also rarely rose above 100 F in the interior of the Eel River basin, which moderated water temperatures as well. Consequently, toxic algae blooms were limited or non-existent. The Phillipsville toxic algae monitoring location on the Russell property serves as an example. No problem developed in 2012 (Figure 21a), while toxic algae did form there in the drier and warmer year 2009 (Figure 21b). ERRP volunteers also noted that the shape of pools can vary from year to year and can be more prone to toxic algae development, if extensive slow edge-waters form. Some nuisance algae were noted in the Holmes Pool in 2012 because of its extensive shallow areas, although whether toxic algae formed there is unknown. This variability called attention to the fact that ERRP needs to expand its monitoring capacity to cope with the magnitude and extent of this problem.
