Eel River Monitoring and Water Quality Awareness Pilot Project Final Report

The Eel River Recovery Project
Funded by the CA Water Resources Control Board *Grant Agreement 14-679-550*
Administered by the Institute for Fisheries Resources

April 15, 2016

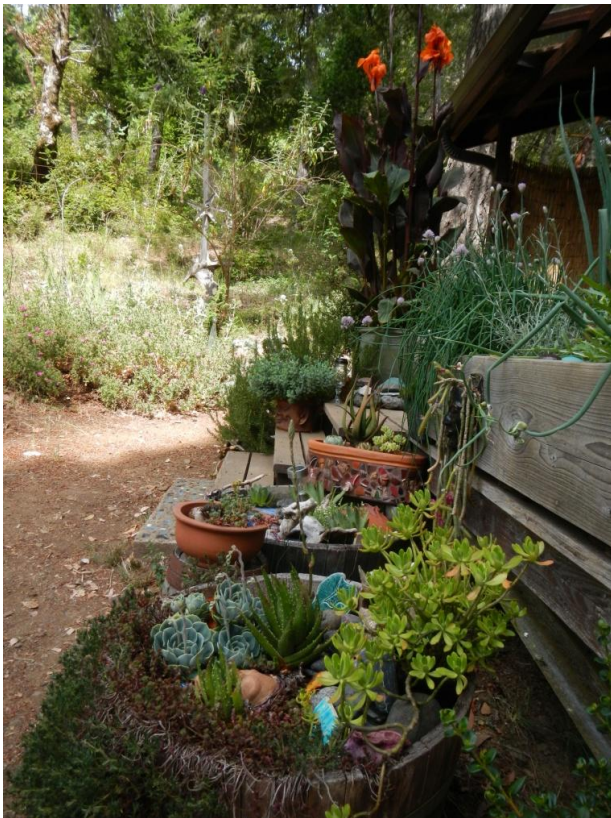
Figure 7 Planter boxes and pots watered with grey water. Fool's Farm 6/20/16.

Kyle Keegan provided data on rural residential water use when water conservation is put into full practice. His family of three uses less than 40 GPD or less than 15 GPD per family member. They achieve savings by taking showers of no more than two to three minutes, which use about a gallon a minute. Dish water and shower water are captured and distributed in a grey water system that waters garden spaces and pots through drip systems and by direct application.

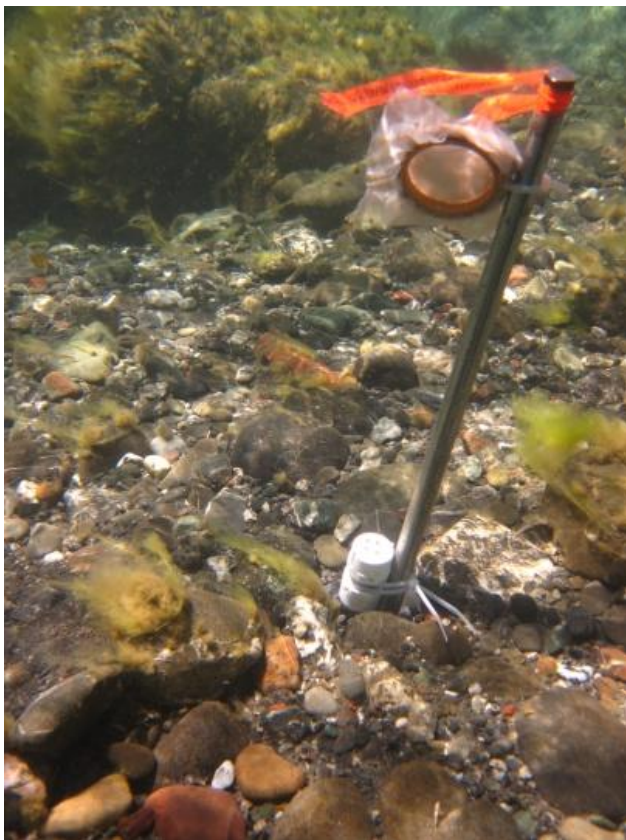
Figure 9 Alderpoint SPATT at top and encased I-Button temperature gauge below.

Outreach to and Monitoring Cooperation with Small Water Districts (Task 1.5.1) ERRP initiated contact with the Redway Community Services District (RCSD), the Garberville Services District (GCSD) and the Alderpoint Water District (AWD) to explore cooperative monitoring at the beginning of the project. Although there was some interest from RCSD Board Chair Michael McKaskle, their staff thought it premature for their participation in 2015 monitoring, and GSD Executive Director Ralph Emerson also declined participation. Despite numerous attempts, ERRP was never able to establish contact with the AWD. To fulfill the requirements of this grant, ERRP took initiative and deployed SPATTs upstream of the GSD and RCSD intakes on the South Fork Eel River and on the main Eel River proximate to the AWD intake at Alderpoint. ERRP volunteer Larry Bruckenstein helped cleaned and replace the SPATT below Sproul Creek from July through September 2015 and volunteer Willie Grover assisted with the Alderpoint SPATT . ERRP placed SPATTs above the intake for the AWD.

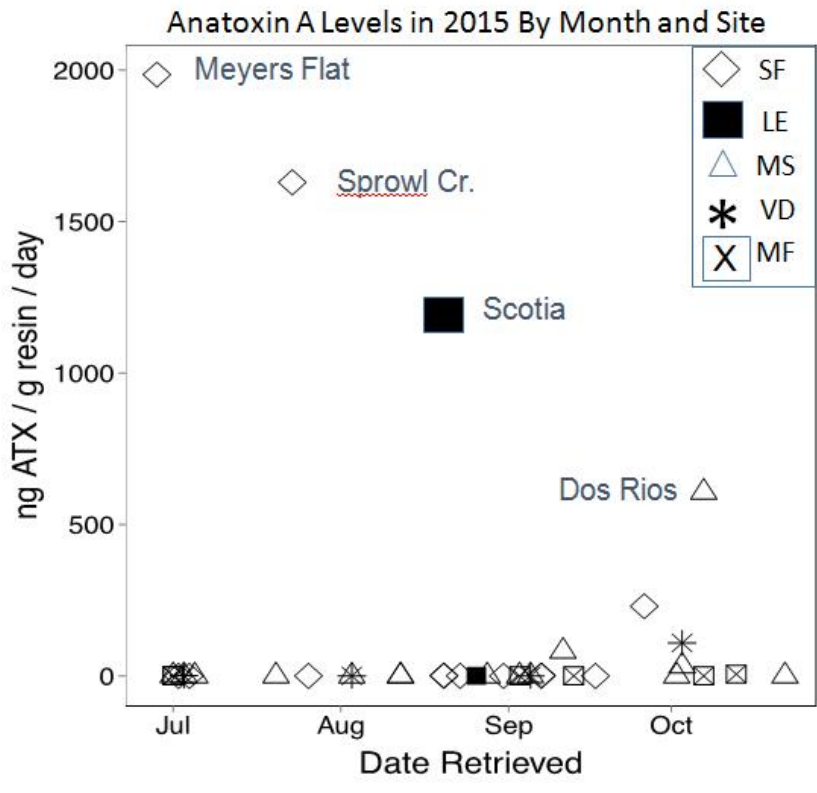
Figure 11 Chart indicating the highest levels of ATX in July and August on South Fork and lower Eel in September.

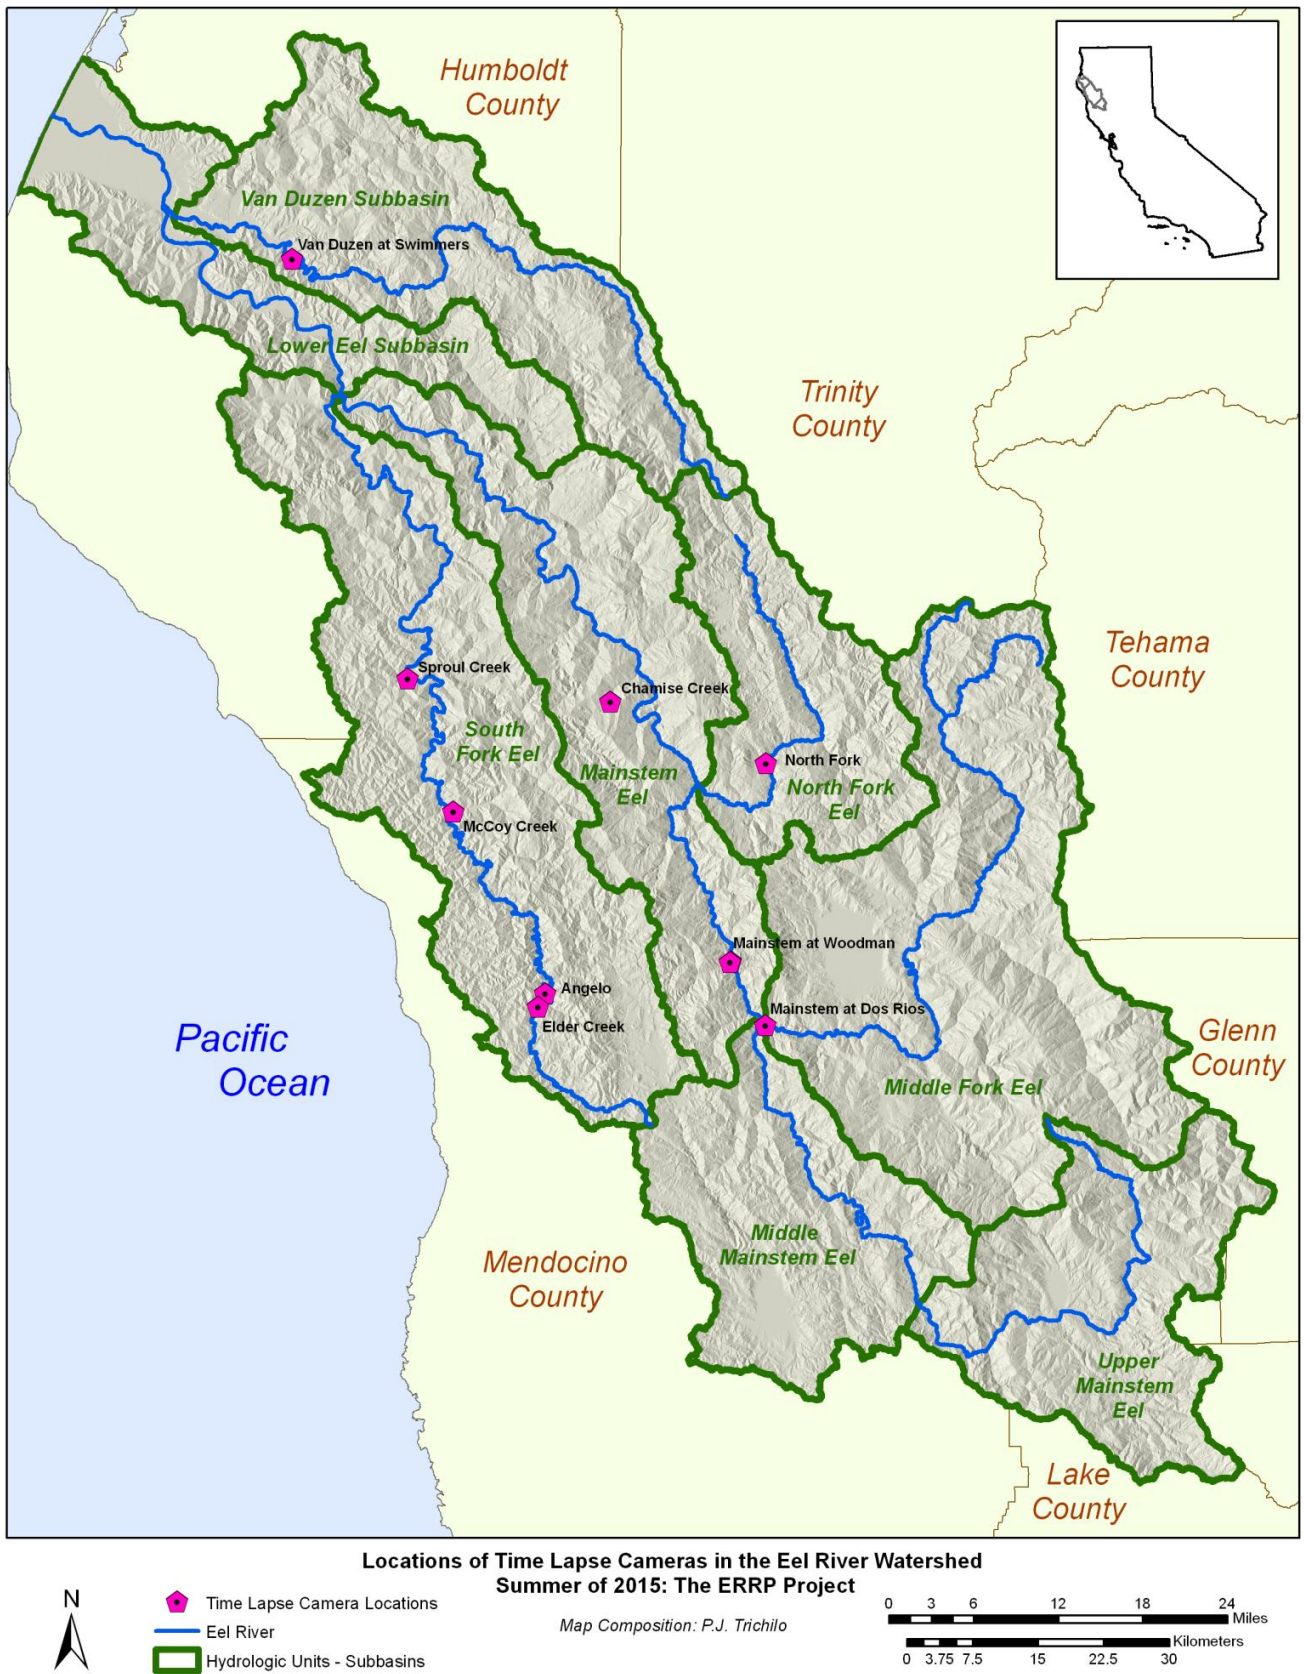
Figure 14 Map of time-lapse camera locations.

Time Lapse Cameras (2.1.4, 2.2.2, 2.2.3) Ten time-lapse cameras were purchased and placed in cooperation with the assistance of volunteers at strategic locations throughout the Eel River basin (Table 4). This was a new activity for ERRP and results from time lapse camera placement were less than optimal at some locations, but very useful at others. Camera imagery illustrates drought stress at some mainstem Eel River locations as well as in tributaries where baseline conditions can be established for flow monitoring. See the location of time-lapse cameras (Figure)

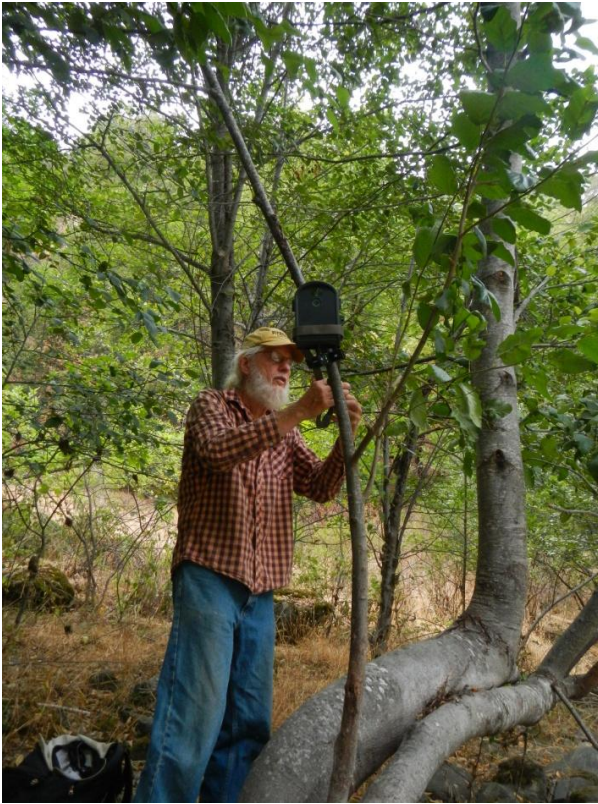
Figure 15 Volunteer Proud Savage tightens clamps holding Chamise Creek time lapse camera. 8/28/15.

Chamise Creek: This stream has an important steelhead population and joins the middle fork mainstem Eel River from the west side just downstream of Island Mountain. Volunteer Proud Savage has deployed water temperature gauges in the creek on his property since 2012 and allowed placement of the time lapse camera in 2015. The camera was placed on August 28 and imagery was downloaded on January 10, 2016. While Chamise Creek maintained surface flow at the location of the camera, flow was disconnected in a reach just upstream. The flow fluctuation shown in the composite film of the time-lapse imagery is dramatic with videos for both July-Dec 2015 <https://vimeo.com/152285876> and early 2016 <https://vimeo.com/162623242>.

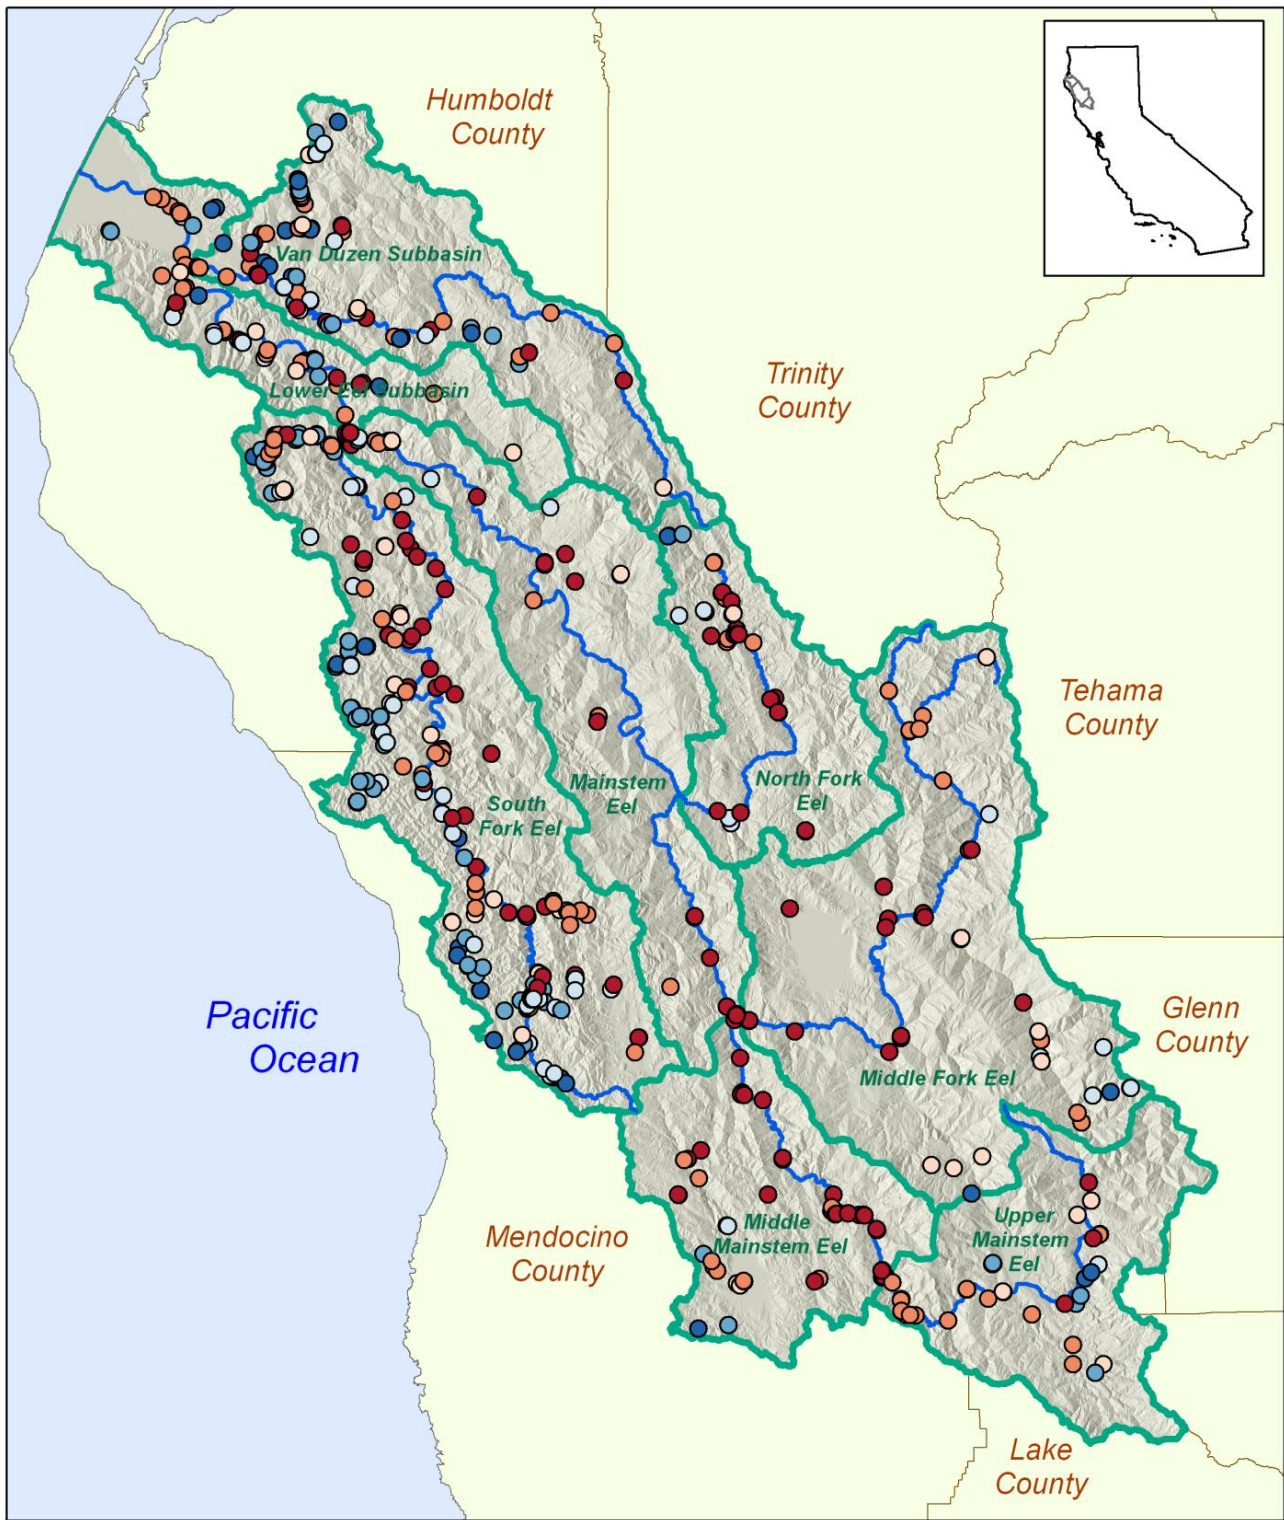
Location and Recorded Range (MWMT) of Temperature Data Loggers Placed in the Eel River Watershed Summer of 2015: The ERRP Project

Figure 16 All Eel River water temperature monitoring locations with color coding based on the average of maximum floating weekly maximums (MWMT) for all years of data from 1980 to 2015.
