Tenmile Creek Water Temperature, Fish Community and Flow Summary Report Water Years 2020-2021

**By Patrick Higgins, Eel River Recovery Project
For the California Coastal Conservancy (Agreement # 20-076)**

February 28, 2022

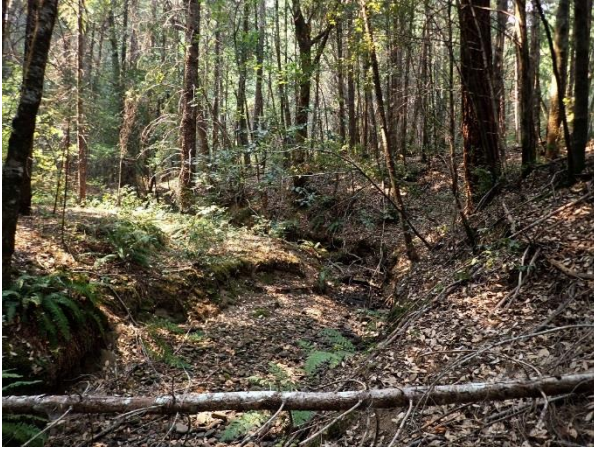
Figure 6. Dry bed of unnamed Cahto Creek tributary on Kovner property. 8/25/21.

In 2018, the creek at the top of the Kovner property had perennial flow and temperatures ideal for steelhead juvenile, with a 66.7 F maximum an average of 57.8 F from late July through mid-October (ERRP 2020). No water temperature data were collected in 2019, although flow was maintained at this location, but this reach was dry in late summer and fall in 2020 and 2021.

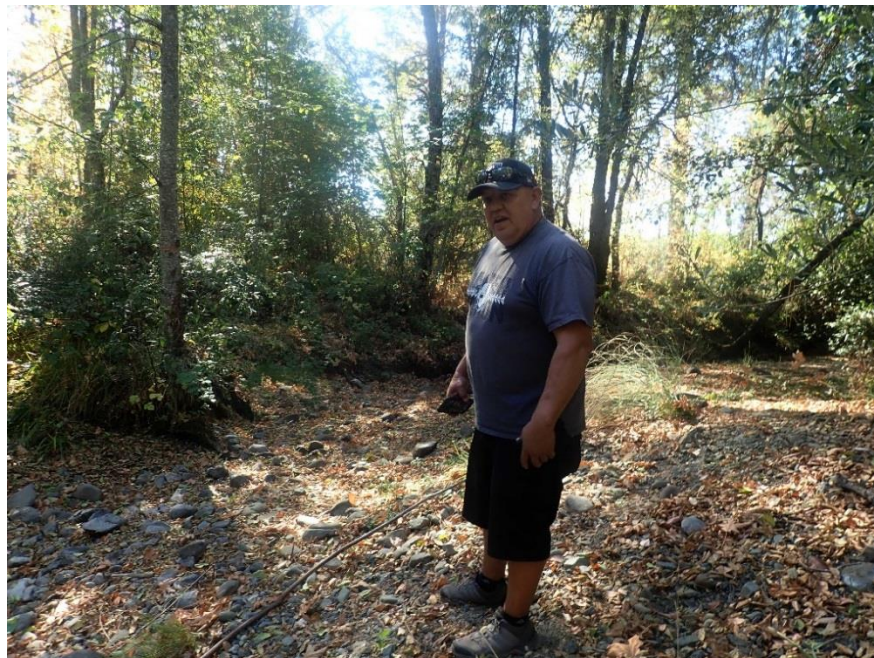
Figure 10. Cahto Tribe NR staff Fred Simmons in dry bed of Cahto Creek on the Reservation. 10/15/2020.

Cahto Creek on the Cahto Tribe Reservation: ERRP has been a partner with the Cahto Tribe Natural Resources (NR) Department, monitoring temperature in the creek on the Reservation in 2019, and periodically conducting fish direct observation dives. The reach of Cahto Creek within the Reservation has good habitat for spawning and rearing, when flows allow. The Cahto Tribe has won numerous grants to stabilize stream banks and to promote scour of deeper pools with log structures. ERRP has helped document high densities of juvenile steelhead using these pools in some years. However, juvenile warmwater fish, like green sunfish, may also be abundant, depending on the spill of ponds in spring further up in the watershed. Joe Scriven (personal communication) of the Mendocino County Resource Conservation District found juvenile coho rearing in Cahto Creek on the Reservation in 2010-2012, which were all wet years. The maximum floating weekly average water temperature (MWAT) of Cahto Creek on the Reservation in 2019 was 65 F (ERRP 2020), which was within the suitable range for steelhead rearing. Unfortunately, this reach of Cahto Creek dried up in 2020 (Figure 10) and again in 2021. It is not known why this reach of Cahto Creek dries up when the reach upstream on the Cahto Creek Ranch does not. Hypothesis are variable bed permeability and possibly surface or groundwater extraction.

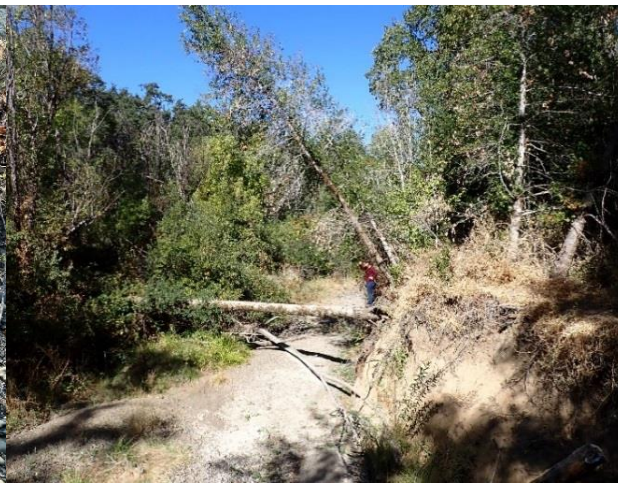
Figure 15. Dry bed of Cahto Creek on Hogan property along Cahto Trail that is slated for repair bioengineering. 10/11/21.

Cahto Creek at Cahto Creek Trail: This location is about a quarter mile upstream of the convergence with Tenmile Creek on the Dennis and Marybeth Hogan property. They are great ERRP partners for stream monitoring, forest health, and riparian restoration. This reach of Cahto Creek is frequently used by Chinook salmon (Figure 14) and steelhead for spawning and rearing, and occasionally by coho salmon. The gravel bed is coarse and there is good riparian cover for much of the reach on the Hogan property, with the exception of a 160-foot-long section of failing bank adjacent to the Cahto Trail (Figure 15). Bank erosion at this site was active during the storm of October 23, 2021, and a bioengineering project will be implemented in fall 2022 that will stem this source of pollution and create much improved fish habitat.

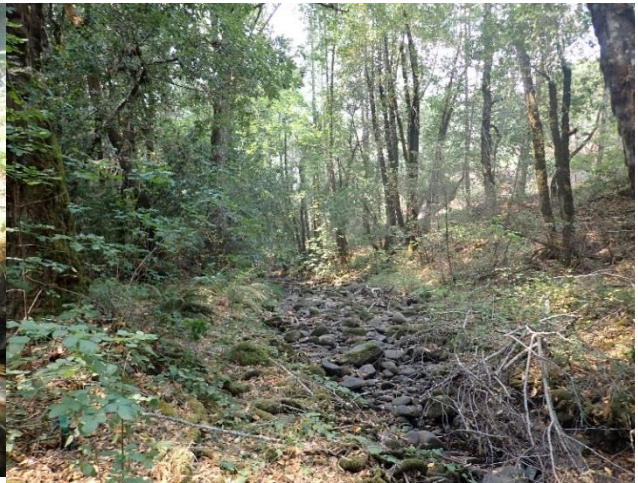
Figure 18. Upper Mill Creek on property of Mare Murphy dry. 8/20/21

Upper Mill Creek: We have been monitoring upper Mill Creek on the property of Mare Murphy since 2019. The MWAT in 2019 was 62.4 F, which is cold enough for coho salmon (Welsh et al. 2001). In 2020, the stream temperature warmed (Figure 16) but was still optimal for steelhead juvenile rearing. Lack of adequate rainfall in the windows for steelhead spawning over the last few years has resulted in a low standing crop of juvenile steelhead. Only one four-inch specimen was noted in about a ¼ mile survey upstream of the Murphy property in 2020. A time-lapse camera showed that Upper Mill Creek dried up in August in 2021 (Figure 17-18).

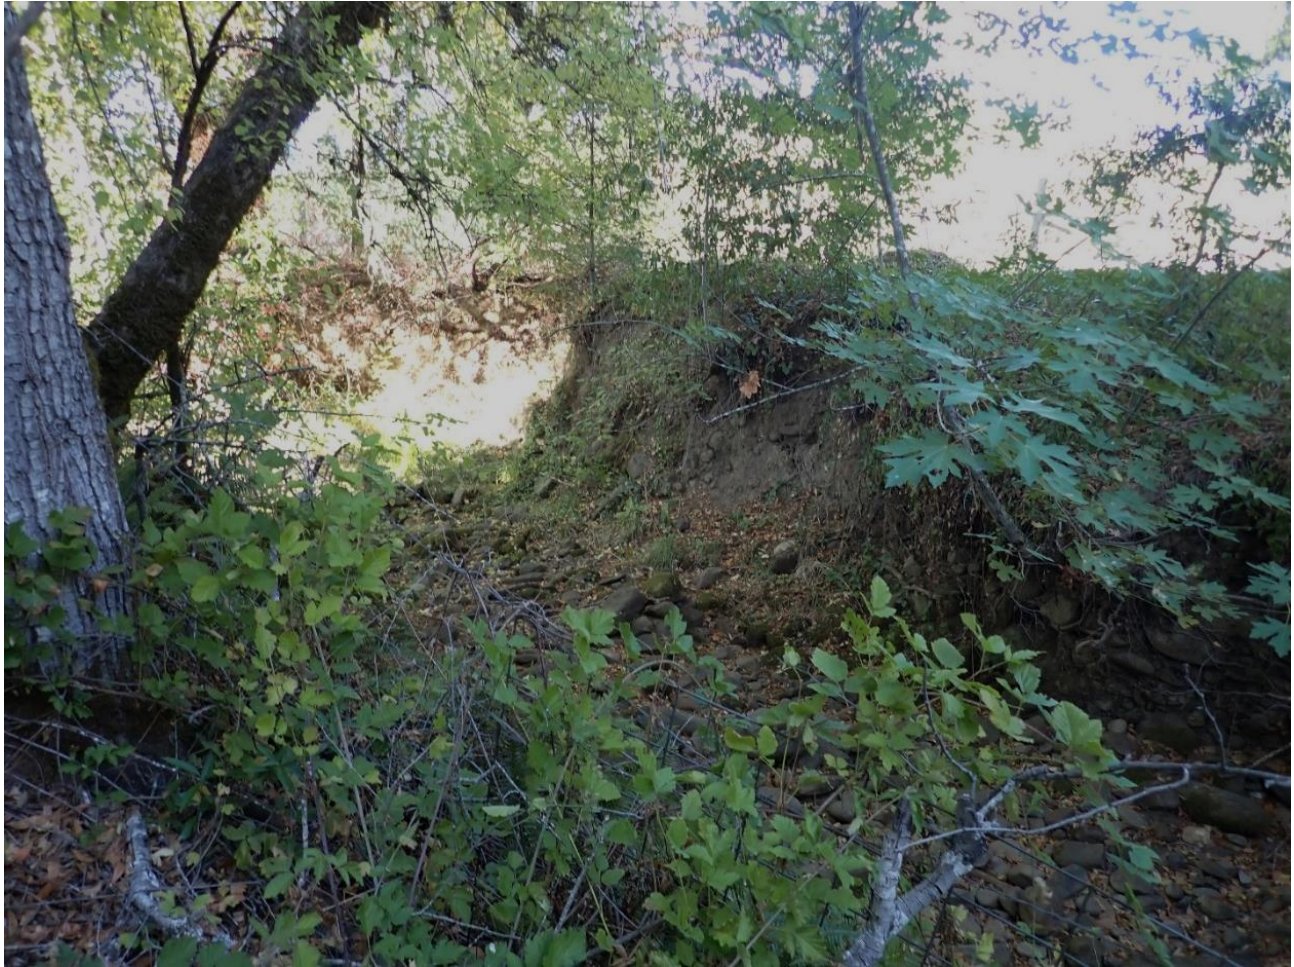
Figure 22. Dry bed of Little Case Creek just upstream its convergence with Mill Creek. 10/11/21.

While ERRP has not monitored Little Case Creek, reconnaissance in 2018 and 2019 established that it typically loses surface flow in summer. This condition was photo-documented just above the convergence with Mill Creek in late October 2021 (Figure 22). The hydrology of Little Case Creek is likely profoundly altered as a result of channelization that occurred to increase agricultural land in the late 19th Century (see Discussion).

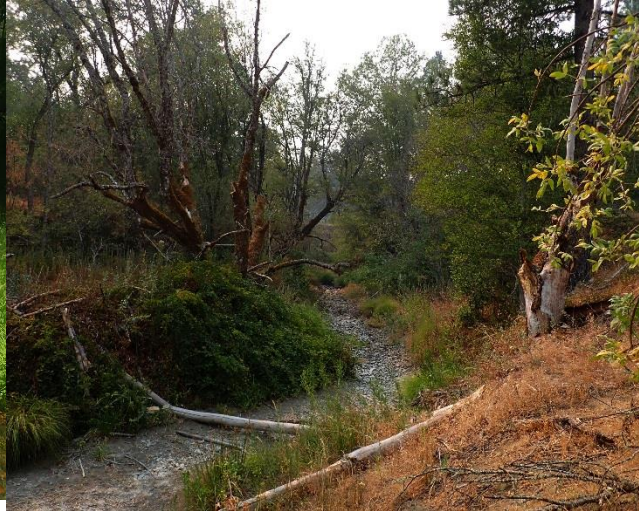
Figure 24. Lower Big Rock Creek dry. 8/20/21.

In 2019, lower Big Rock Creek maintained surface flow and had a floating weekly average water temperature (MWAT) of 67.4 F, which was suitable for steelhead (McCullough 1999). While Big Rock Creek lost surface flow in mid-August 2020, it went dry even earlier in 2021. No stratified pools with salmonids were noted in reaches further upstream in 2020 or 2021, unlike in 2018. Photos of flow conditions of Big Rock Creek in May and August 2021 are shown in Figures 23 and 24.

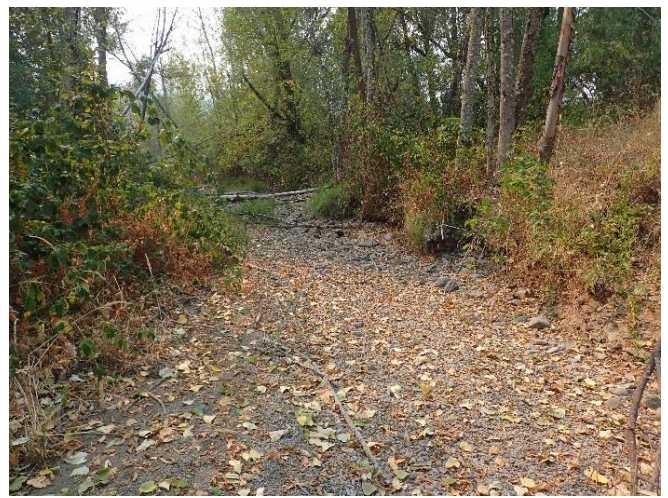
Figure 28. Lower Streeter Creek dry. 8/20/21.

Streeter Creek, another major west-side Tenmile Creek tributary, flows from an elevation of about 2,700 feet to its convergence at 1,459 ft. CDFW (2009c) estimated the watershed as 3.2 square miles in size. ERRP has had a working relationship with the Black Oak Ranch, including monitoring lower Streeter Creek near its mouth, since 2012. In 2018, with the inception of the SCC Prop 1 pilot project, when flow monitoring began. Streeter Creek dried up in its lower reaches and failed to maintain habitat for steelhead juveniles in 2018, but flow was perennial in 2019 with temperature data indicating suitability for salmonids (67.5 F MWAT). Numerous steelhead juveniles were video documented in October 2019 (<https://vimeo.com/433339215>). Streeter Creek, like Big Rock Creek, lost surface flow in mid-August 2020 and it went dry in July in 2021. No pools with salmonids persisted in either 2020 or 2021. Flow conditions in Streeter Creek in May and August 2021 are shown in Figures 27 and 28.

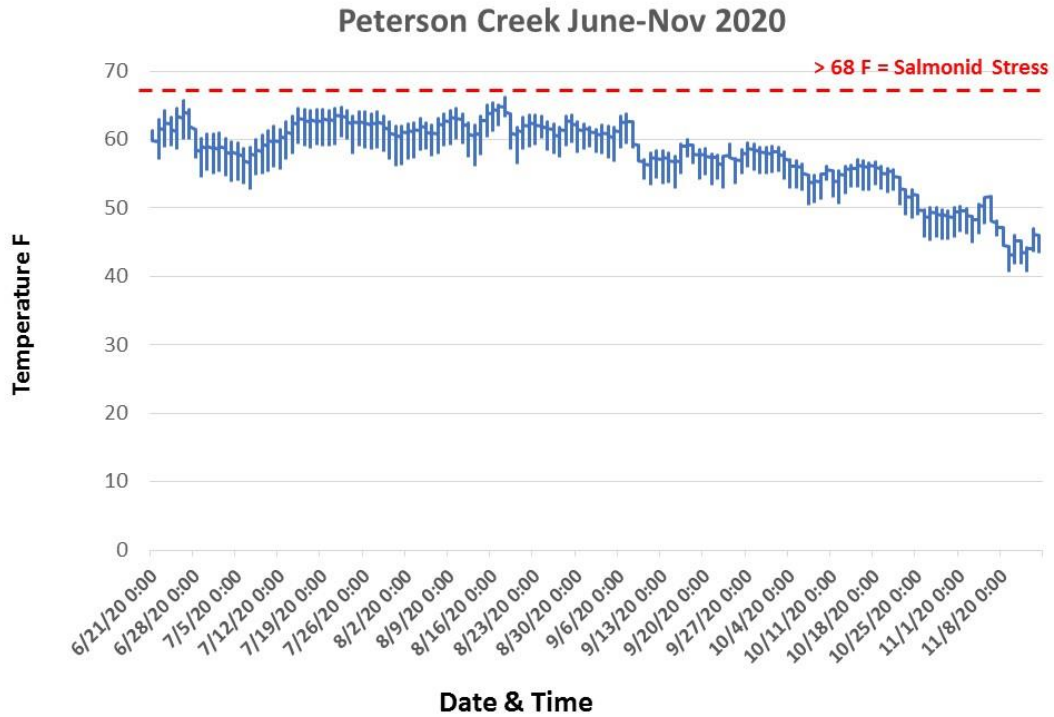
Figure 30. Lower Peterson Creek water temperature June – October 2020.

Lower Peterson Creek water temperature data for 2020 are shown in (Figure 30) and for 2021 in (Figure 31). Both years had optimal temperature for rearing steelhead, but 2021 appears colder. This is likely owing to very low surface flows, with water temperatures more influenced by cold groundwater. Peterson Creek maintained connectivity above a road crossing low in the watershed, but disconnected closer to the mouth in late summer. On the evening of August 20, 2021, Peterson Creek was underground just above its convergence with Tenmile Creek, but at 10 AM the next morning it was reconnected, likely due to a reduction in tree evapotranspiration overnight (see Discussion).

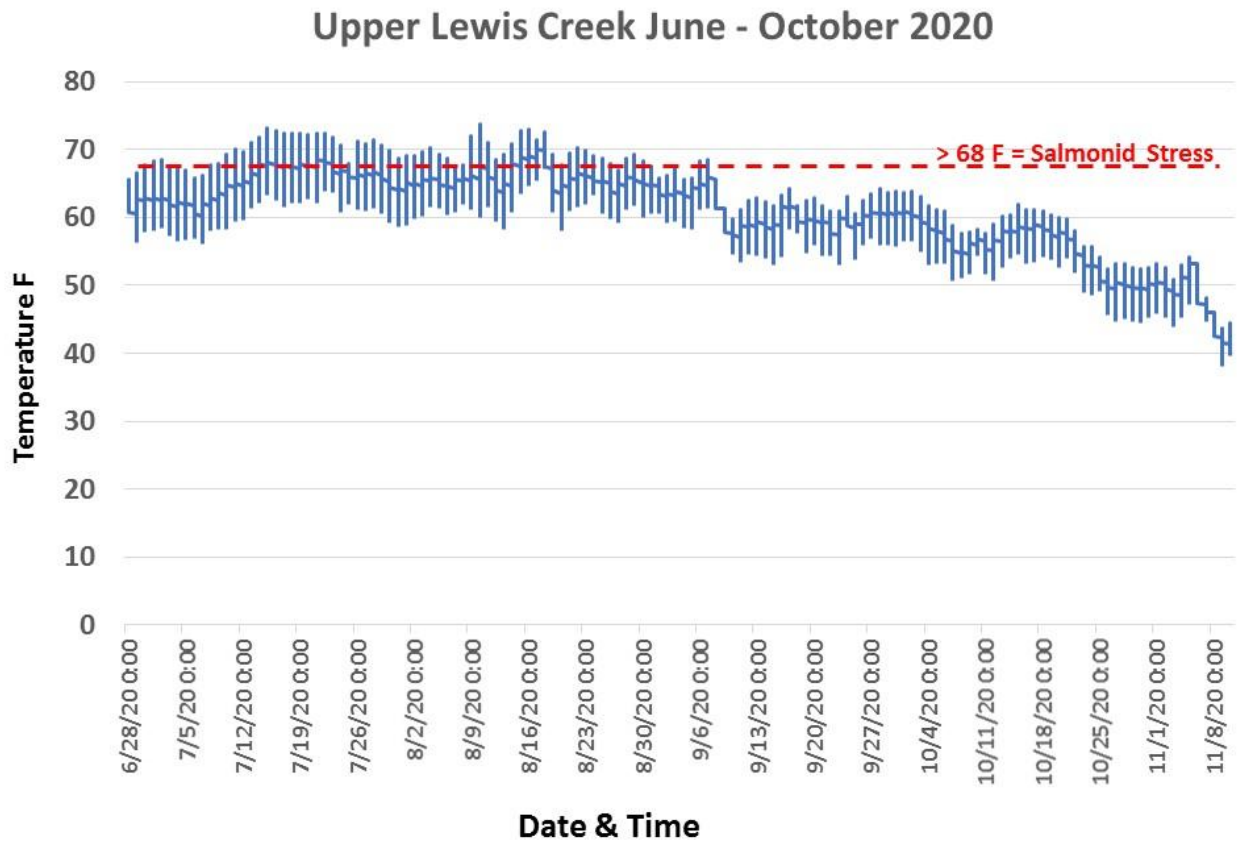
Figure 34. Lewis Creek water temperature from June to October 2020.

We began studying Lewis Creek in 2019, when flow was perennial and water temperatures optimal for juvenile steelhead and/or native trout (66.1 F MWAT), which were observed in moderately high densities (ERRP 2020). The Maacama Fault bisects the Tenmile Creek watershed with sandstone geology to the west and Central Mélange Terrain to the east. West-side vegetation is dominated by coniferous forest and the eastern half of the basin by oak woodlands and grasslands (Figure 32). Soil moisture is greater in sandstone geology than in the mélange (Hahm et al. 2019). Lewis Creek, in the Mélange Terrain, is the only perennial tributary flowing from the eastern Tenmile Creek watershed. In 2020, Lewis Creek maintained surface flow through fall (Figure 33) and temperatures were still cool enough for steelhead (Figure 34), although warmer than 2019. In 2021, Lewis was disconnecting in late June and dry in August. While some pools retained water, no fish life was observed in fall.

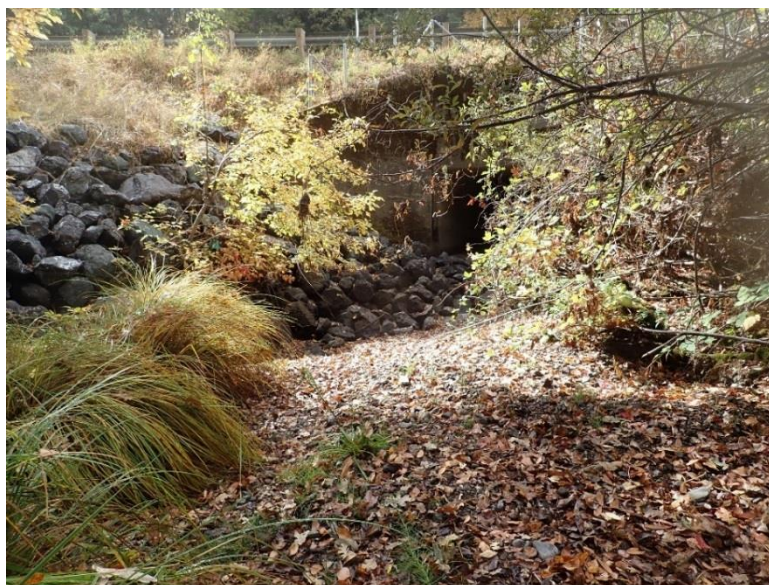
Figure 35. Upper Tenmile Creek bed dry looking downstream towards Highway 101. 8/20/21.

Upper Tenmile Creek (above Little Case Creek): This reach of Tenmile Creek has the most impaired conditions of any other sub-basin. We placed temperature probes in the channel above Highway 101 in 2018 and 2019, but Tenmile Creek went dry at this location in both years. The creek went dry even earlier at this location in 2020 and 2021 (Figure 35). We have also done reconnaissance in the reach at Harwood Park, not far above Cahto Creek, where the bed is comprised of silt and sand, and highly aggraded, with pools filled and spawning gravels silted in. This is indicative of major sediment sources somewhere in this sub-basin. When a stream bed is buried or aggraded, that can contribute to loss of surface flow. The U.S. Geologic Survey (Ferrari 1986) noted that groundwater resources in the upper Tenmile Creek sub-basin are very poor, which likely contributes to lack of flow. Also, the headwaters arise on the east side of the Maacama Fault in an area that is less water bearing.

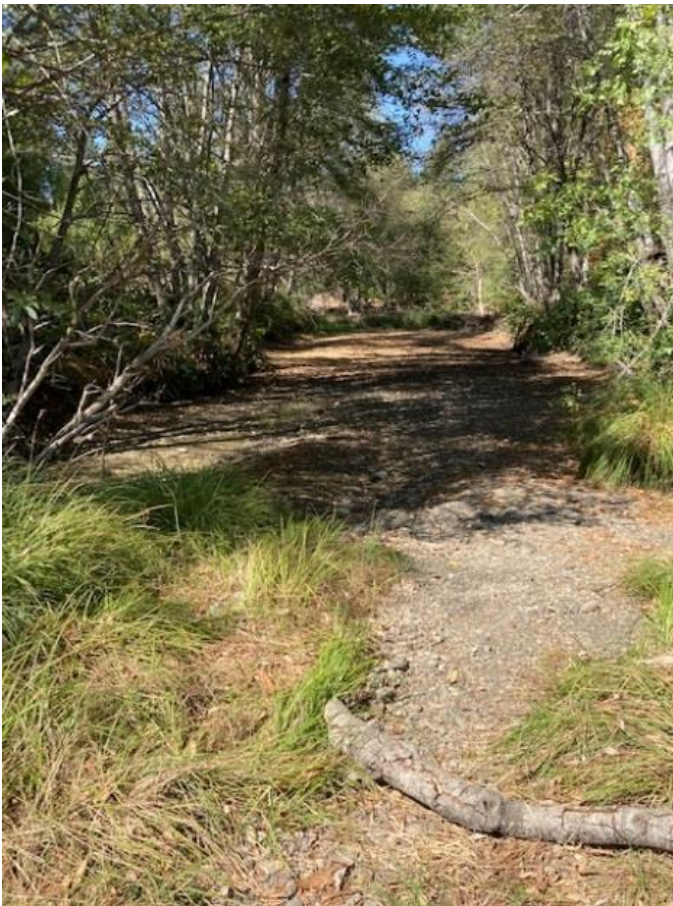
Figure 37. Tenmile Creek dry below Tenmile Creek Road. 9/17/21. Photo by Margaret Andrews.

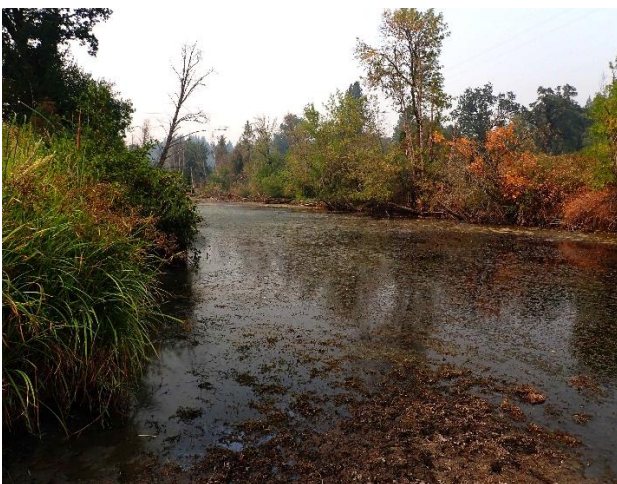
Figure 40. Tenmile Creek downstream of Big Rock Creek choked with algae. 8/10/2021.

In 2019, hundreds of steelhead juveniles were able to survive in cold water refugia in main Tenmile Creek immediately below Streeter Creek, and resident rainbow trout utilized larger pools despite warm temperatures. In 2020, connecting flow was lost in August and isolated pools that remained strongly favored warmwater fish, such as green sunfish, and bullfrog larvae. Aquatic function deteriorated further in 2021, as pools dried up altogether or were so choked with algae that they were not suitable for fish life (Figure 39). On the Black Oak Ranch above Streeter Creek, the index pool dried up to the point that even bullfrog tadpoles were scarce (Figure 40).

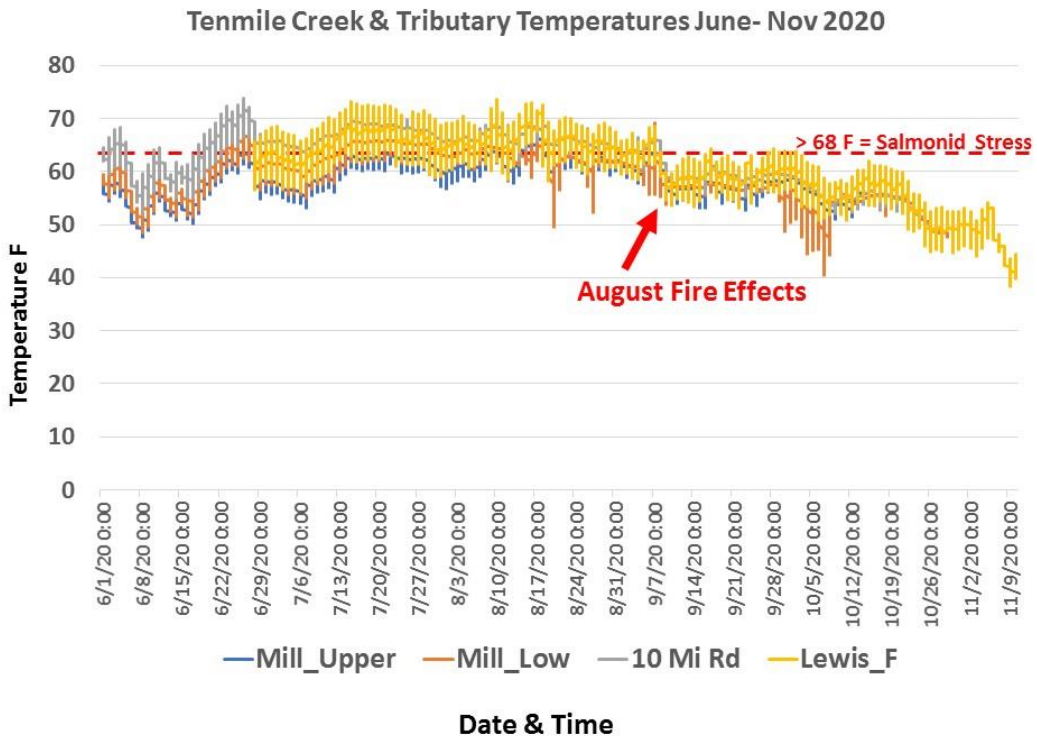
Figure 54. Water temperature of Tenmile Creek and tributaries cooled due to smoke from the August Fire.

The period of the August Fire blow up after September 8, 2020, when it moved into dead and dying oak woodlands in the North Fork Eel River watershed, created an interesting pattern in water temperatures with a universal decline after that date as a result of smoke (Figure 54).

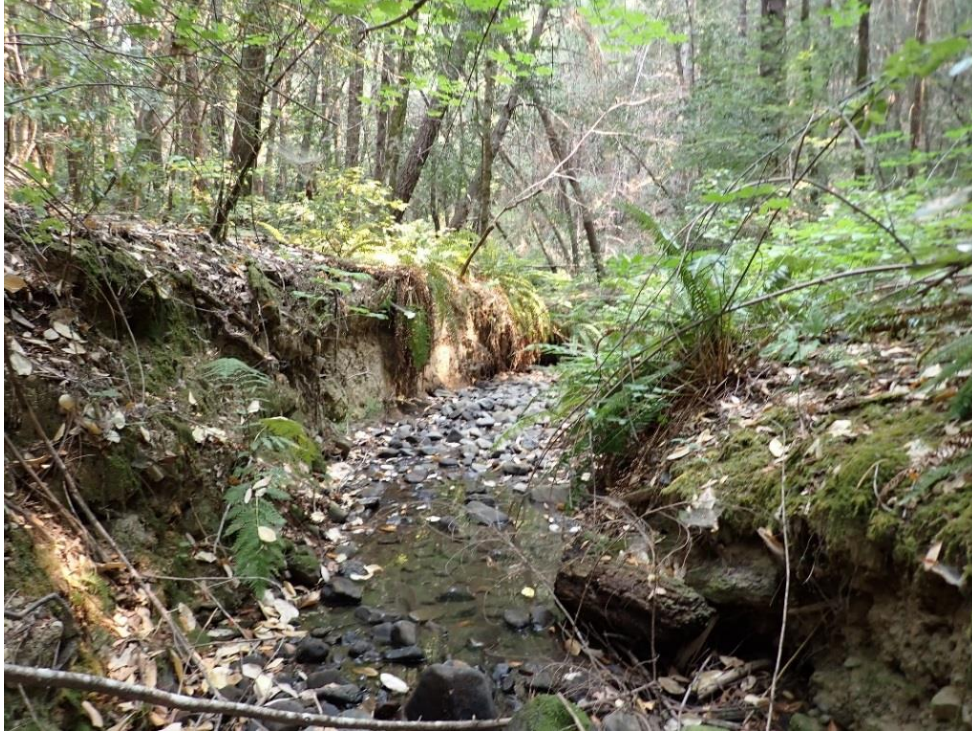
Figure 60. Unnamed tributary of Cahto Creek on Kovner property with good steelhead spawning gravels, but with channel down-cut five to six feet lessening nearby groundwater storage. 8/20/20.

Many headwater channels of Tenmile Creek have lasting hydrologic impairment as a result of past logging activities, including yarding and skidding logs up and down creek beds and sometimes completely re-routing streams. Historically headwater tributaries would have had a series of very large wood jams that would meter sediment, provide complex habitat for salmon and steelhead, and also constitute a water bank (Sedell et al. 1988). Skidding logs down channels caused a complete removal of large wood, sedimentation of the stream bed and downcutting that causes nearby hillslope instability. In aggregate, these changes have compromised water storage and water supply in affected tributaries. Large woody debris from forest health projects could be used to restore headwater stream channels and water storage capacity. ERRP recently completed a Forest Health Management Plan for the Kovner property on the unnamed tributary of upper Cahto Creek. The channel is down-cut (Figure 60) and ERRP recommends that large wood be used from subsequent forest health projects to create stair-steps to meter sediment, sort spawning gravels and rebuild the water table. This is similar in concept to the Sanctuary Forest large wood installations on upper Mattole tributaries that were shown to have benefit for nearby groundwater storage (Formosa 2013). These projects would need separate permitting and planning apart from forest health implementation, but the timing of the two projects would be closely coordinated.
