Tenmile Creek Watershed Conservation and Restoration Action Plan

By the Eel River Recovery Project

For the California State Coastal Conservancy & Prop 1 Grant Fund
July 31, 2020

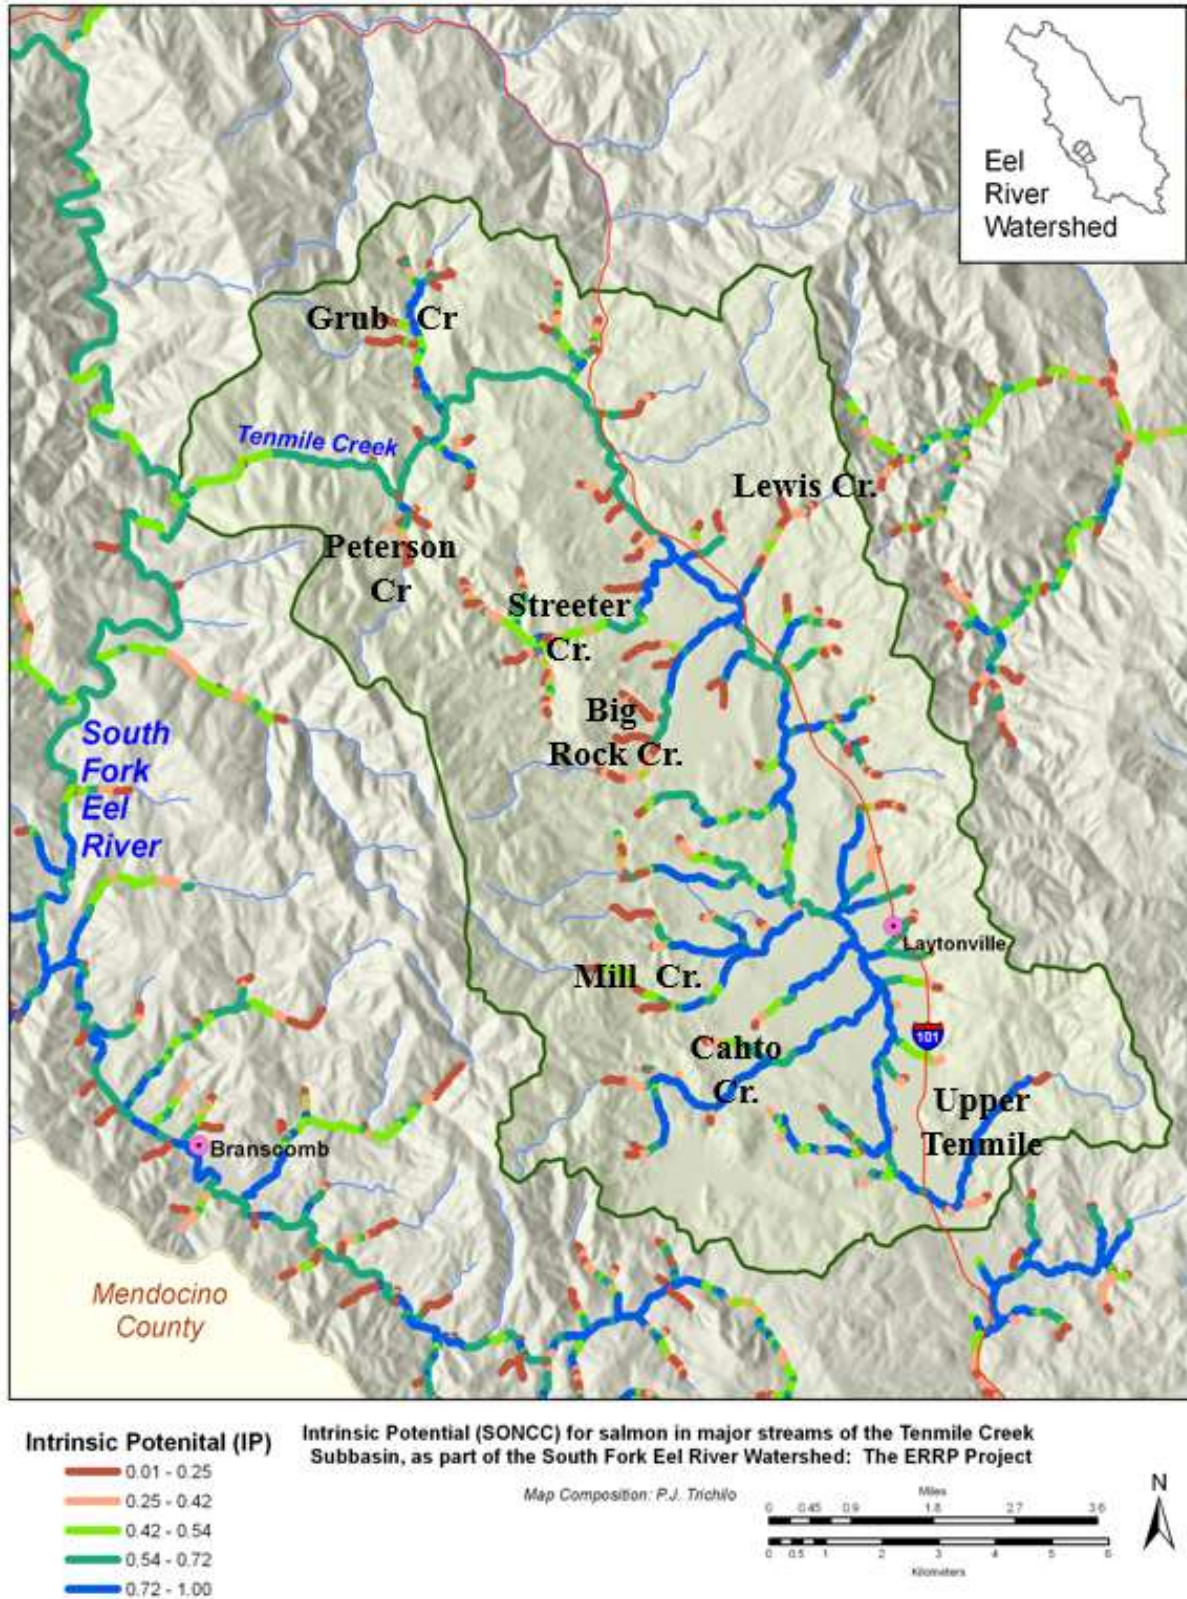
Figure 3 Map of Tenmile Creek with coho salmon Intrinsic Potential, with darkest blue of greatest likely historic use by coho salmon. IP data from Williams et al. (2004). Map by Dr. Paul Trichilo for ERRP.

Before European contact, the Tenmile Creek valley would have been a vast interconnected system of wetlands, including beaver dams. Coho salmon juveniles likely thrived in the ponds above the dams, which also helped maintain stream baseflow. National Marine Fisheries Service maps of coho salmon intrinsic potential indicate that Tenmile Creek had some of the most optimal habitat in the Eel River watershed for the species (Figure 3).

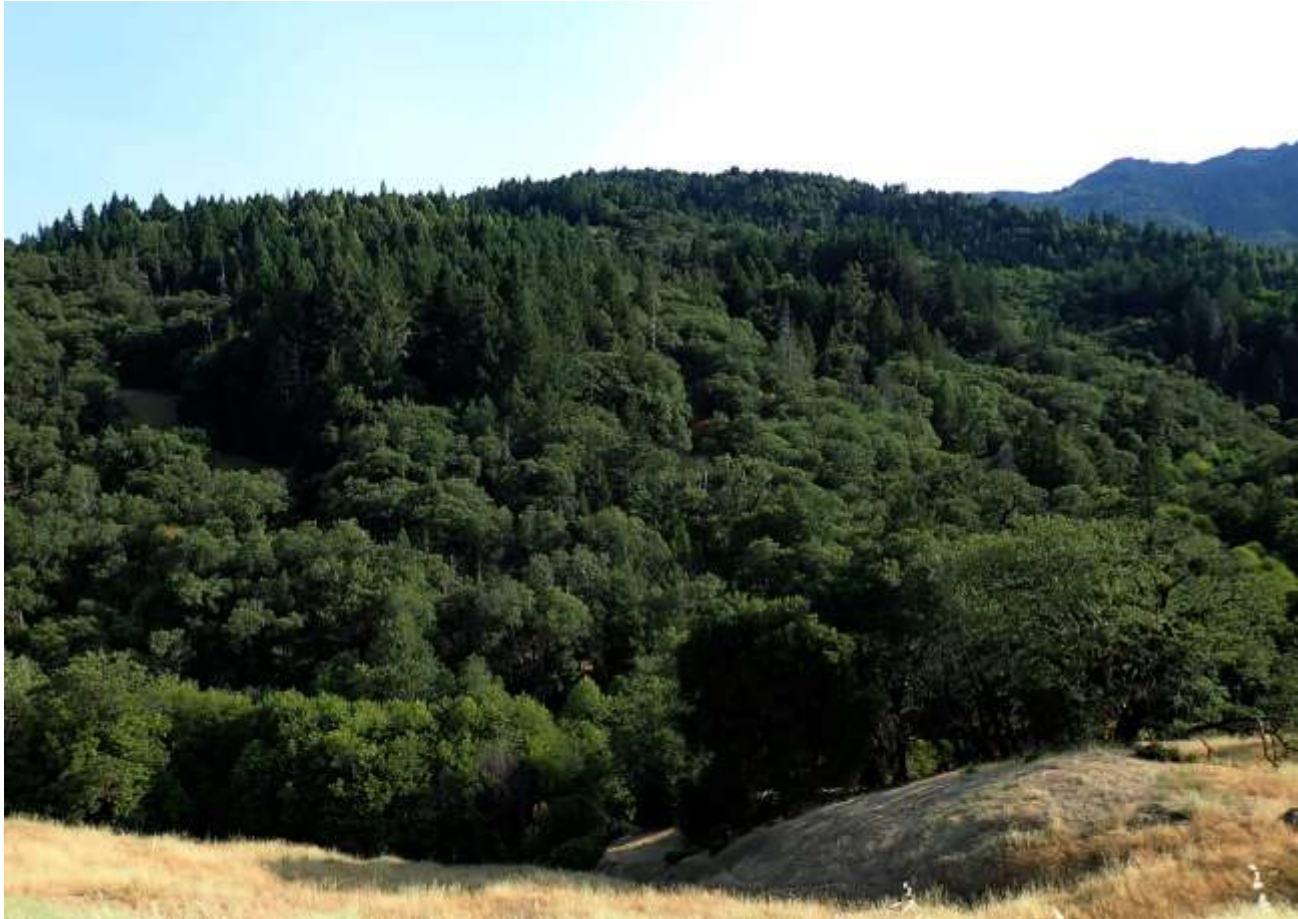
Figure 4 Coniferous trees over-topping oak forest in upper Streeter Creek watershed, which is undesirable for a number of reasons, including loss of summer base-flow.

Post WWII logging led to over-stocked forest conditions that are depleting baseflow in streams like Streeter Creek. Young firs use much more water than old growth trees and there are thousands more trees in the same area as before logging. This leads to an increase in the amount of water the forest uses during evapotranspiration, which leaves less water in the stream in late summer.

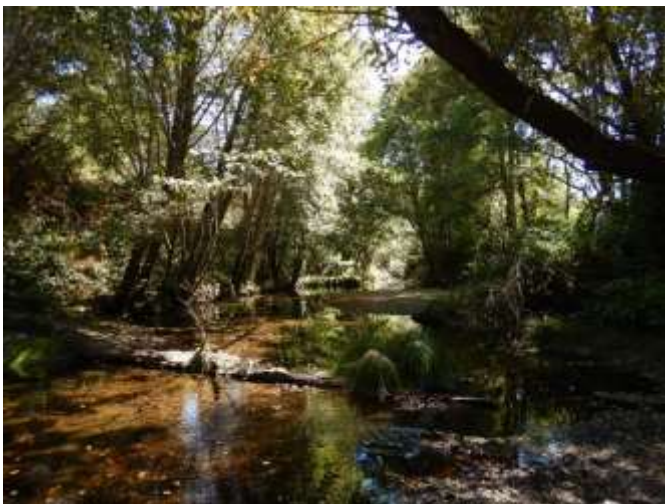
Figure 5 Reach of mainstem Tenmile Creek above Tenmile Creek Road with mature oak and hardwood canopy.

The California State Coastal Conservancy (SCC) awarded Prop 1 funds to the Eel River Recovery Project requiring a plan to be formulated for restoring Tenmile Creek riparian zones basinwide. Much of the riparian zone of Tenmile Creek is unique in the Eel River watershed because it is intact, and often comprised of old growth oak species (Figure 5).

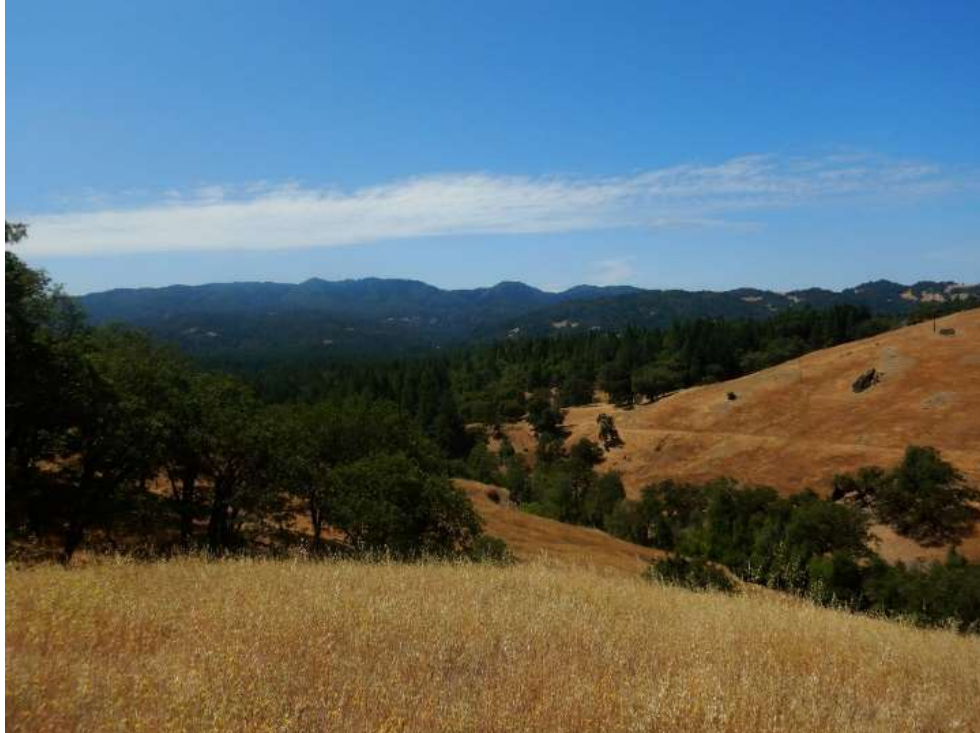
Figure 7 Lewis Creek flowing west to Tenmile Creek with good hardwood canopy with Cahto Peak in the distance.

The western watershed is underlain by the porous sandstone of the Coast Range with slopes covered by coniferous forest. Steep tributaries coming off Cahto Peak have conifer and hardwood canopies, some impacted by past logging, but most largely in recovery from previous disturbances (Figure 6). The east side of Tenmile Creek is underlain by Central Belt Franciscan Mélange Terrain with sheared underlying soil materials that tend to have more grasslands. The creeks flowing from the east side, such as Lewis Creek, have good riparian shade provided by native hardwoods, but do not tend to develop a second tier of canopy (Figure 7) like Tenmile Creek on the valley floor.

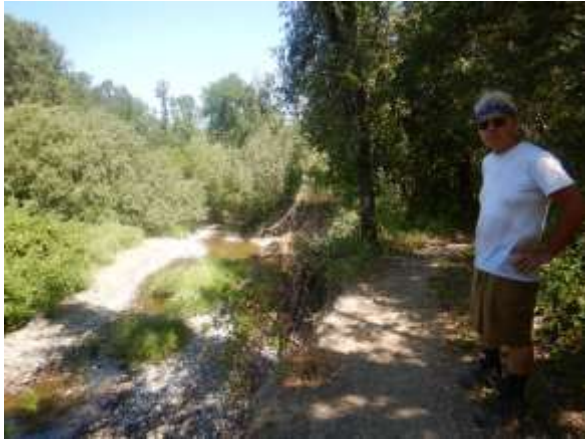
Figure 9 Dennis Hogan on Cahto Creek with eroding bank threatening Cahto Trail.

Hogan Property (Cahto Creek): Cahto Creek has steelhead, Chinook and even coho salmon in some years and in general is not over-supplied with sediment. The total length of the site on the Hogan property is 130 feet and the height of the streambank is 9 feet (Figure 9). The streambank is near vertical and lacking any stabilizing vegetation. There are many exposed tree roots along the bank and five mature trees which are growing near the top of the bank and are in danger of falling into the creek. The streambank erosion threatens the popular Cahto Creek Trail, which runs from Mulligan Lane to Harwood Park.

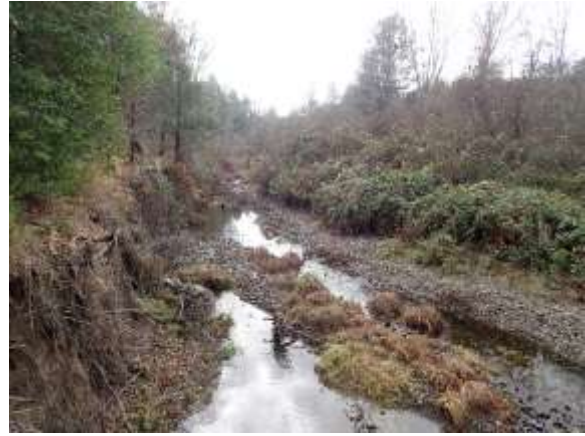
Figure 10 The Kelly property on Cahto Creek and also along the Cahto Trail.

Kelly Property (Cahto Creek): The actively eroding streambank of Cahto Creek at the Kelly property is near vertical and lacks stabilizing vegetation (Figure 10). The site is 110 feet long and the streambank is 12 feet high. The site is located on the outside of a sharp 90-degree bend in the creek. Numerous trees that have fallen into the creek from the bank and there are two trees which are poised to fall into the stream, if the erosion is allowed to continue. The Cahto Creek Trail runs along the stream at the top of the bank and streambank erosion is threatening a section of the trail as well.

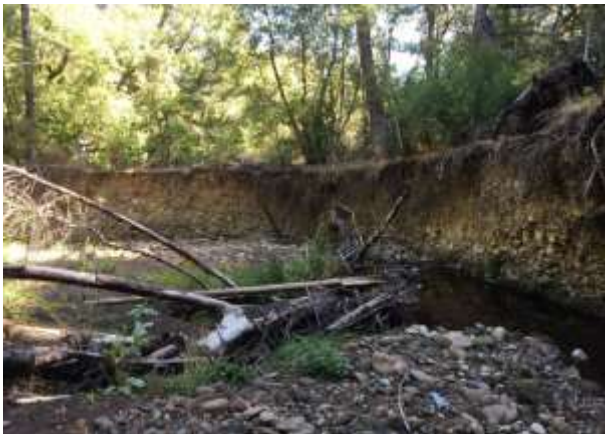
Figure 11 Mill Creek 300-foot-long failing bank on Feigon property.

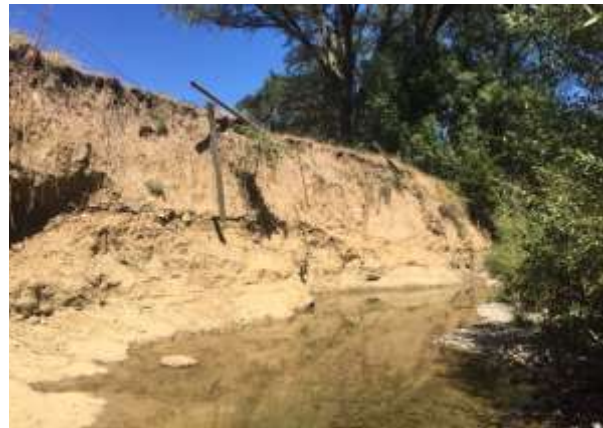
Figure 12 Bank failure on Streeter Creek dumping soil into prime fish habitat.

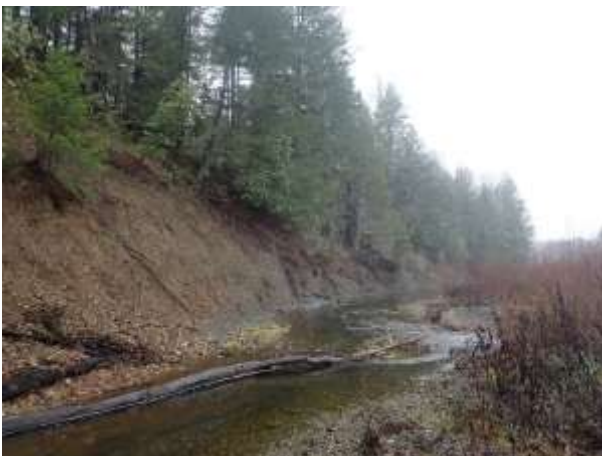
Figure 13. Tenmile Creek on Weaver property below Big Rock Creek. 1/13/20.

Weaver Property (Main Tenmile Creek): The Weaver property is just upstream of the Black Oak Ranch. There is a major bank failure along the west side of Tenmile Creek not far below the convergence of Big Rock Creek (Figure 13). The site is located along the downstream end of a long outside bend in the creek. The actively eroding streambank is 175 feet long with 6 to 25-foot-tall banks. The streambank is nearly vertical and lacking any erosion resistant vegetation. There are numerous ponderosa pine trees growing near the top of bank that are in danger of falling into the stream if the erosion is allowed to continue.

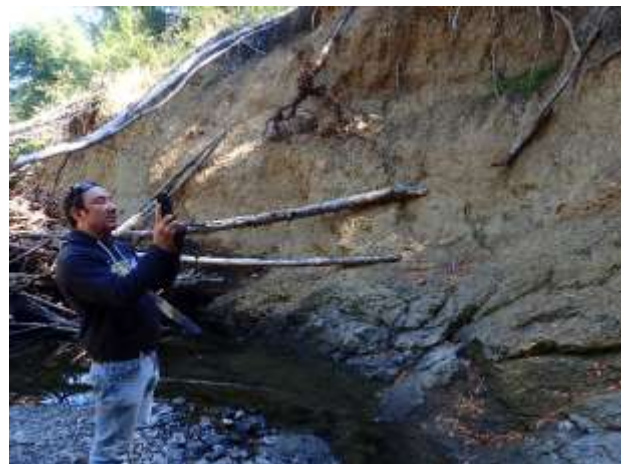
Figure 14. Tony Varnhagen and bank erosion site on his property. 9/8/19.

Varnhagen Property (Cahto Creek): This reach of Cahto Creek is above the Cahto Tribe Reservation where extensive riparian restoration and bank erosion repair has taken place. The Varnhagen site is a rare large erosional feature and a major source of sediment to this reach. The site is an actively eroding streambank 250 feet long with a 10 to 25-foot-tall bank (Figure 14). The creek makes a sharp 90-degree bend with the actively eroding streambank on the outside bend of the creek. On the inside of the bend on the opposite side of the creek is a large gravel bar. There are many fallen trees which have been deposited on the bar. The gravel bar is increasing in size with each large storm and putting more pressure on the actively eroding streambank.

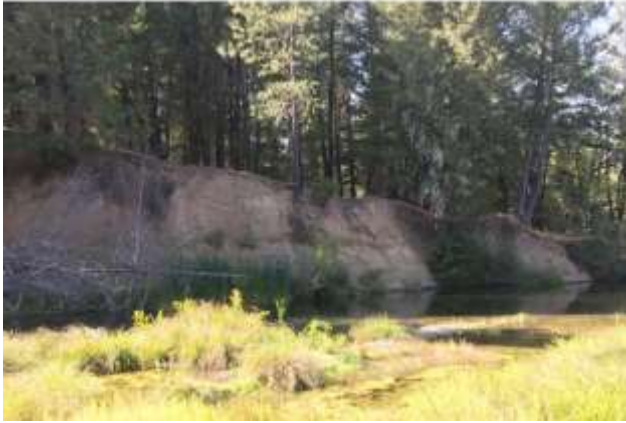
Figure 15. Eroding bank on main Tenmile Creek on BOR.

Black Oak Ranch (Main Tenmile Creek): Several sites with large vertical, eroding cut-banks, exist on the BO. The site shown in Figure 15 is 530 feet long with 12 to 20-foot-tall banks. The streambank is actively eroding and lacking any erosion resistant vegetation. There are numerous trees growing at the top of bank which are in danger of falling into the creek if the erosion is allowed to continue.

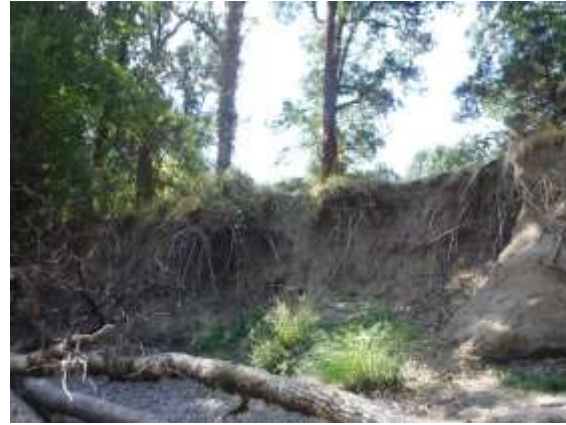
Figure 16. Main Tenmile Creek below Cahto Creek. 9/13/18.

Unknown Landowner (Tenmile below Cahto Creek): ERRP and BE have identified several other significant bank erosion sites that need treatment, but we have not had time to contact land owners or do in-depth exploration of the size of features and potential for sediment pollution. Figure 16 shows a major bank failure downstream of Cahto Creek with potential to cause major sediment pollution. There are similar features across from Harwood Park along the mainstem of Tenmile Creek where work is needed but contacts not yet made.

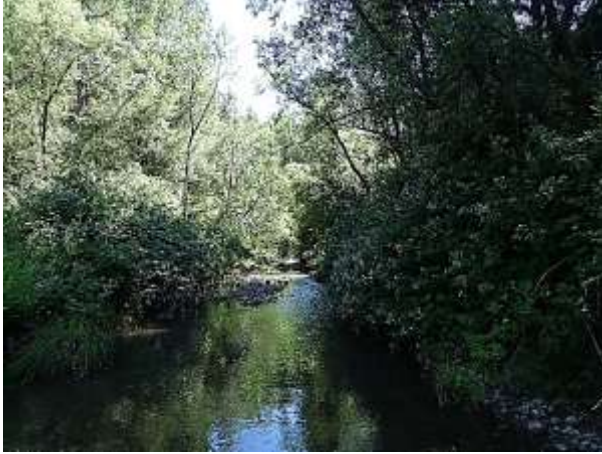
Figure 17. Streeter Creek above Tenmile Creek with restored riparian but out of control Himalaya berries. 6/23/19.

Black Oak Ranch (Streeter Creek): Bank failures on Streeter Creek associated with high flows in the 1983 El Nino year triggered the interest and sparked the career of Evan Engber, a Black Oak Ranch member and the founder of BE. Riparian shade has been restored and channel width decreased on lower Streeter Creek, as a result of bioengineering projects in the 1980s and 1990s. Riparian air temperatures also cooled, which has a cooling influence on stream temperatures. However alder mortality is occurring along Streeter Creek, possibly spurred by recent droughts. Himalaya berry, a non-native species, is taking over the riparian zone and some effort is needed to control it (Figure 17).

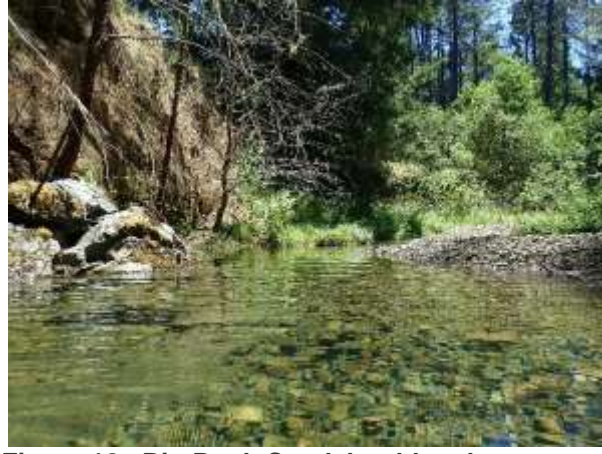
Figure 18. Big Rock Creek boulder clusters installed in the 1990s still preventing bank erosion and scouring a pool. 6/23/19.

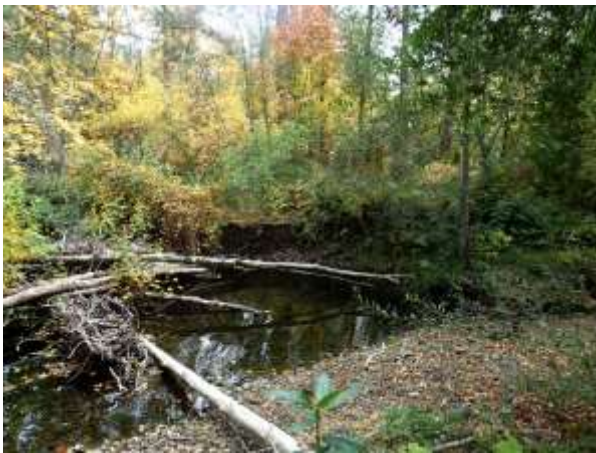
Figure 19. Bank erosion control and fish habitat improvement structure on Cahto Reservation.

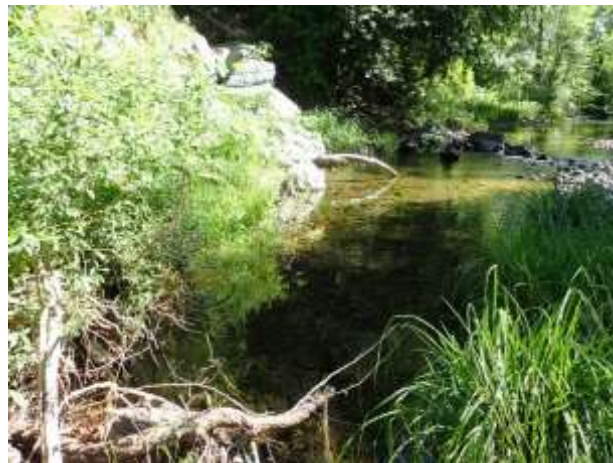
Figure 20. Cahto Creek with bank revetment on Boule property.

Boule Property (Cahto Creek): This property was threatened by bank erosion in the 2017 Water Year and the land owner Cheryl Boule opted to install large rock on an emergency basis, after Cahto Creek cut a 50-foot swath into her property. She used local experienced contractors to construct the bank stabilization structure to save her barn. Although she was later cited by the California Department of Fish and Wildlife for her unpermitted activities, the structure has created a pool that provides some of the best fish habitat for juvenile steelhead in the adjacent reach of Cahto Creek (Figure 20). Pool scour associated with the structure has created stratification that allowed juvenile salmonid survival in the summer of 2019, when connecting flow in this reach of the creek was lost. ERRP is interested in recruiting volunteers to improve willow growth and to increase riparian species diversity, with land owner permission.

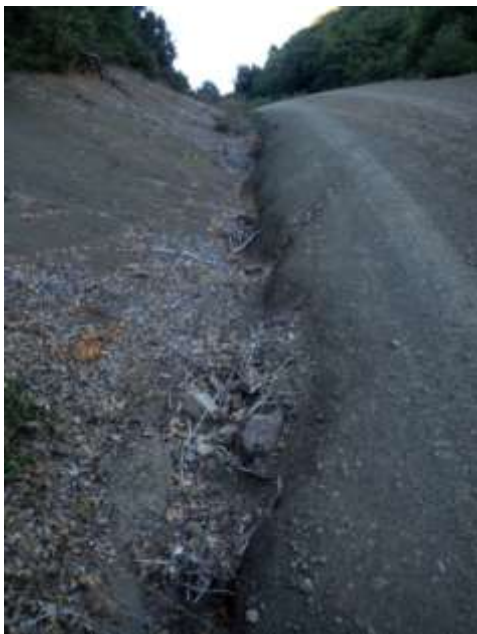
Figure 23. Gully in upper Cahto Peak Rd.

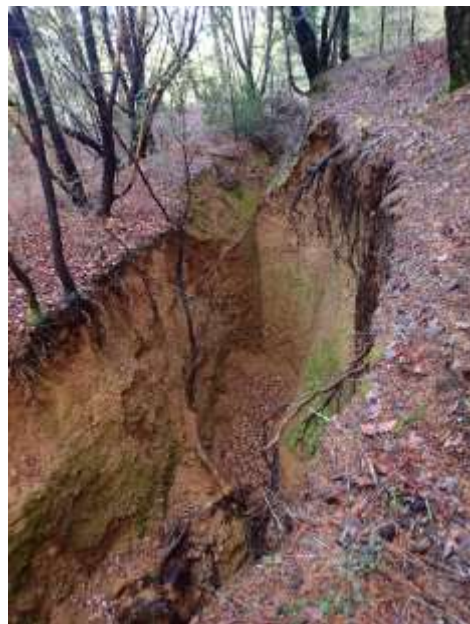
Figure 24. Forest gully formed due to deflection of water onto unarmored hillslope.

A gully is defined on Dictionary.com as “a small valley or ravine originally worn away by running water and serving as a drainage-way after prolonged heavy rains”. Gullies can form at many scales, with small ones formed by the in-board ditch of a road (Figure 23) or larger ones when water is deflected on to unarmored hillslopes (Figure 24).

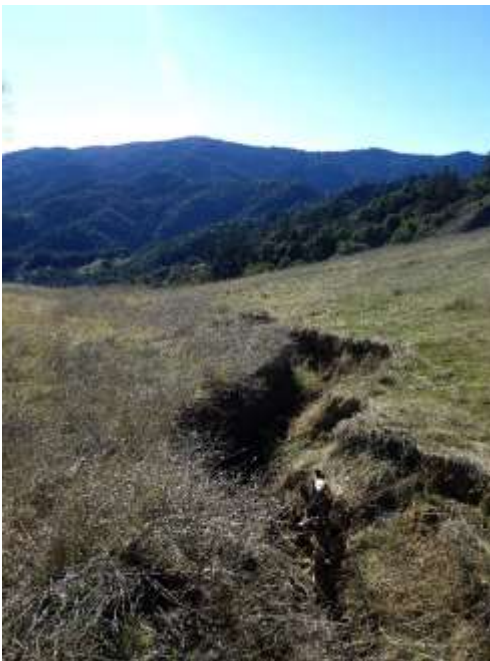
Figure 25. Gully in upper Grub Creek watershed as a result of road drainage. 3/10/20.

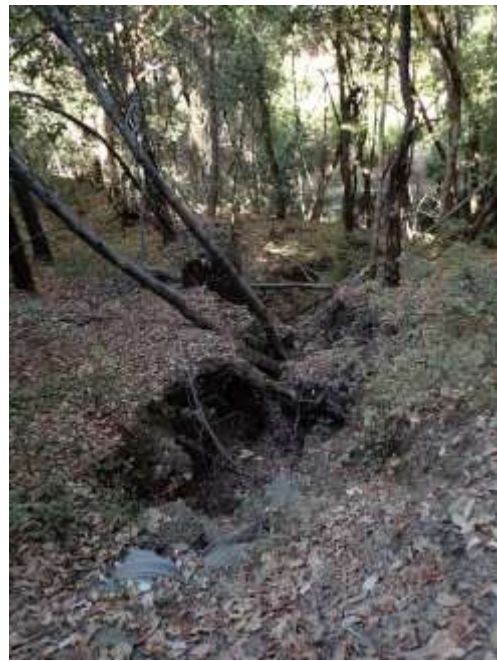
Figure 26. Gully formed by drainage from Cahto Peak Road contributing sediment to upper Mill Creek. 7/27/19.

One factor that makes the Tenmile Creek watershed susceptible to gully erosion is that the Central Belt Mélange Terrain covers the eastern half of the watershed and sheared soils give rises to extensive grasslands. There is no rock layer within the soil of meadows, so if roads cross these areas and concentrate water without armoring below downspouts, they may cause gullies to form (Figure 25). Similar problems may occur below culverts in forested areas as well (Figure 26).

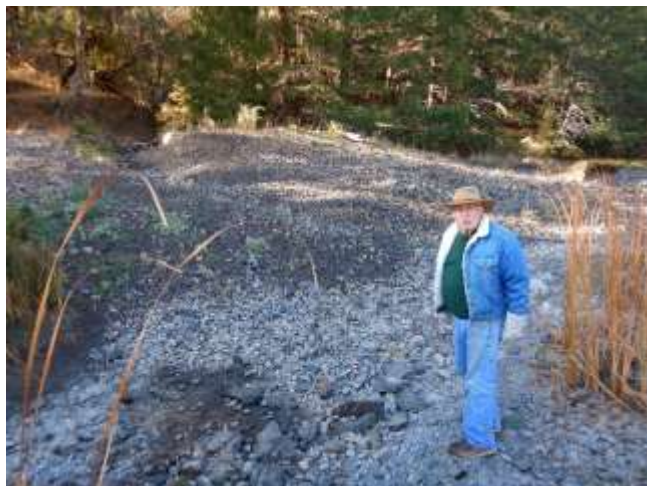
Figure 27. Landowner Bob Vassar points out major sediment deposition from gully on lower Tenmile Creek. 10/16/18.

Over 740 landowners in the Tenmile Creek watershed received questionnaires that included questions related to problems with gully erosion. ERRP sub-contractors followed up in the field with those requesting services (Figure 27), photo-documented conditions, and scheduled additional visits to those location with significant gullies in need of treatment. The Star Worksheet (Attachment 1) field form proved useful for data collection (Figure 28). Since gullies often form at the outlet of culverts under roads, ERRP generated a map of road stream crossings as a means of understanding potential sources (Figure 28), and then conducted a partial inventory of accessible roads using Star sheets. Some stream segments with a high number of stream crossings per mile, such as in Grub Creek, pose a significant risk of multiple-crossing road failures and catastrophic channel change.

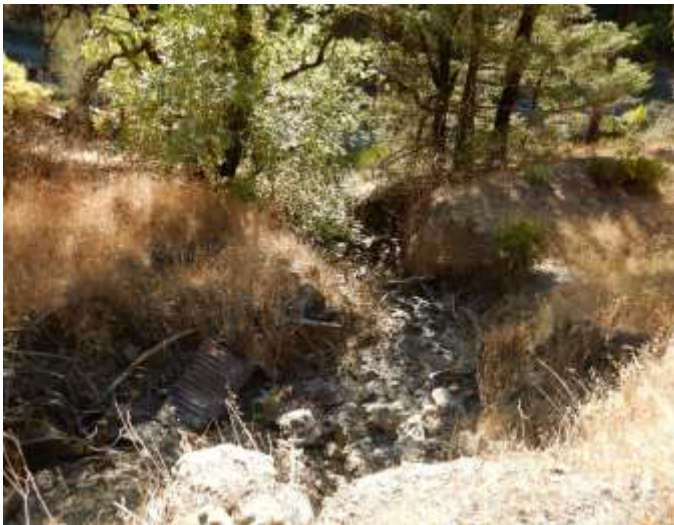
Figure 33. Eroding gully below road paralleling lower Tenmile Creek on Vassar property. 10/16/18.

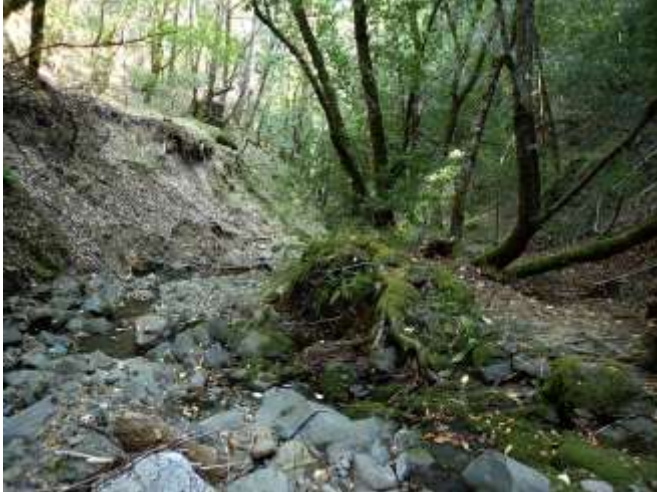
Figure 35. Down-cut Streeter tributary.

We discovered that use of a major tributary of Streeter Creek as a skid and haul road during Post WW II logging had caused a devastating impact on the creek's hydrology. The cat-logging removed all large wood from the channel. Large wood jams in old growth headwater stream systems form stair steps that slow the flow of nutrients out of tributaries and create excellent habitat conditions for fish, and metered and stored sediment. Each jam also creates a water storage area that discharges cold water over a prolonged period. Removal of large wood allowed the speed of the water in the tributary of Streeter Creek to increase, which in turn translated into increased shear stress, causing the bed of the

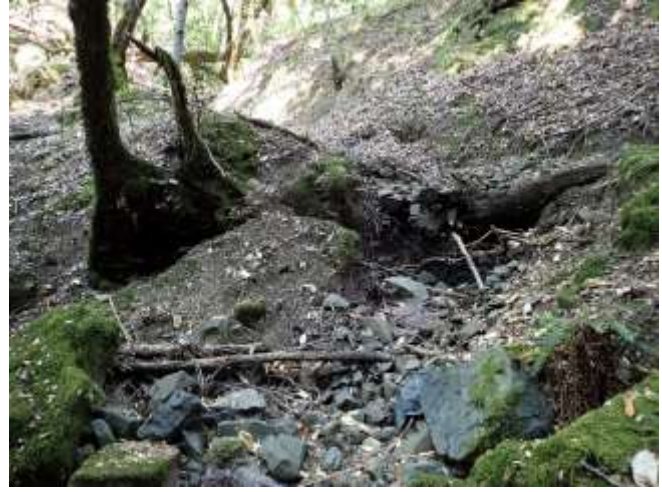
Figure 36. Tributary channel also used as skid trail, bare-banked and down-cutting.

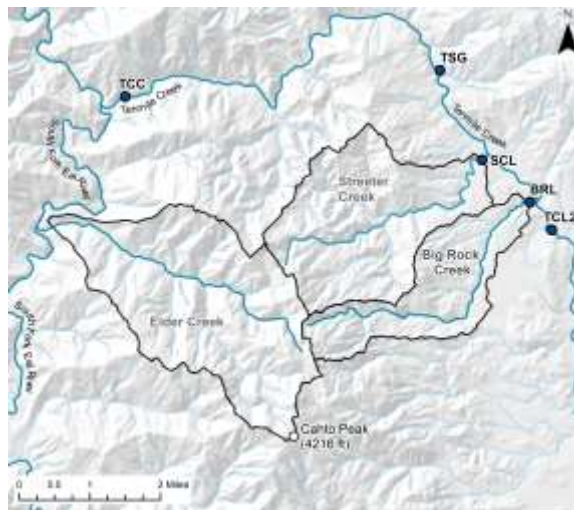
Figure 37. Map of TGAEC flow gauge locations. TCC = Tenmile Cr Confluence, TSG – Tenmile Cr. near Spring Gulch, TCL2 = Tenmile Cr Laytonville, SCL = Streeter Cr., BRL – Big Rock Cr.

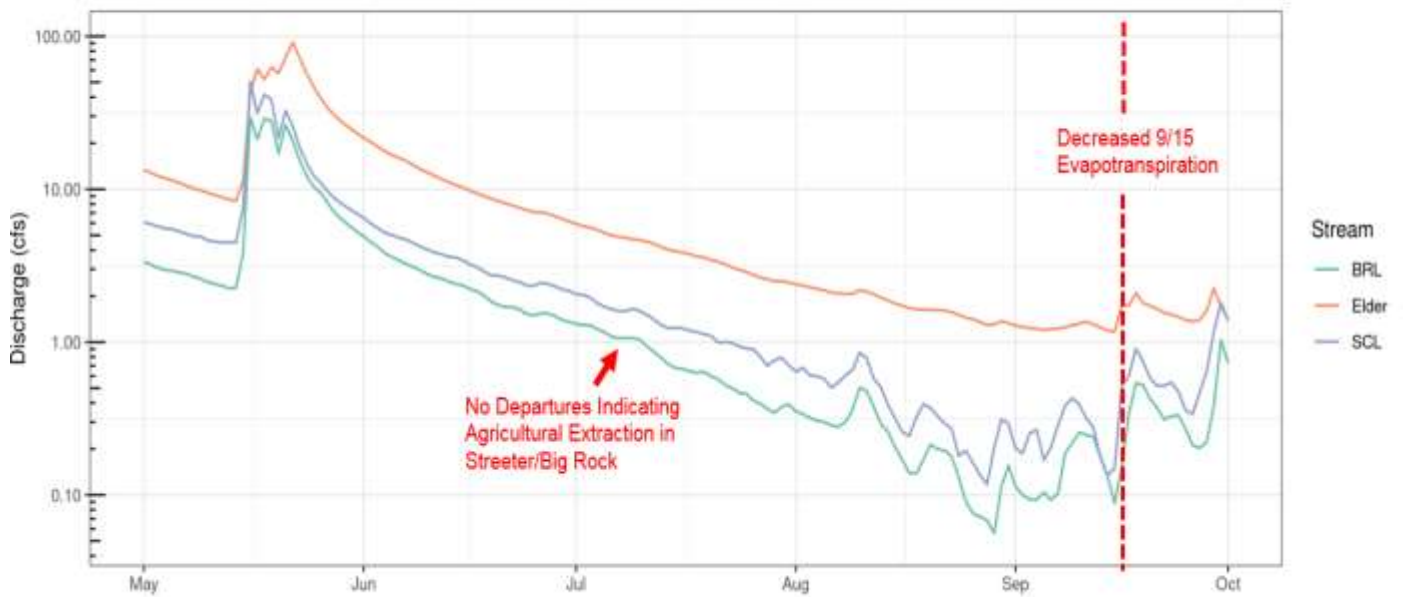
Flow of Elder, Streeter and Big Rock Creeks – Falling Hydrograph May-Oct. 2019

Figure 38. Chart comparing descending hydrograph of Elder, Streeter and Big Rock Creeks, May through October 2019. TGAEC.

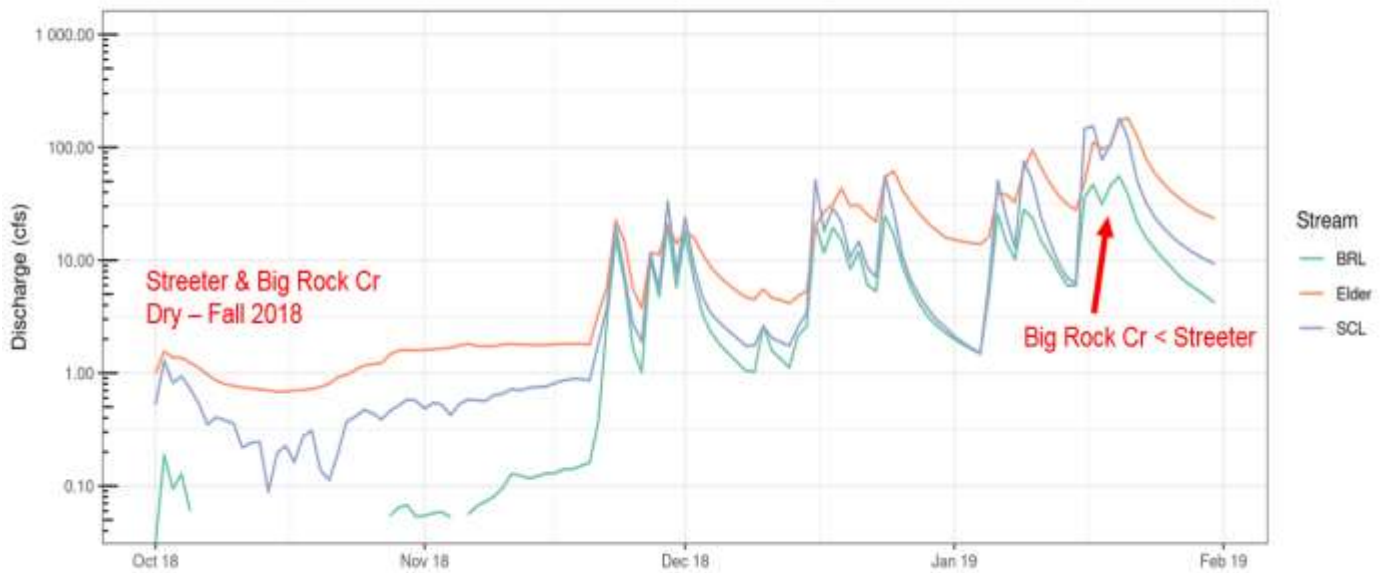
Flow of Elder, Streeter and Big Rock Creeks – Ascending Hydrograph Oct. 2018 – Feb 2019

Figure 39. Chart comparing ascending hydrograph of Elder, Streeter and Big Rock Creeks, October 2018 to February 2019. TGAEC.

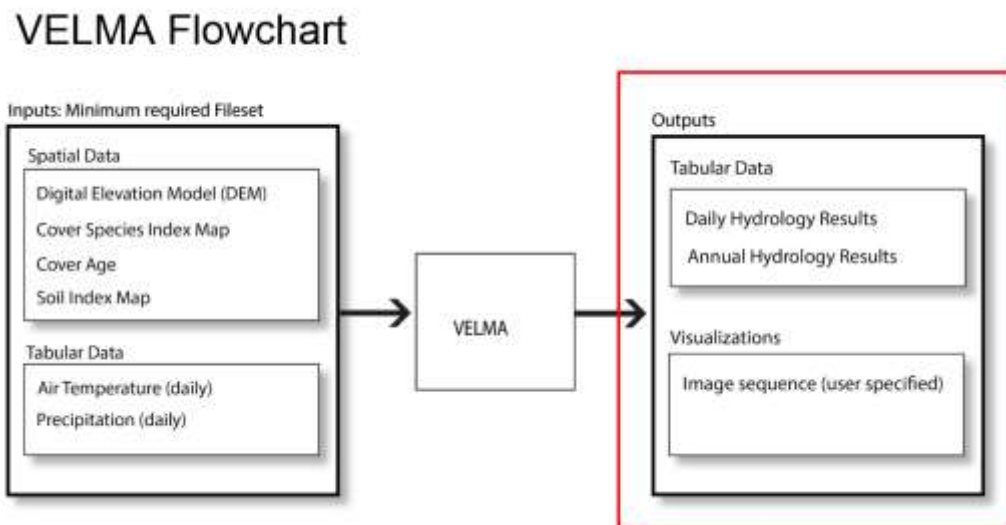
Figure 40. Schematic of VELMA model parameters and outputs. By TGAEC.

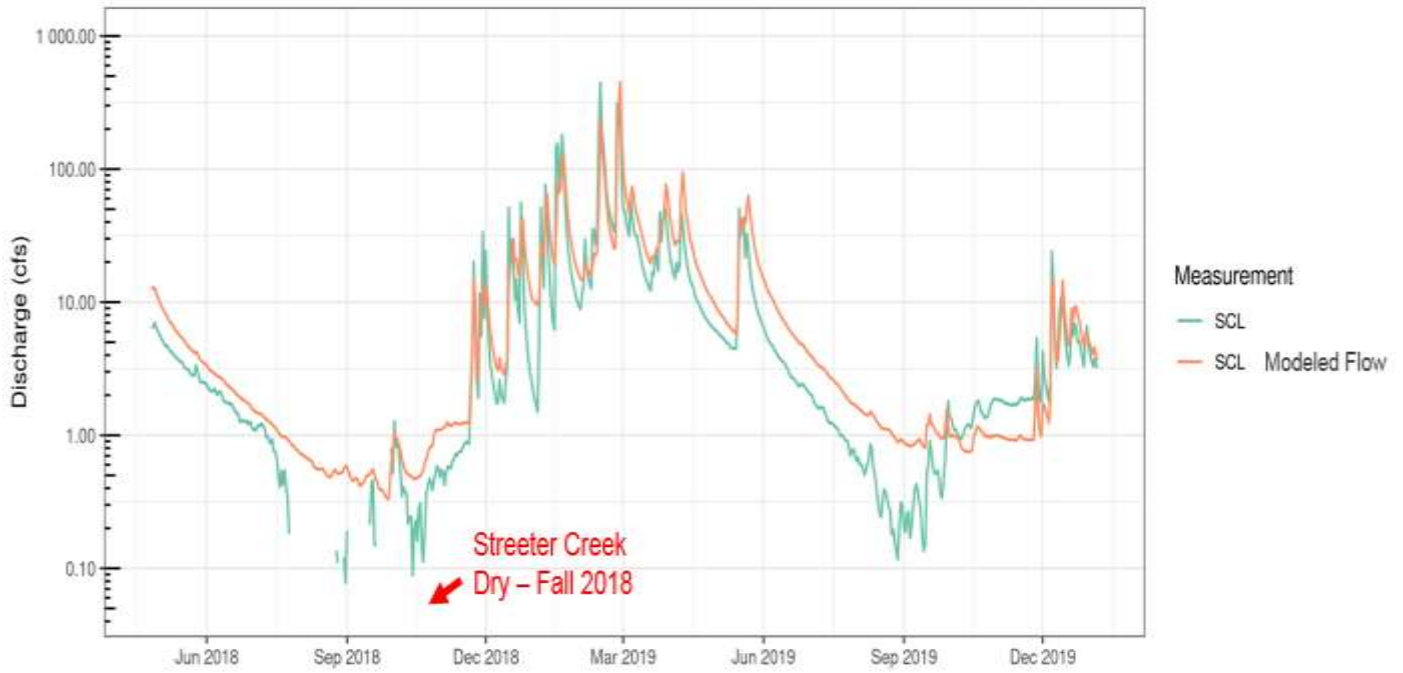
Flow of Streeter Creek Versus Scaled Model Flow for Period of Jun 2018 – Dec 2019

Figure 41. Chart of actual flow of Streeter Creek versus simulated flow generated by the VELMA model for June 2018 through December 2019.

Results for simulated flow of Streeter Creek versus actual flow (Figure 41) show likely historic flow conditions before watershed disturbance and project that the stream would not have gone dry in 2018, and would have had approximately ten times higher baseflow in 2019. The relationship between Big Rock simulated flows and actual flows (Figure 42) show almost identical relationship to those of Streeter Creek and its model run.

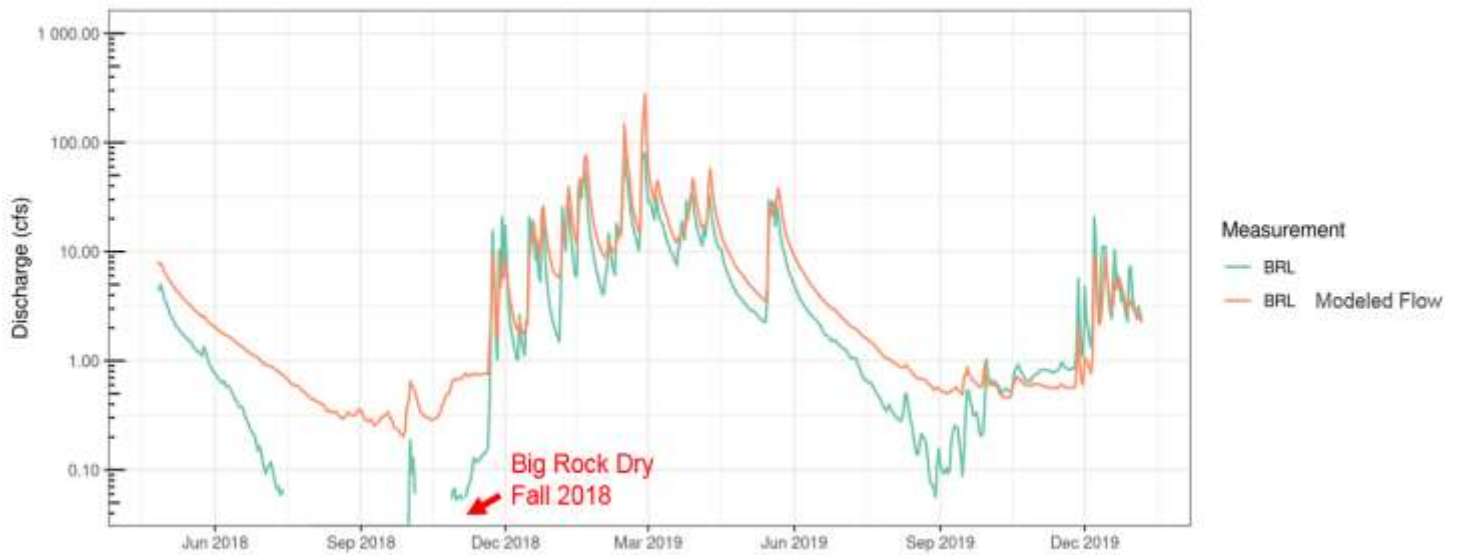
Flow of Big Rock Creek Versus Scaled Model Flow for Period of Jun 2018 – Dec 2019

Figure 42. Chart of actual flow of Big Rock Creek versus simulated flow generated by the VELMA model for June 2018 through December 2019.

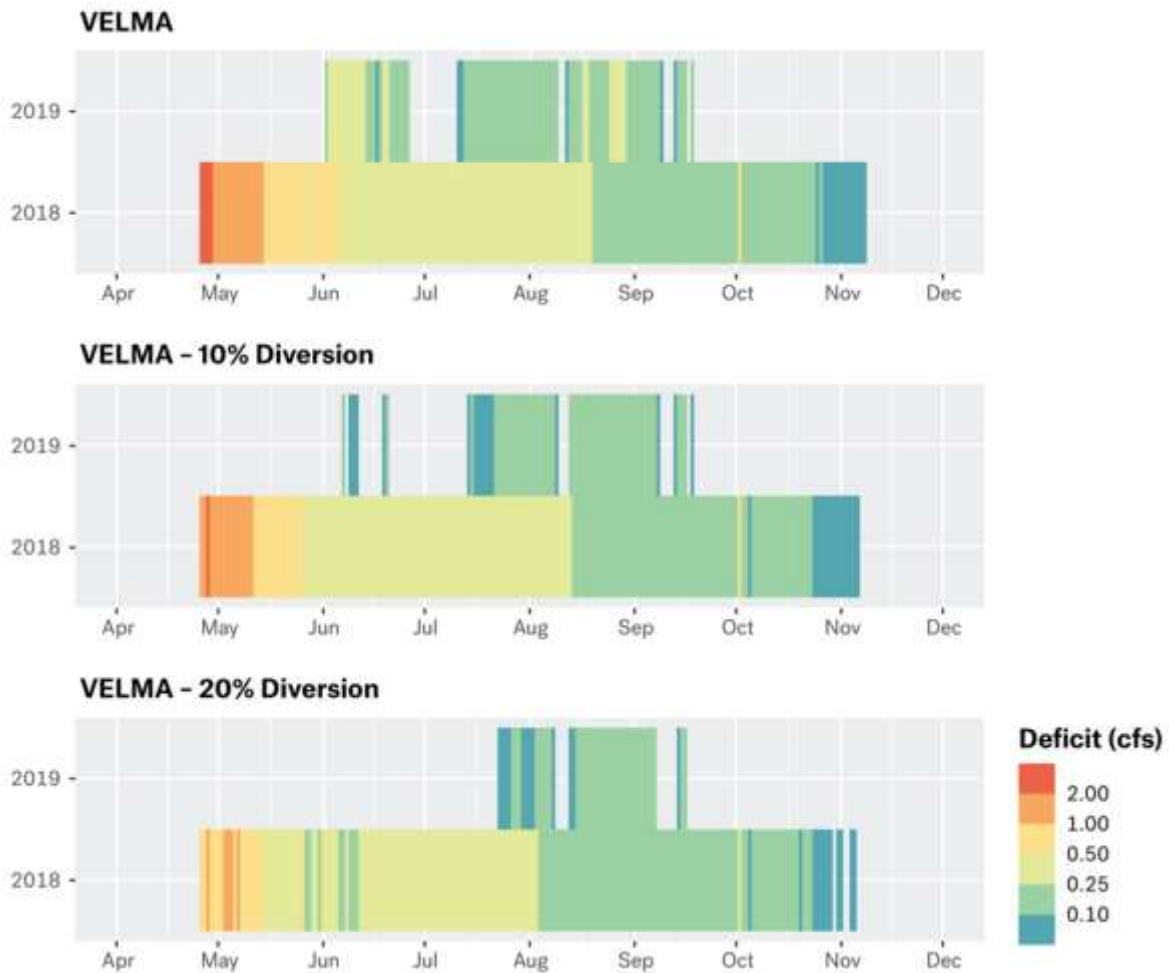
Figure 47. Daily streamflow deficits in Big Rock Creek as calculated under baseline conditions: VELMA modeled unimpaired flow, VELMA modeled unimpaired flow with 10% subtracted, and VELMA modeled unimpaired flow with 20% subtracted.

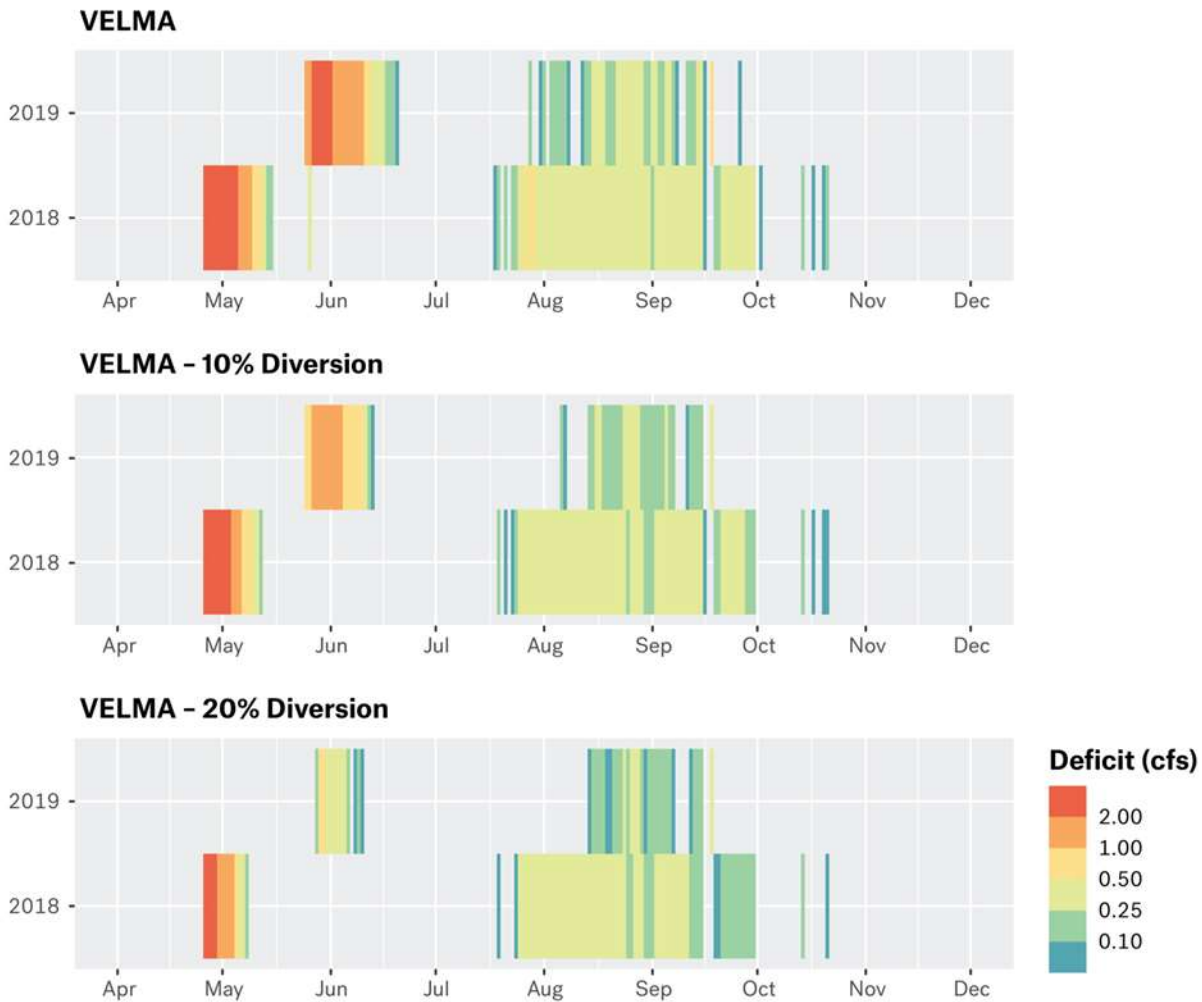
Figure 48. Daily streamflow deficits in Streeter Creek as calculated under baseline conditions: VELMA modeled unimpaired flow, VELMA modeled unimpaired flow with 10% subtracted, and VELMA modeled unimpaired flow with 20% subtracted.

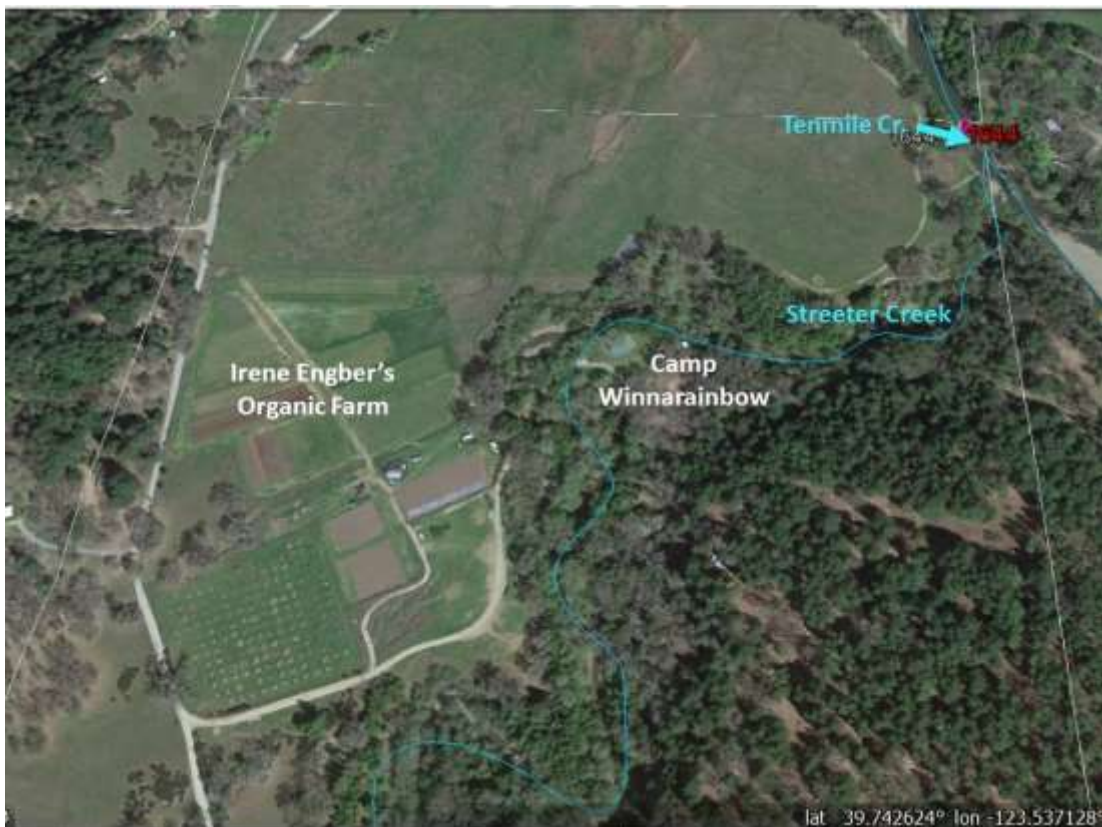
Figure 51. Location of Black Oak Ranch organic farm and Camp Winnarainbow relative to Streeter and Tenmile creeks. Google Earth photo annotated by ERRP.

ERRP applied to the SCC Prop 1 fund in April 2020 to design and permit an off-stream storage pond with sufficient supply to meet the needs of the BOR organic farm, and for watering the grounds of Camp Winnarainbow, across Streeter Creek from the farm (Figure 51). In addition, augmented water storage and all needed infrastructure improvements for the camp would be designed and permitted. This will enable both enterprises to forbear from use of Streeter Creek water in the future. The actual construction of the pond and water infrastructure for the camp would be part of a subsequent grant

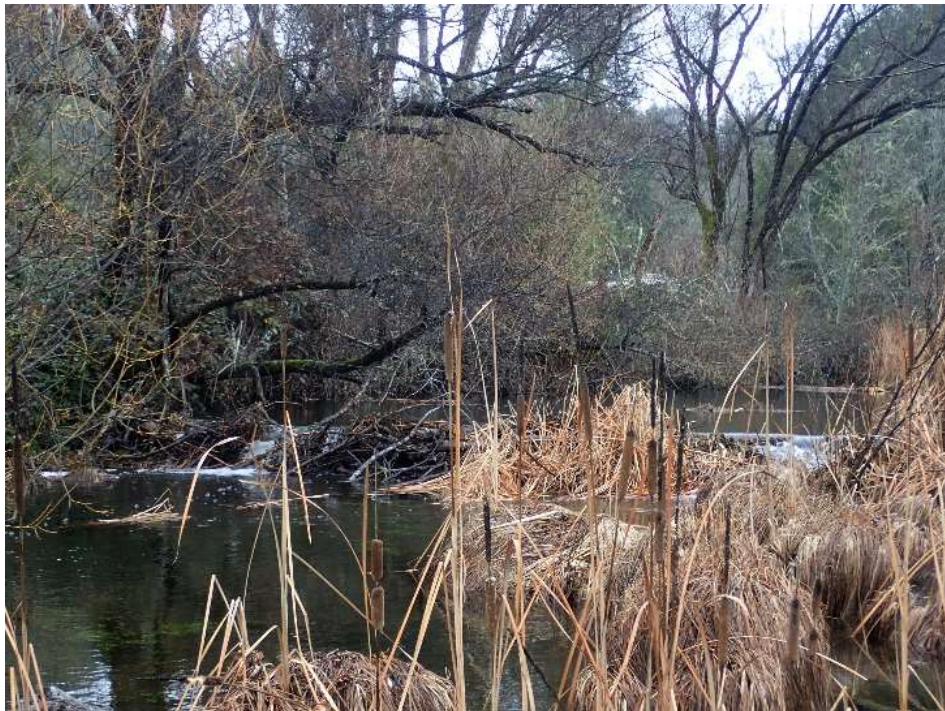
Figure 53. Large beaver dam below Big Rock Creek that causes impoundment in summer at this location. 1/20/20.

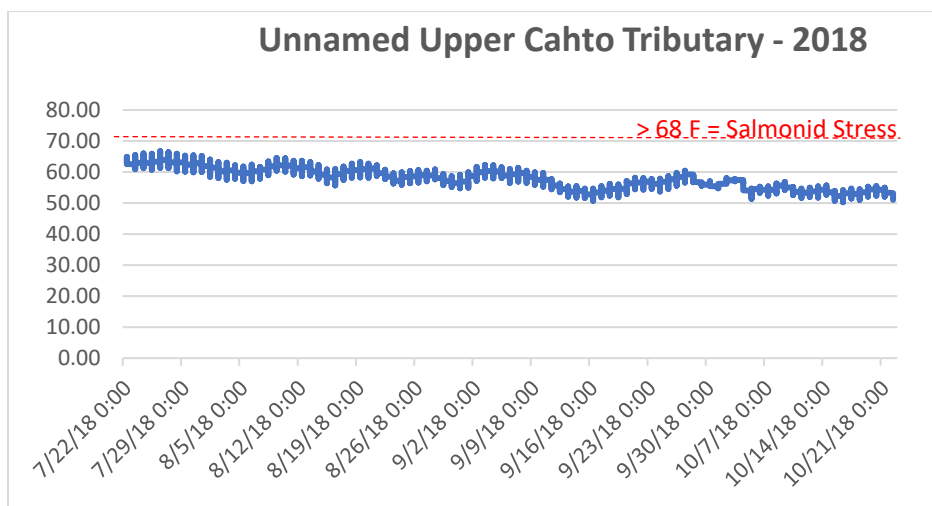
Figure 54. Water temperature of unnamed upper Cahto Creek tributary on Patricia Kovner’s property was cool enough for steelhead rearing.
