Tenmile Creek Watershed Conservation and Restoration Action Plan

By the Eel River Recovery Project

For the California State Coastal Conservancy & Prop 1 Grant Fund
July 31, 2020

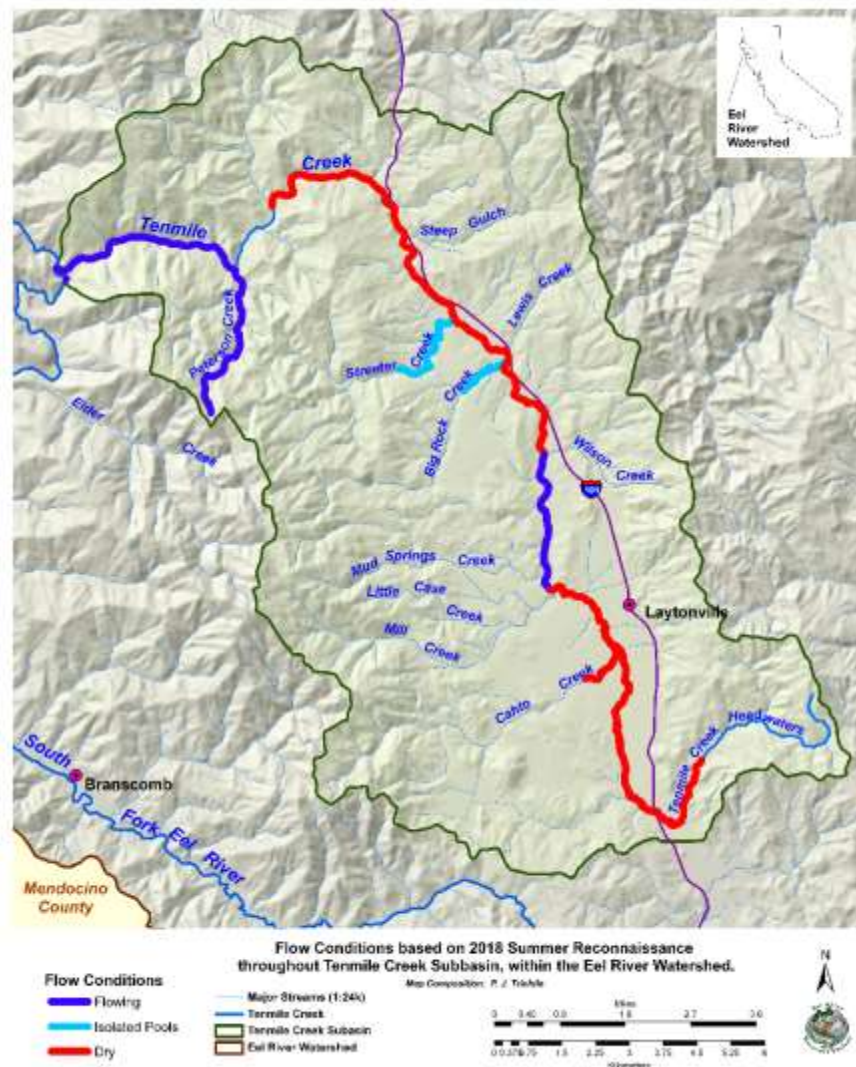
Figure 58. Map of Tenmile Creek flow conditions based on 2018 reconnaissance. ERRP.

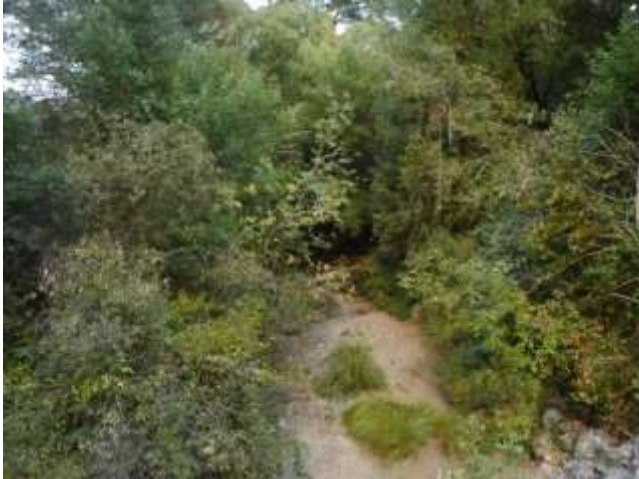
Figure 60. Tenmile Creek dry above Highway 101. 8/15/19.

Figure 59 is a map of Tenmile Creek basin-wide flow conditions in 2019, including fish habitat suitability. Spring rains greatly improved the flow regime and carrying capacity for juvenile steelhead. However, we photo documented dry reaches of Tenmile Creek in 2018 and 2019 at Highway 101 (Figure 60), at Harwood Park, and at Branscomb Road. Isolated pools in this reach lacked fish life. Tenmile Creek at the Black Oak Ranch dried up between pools in 2018, but pools maintained sufficient water quality to support warmwater fish life, although mostly invasive aquatic species (Figure 61). The upper Mill Creek camera documented perennial flow in 2019 (Figure 62). A new location on Mill Creek above Little Case Creek was added in early 2020. The Cahto Creek camera below the Reservation off Mulligan Lane showed that the stream at that location disconnected in 2018 and that flows in winter of 2019-2020 fall were often insufficient for adult salmon and steelhead passage. The lower Tenmile Creek photo location captures the entire valley about a half mile upstream of the SF Eel River (Figure 63).

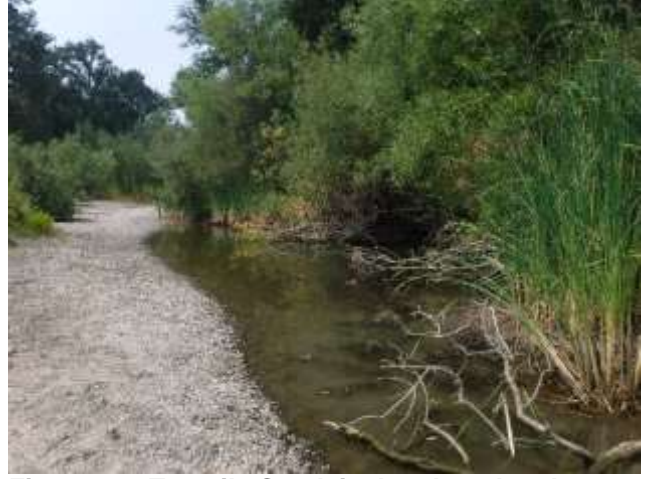
Figure 61. Tenmile Creek isolated pool at the Black Oak Ranch. 9/15/18.

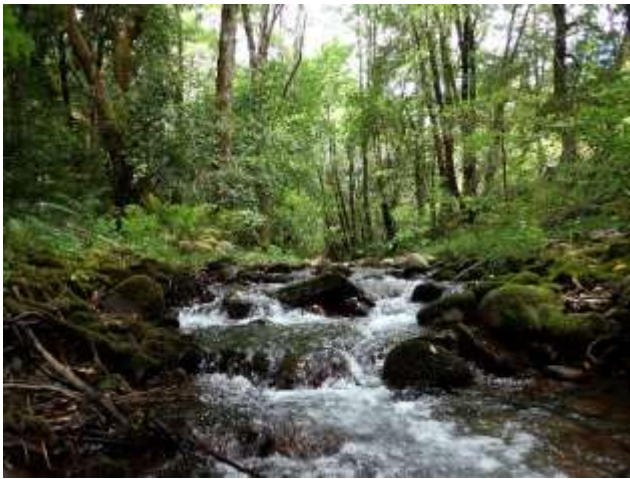
Figure 62. Mill Creek at timelapse camera location. 6/25/19.

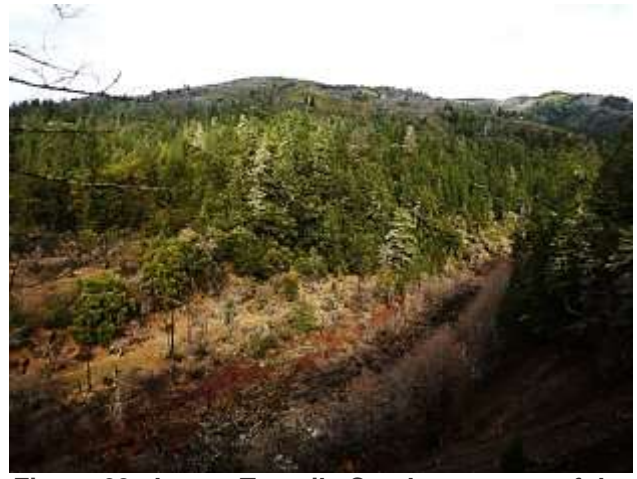
Figure 63. Lower Tenmile Creek upstream of the South Fork Eel River. 12/04/18.

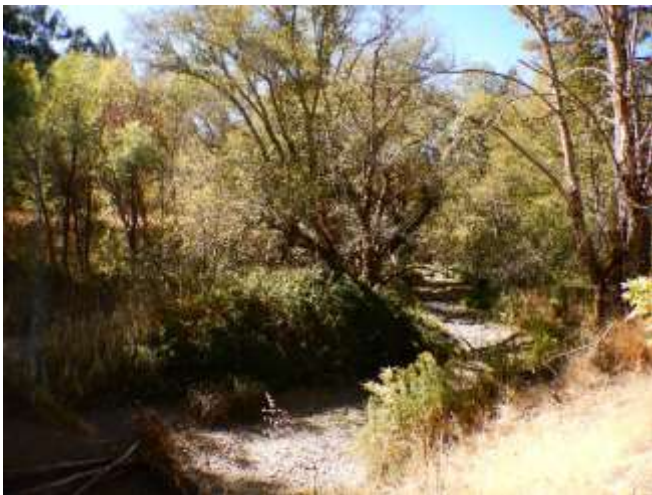
Figure 64. Lower Big Rock Creek dry. 9/12/18.

The camera on lower Big Rock documented lack of flow in the summer and fall of 2018 (Figure 64); however, flow was maintained during the same period in 2019 (Figure 65). These cameras provide a low-cost tool for flow monitoring for adaptive management related to water conservation.

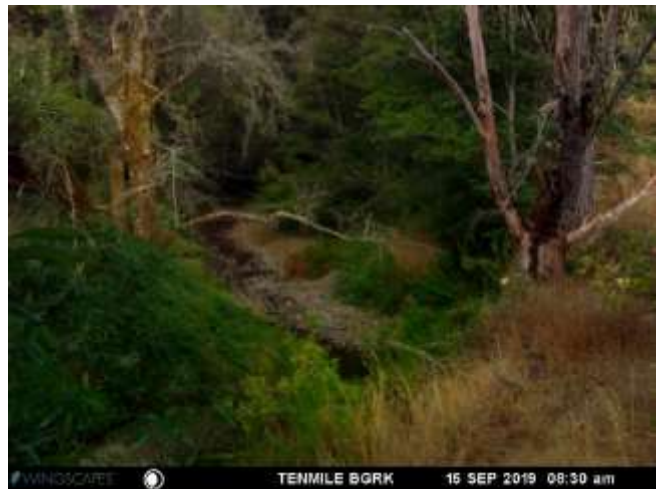
Figure 65. Lower Big Rock Creek with surface flow documented by timelapse camera. 9/15/19

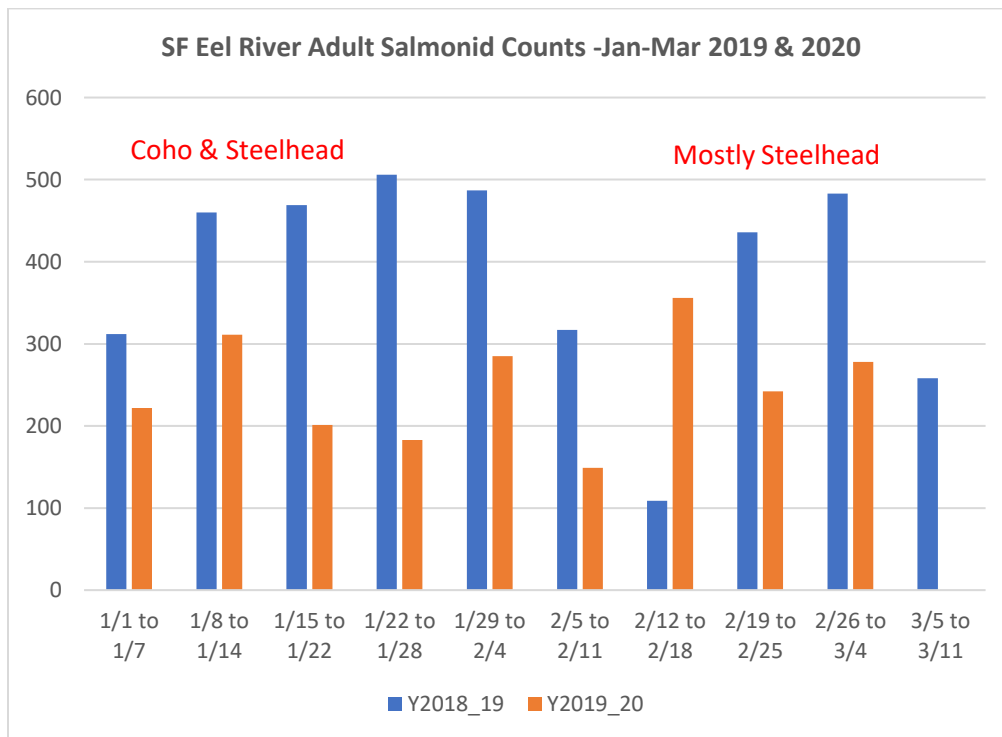
Figure 68. Adult salmon and steelhead counts according to DIDSON data in early 2019 and 2020. Data from Metheny (2020).
